Expertise

Protocol number: 48034457
Order No. / Reference: 27099146
Inspection date: 7 Oct 2026

Manufacturer: Mercedes-Benz	Model: C 220 d T 9G-TRONIC AMG Line
VIN: W1KAH0EB0PF115850

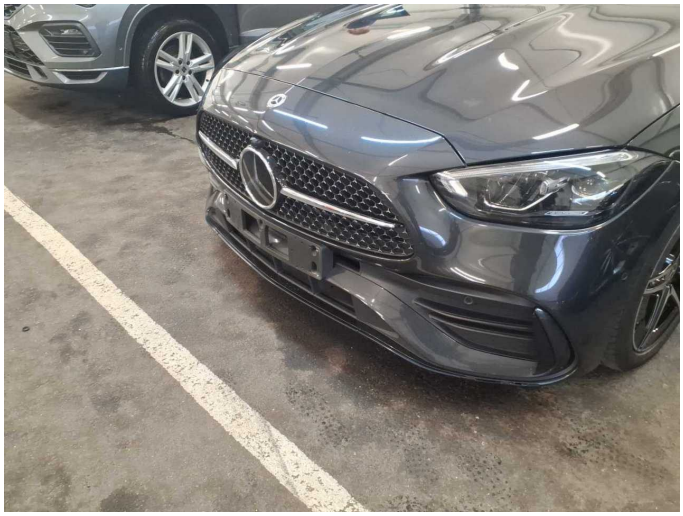
No.	Component group	Description
1	Front bumper	Front bumper - Scratched - Smart repair
2	Front bumper	Spoiler (Blende) - Damaged - Replace
3	Wheel / tyres	Tyres - complete set - Worn - Replace
4	Door - front right side	Door - Scratch(es) - Paint

Damage 1: Front bumper: Front bumper - Scratched - Smart repair
