Expertise

Protocol number: 48499364
Order No. / Reference: 27186065
Inspection date: 4 Nov 2026

Manufacturer: Skoda	Model: Kodiaq 2.0 TDI DSG Sportline
VIN: TMBJJ7NS3N8041459

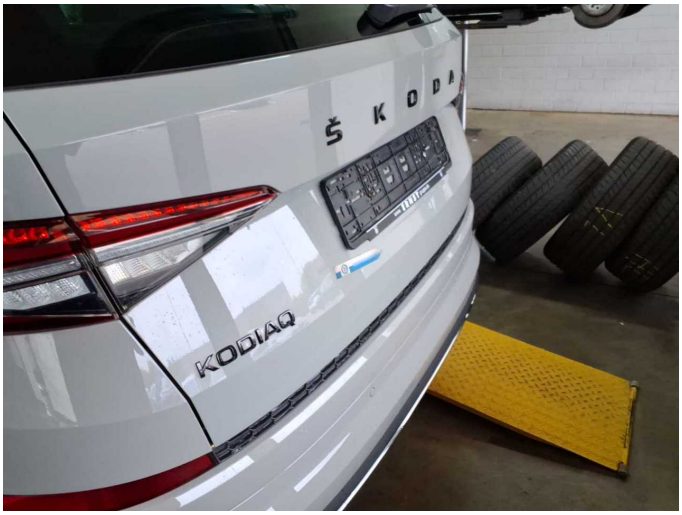
Figure 32: Misc.

Damage 1: Equipment: Tirefit filler - Expired - Replace
