Expertise

Protocol number: 48046913
Order No. / Reference: 27174774
Inspection date: 12 Oct 2026

Manufacturer: Mercedes-Benz	Model: C 200 d T 9G-TRONIC Avantgarde
VIN: W1KAH0DB3PF120302

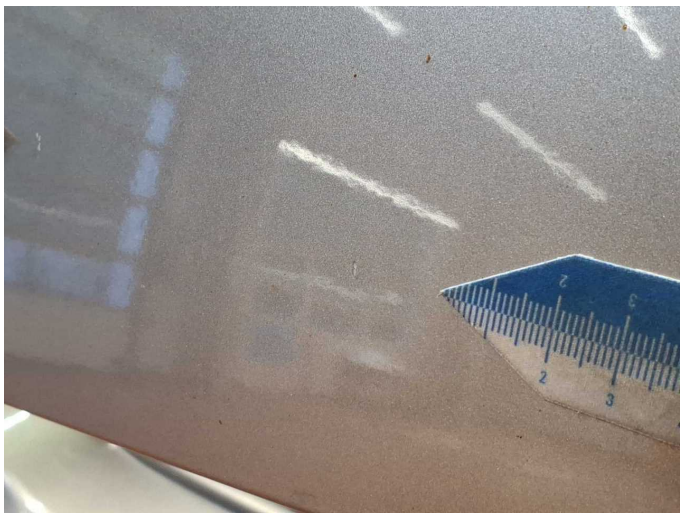
Damage 4: Boot lid / rear door: Boot lid - Dent / paintcoat damage - Smart repair

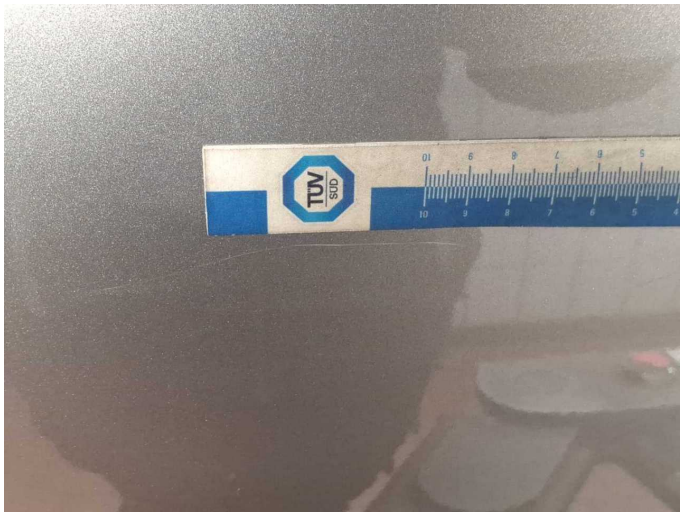
Damage 7: Door - rear right side: Door - Scratch(es) - Paint

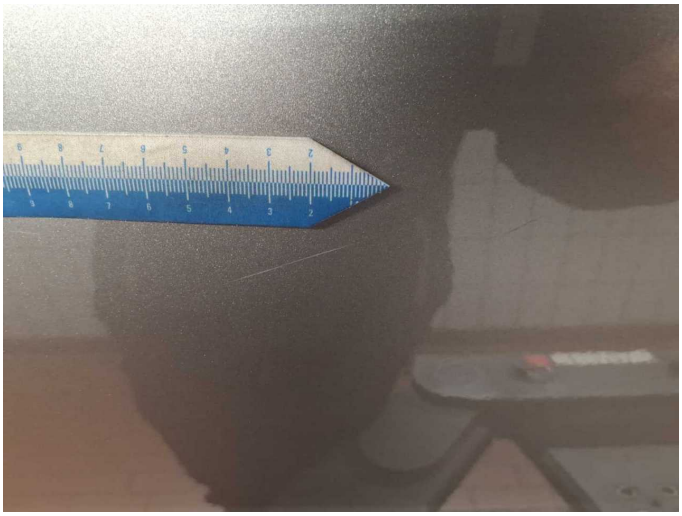
Damage 7: Door - rear right side: Door - Scratch(es) - Paint
