Expertise

Protocol number: 48036174
Order No. / Reference: 27134897
Inspection date: 9 Oct 2026

Manufacturer: Skoda	Model: Octavia Combi 2.0 TDI DSG Ambition
VIN: TMBJG8NX3PY157523

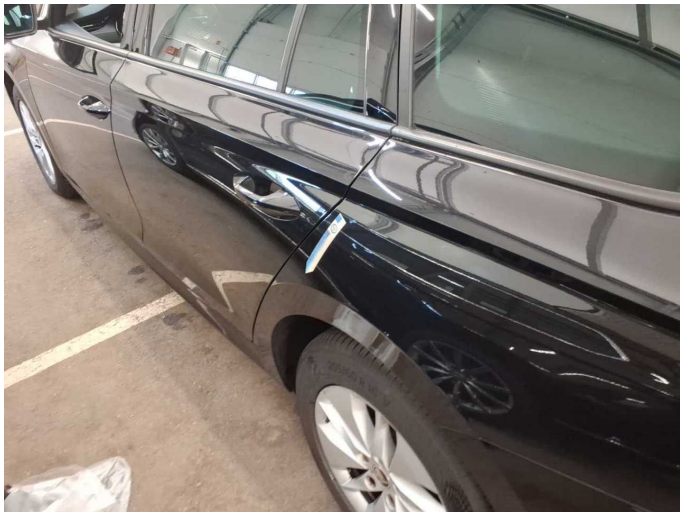
Damage 2: Door - front left side: Door handle - outside - Scratch(es) - Smart repair

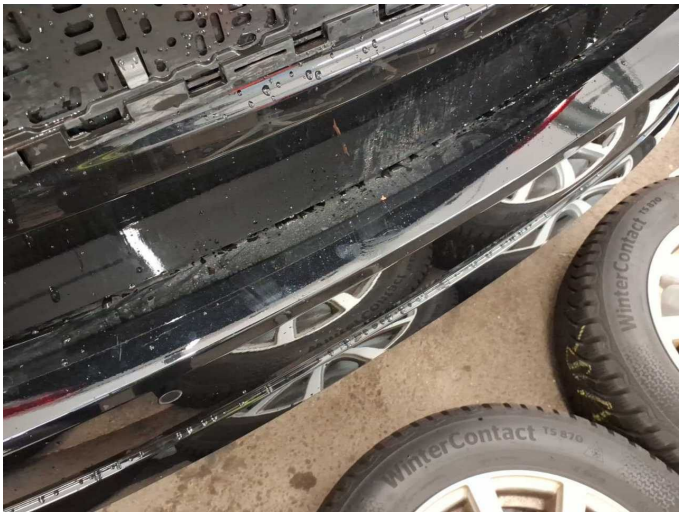
Wear and tear 1: Front bumper: Front bumper (Kratzer nicht spürbar nur oberflächlich) - Scratch(es) - No deduction
