Expertise

Protocol number: 48306131
Order No. / Reference: 26927910
Inspection date: 26 Oct 2026

Manufacturer: Ford	Model: Transit Connect 240 L1 Trend
VIN: WF0RXXWPGRNA86731

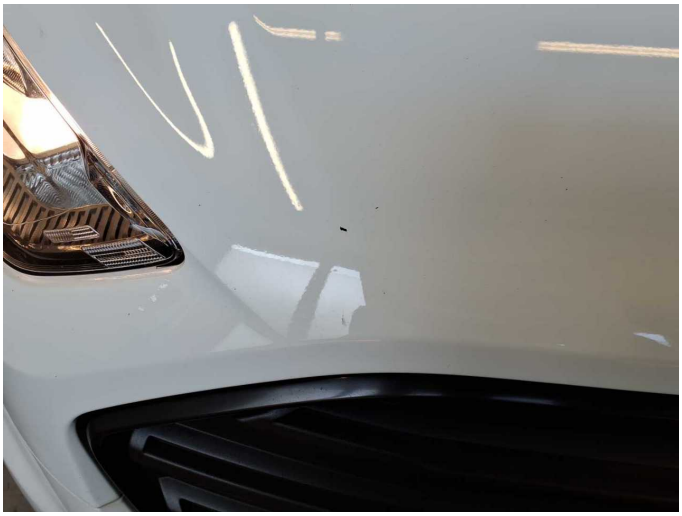
Damage 5: Front bumper: Front bumper - Scratch(es) - Paint
