VOLKSWAGEN ID.5

Vehicle information

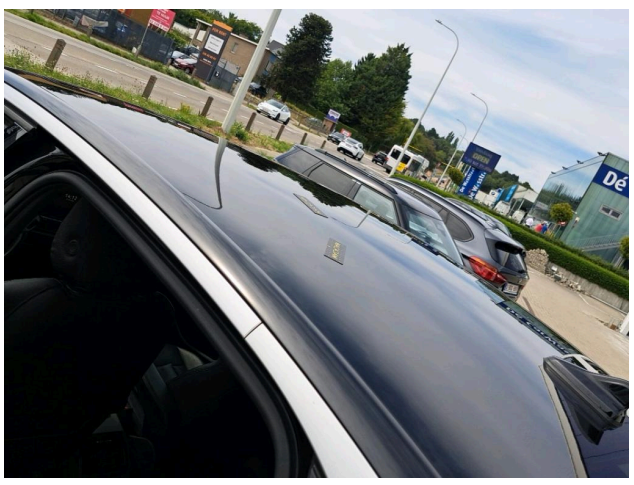
Acceptable.

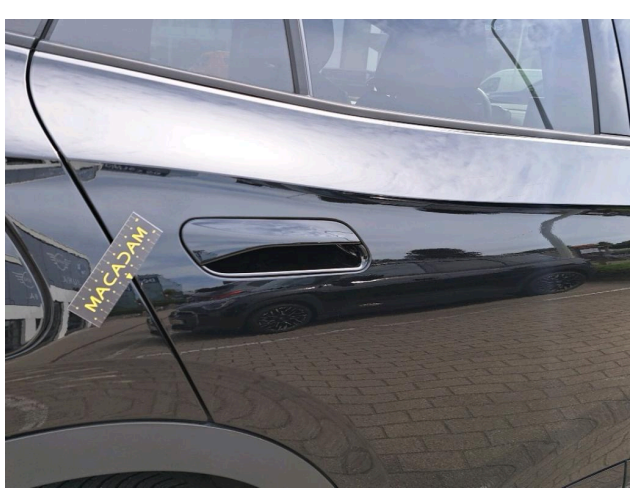
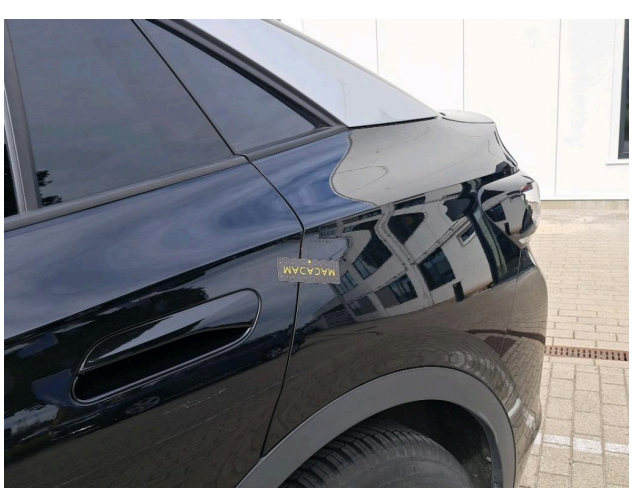
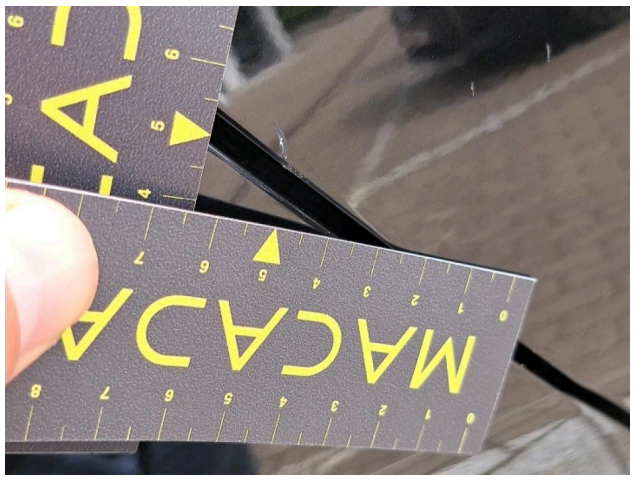
Roof & other

Fuel filler flap
deformed/forced
- Replace and paint
roof & other

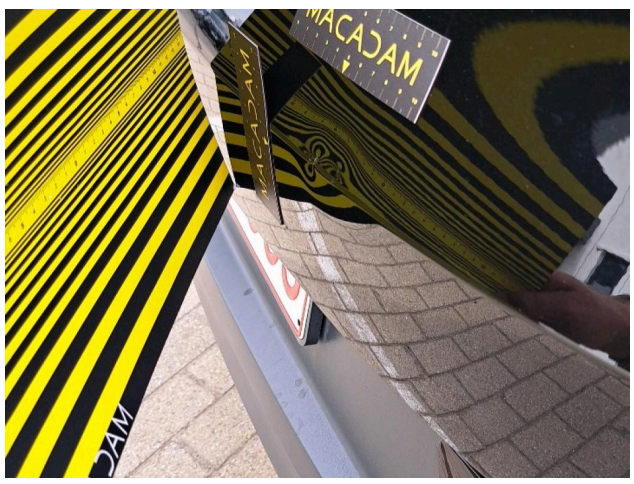
Trunk/
Hatchback Dent(s)
LI - Repair and Paint (Complete)
Rear

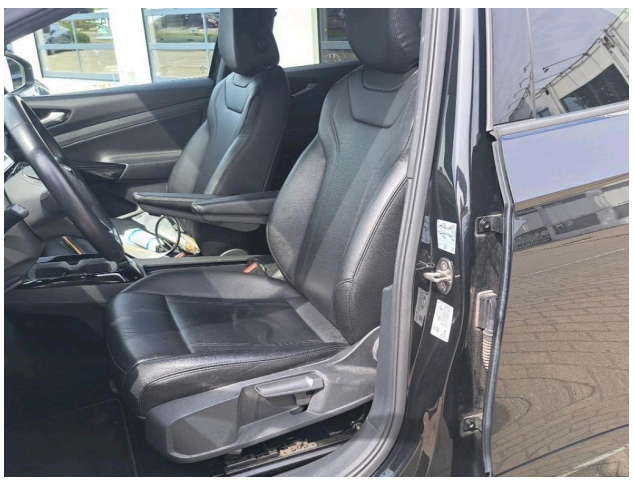
Damaged **Interior**
- Acceptable
Interior

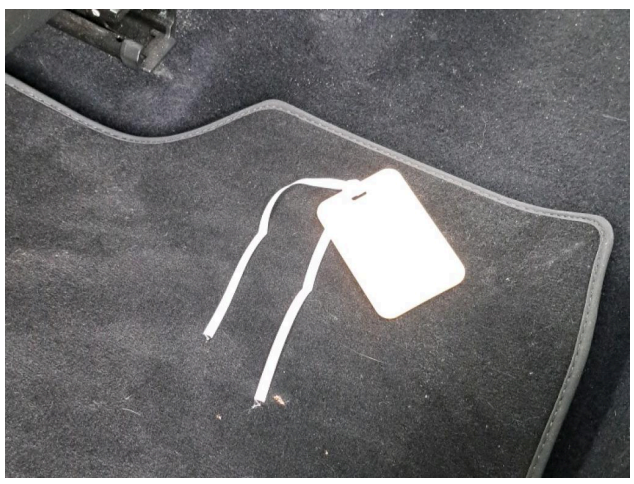
Interior
Odor
Treatment: Ozone Treatment

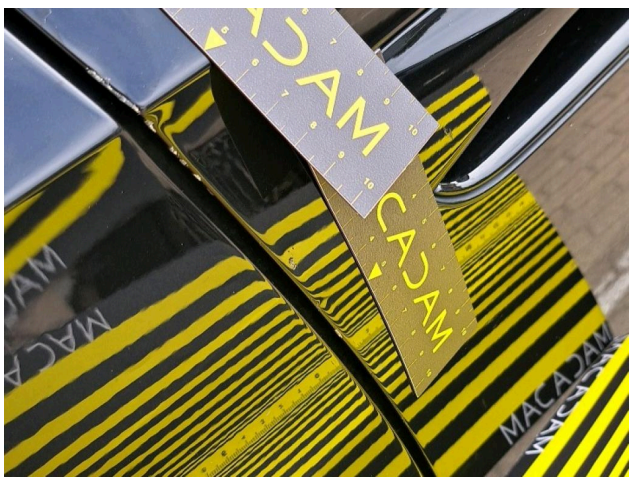
Front **Right Door -**
Dent(s) and Scratch(es)
- Repair and Paint (Complete)
