MACADAM

BYD Atto 3 '22 BEV

Vehicle information

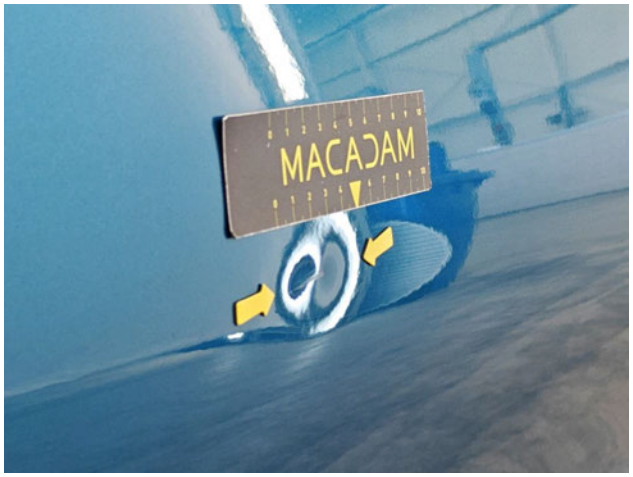
Bumper F
Scratch(es)
Repair and paint (complete)
Front

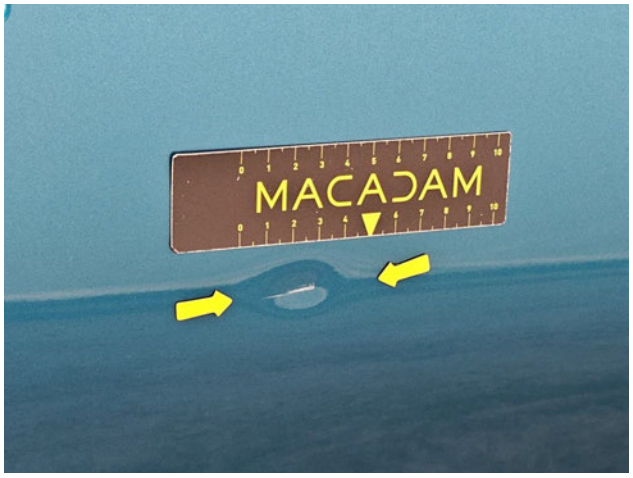
Door FL
Scratch(es)
Repair and paint (complete)
Left

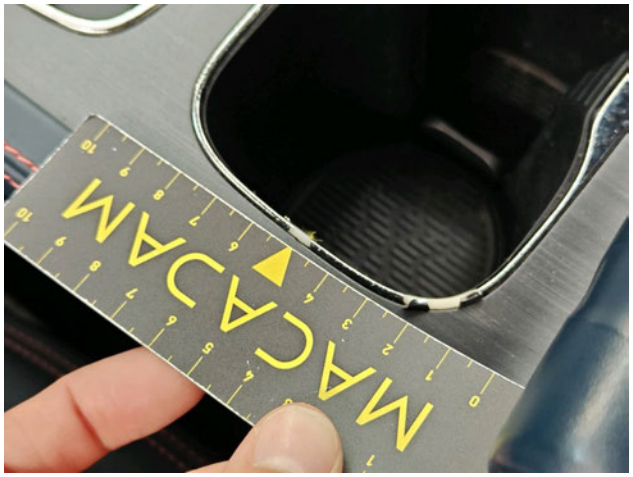
Gear shift lever knob
Worn
Replace
Interior
