Expertise

Protocol number: 48237317
Order No. / Reference: 27140019
Inspection date: 21 Oct 2026

Manufacturer: Volkswagen	Model: Passat Variant 2.0 TDI SCR DSG Business
VIN: WVWZZZ3CZNE085222

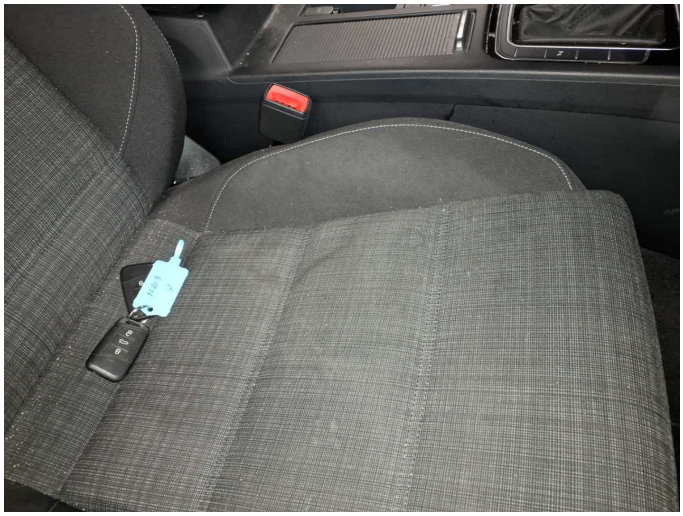
No.	Component group	Description
1	Equipment	Vehicle key with remote control (Batterie) - Empty - Replace
2	Interior	Interior (Flecken) - Soiled - Clean
3	Body	Door seal - front left side - Broken / torn - Replace
4	Front bumper	Front bumper - Scratch(es) - Paint
5	Bonnet	Bonnet - Dent / paintcoat damage - Repair and paint

Damage 1: Equipment: Vehicle key with remote control (Batterie) - Empty - Replace

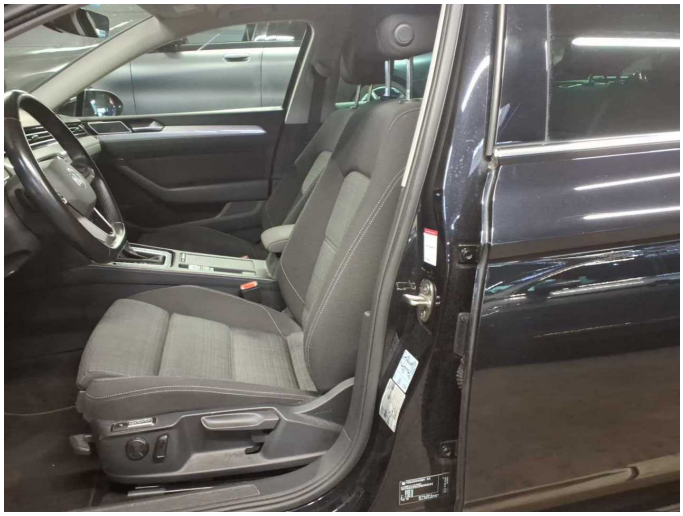
Damage 2: Interior: Interior (Flecken) - Soiled - Clean

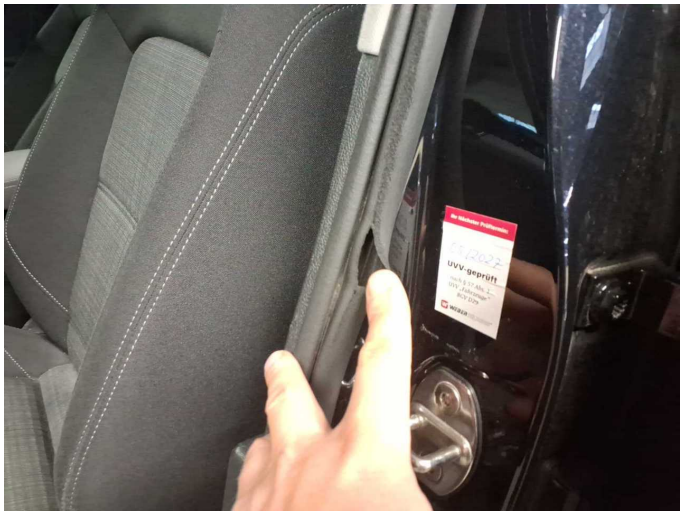
Damage 3: Body: Door seal - front left side - Broken / torn - Replace

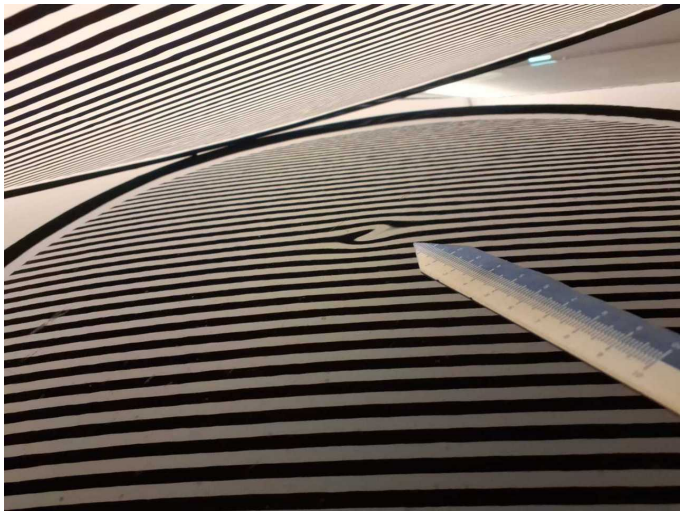
Damage 4: Front bumper: Front bumper - Scratch(es) - Paint

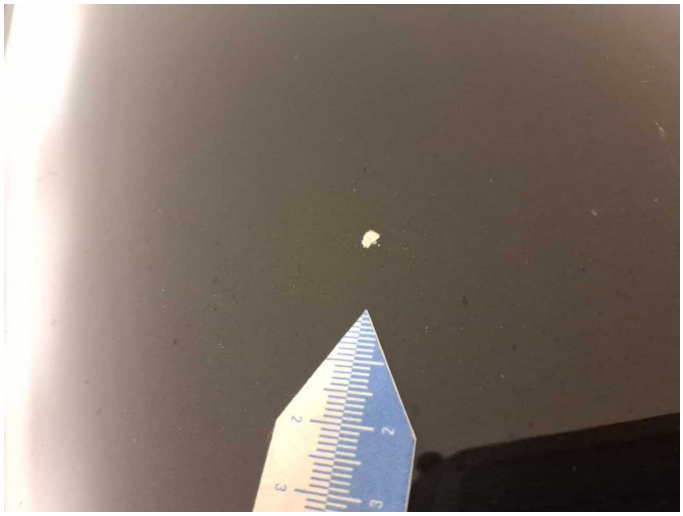
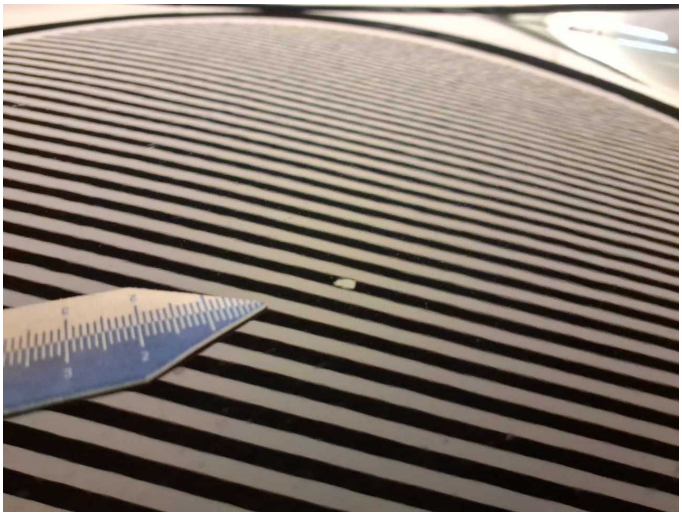
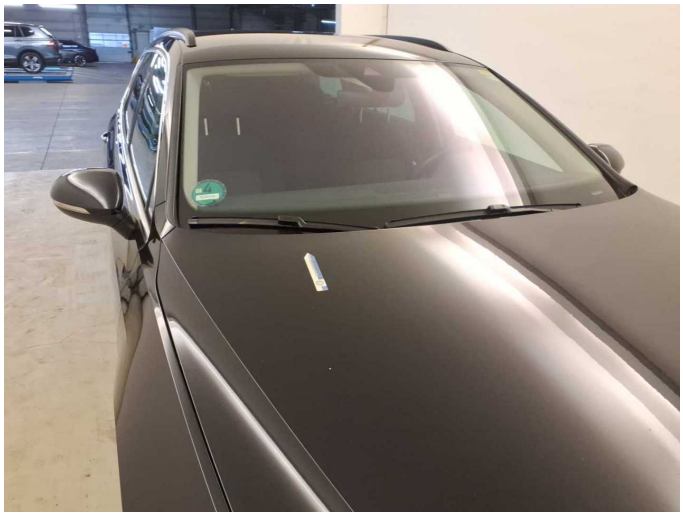
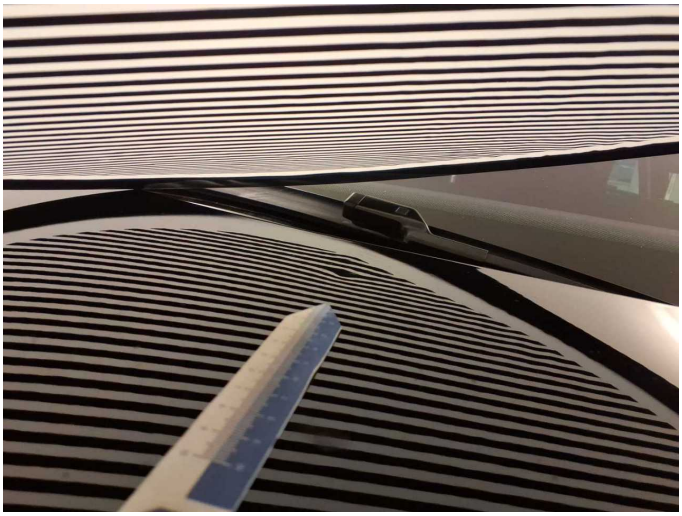
Damage 5: Bonnet: Bonnet - Dent / paintcoat damage - Repair and paint
