Expertise

Protocol number: 47952865
Order No. / Reference: 26883481
Inspection date: 6 Oct 2026

Manufacturer: Opel	Model: Astra Sports Tourer 1.5 D Automatik Business Elegance
VIN: VXKFCYHZTP1039697

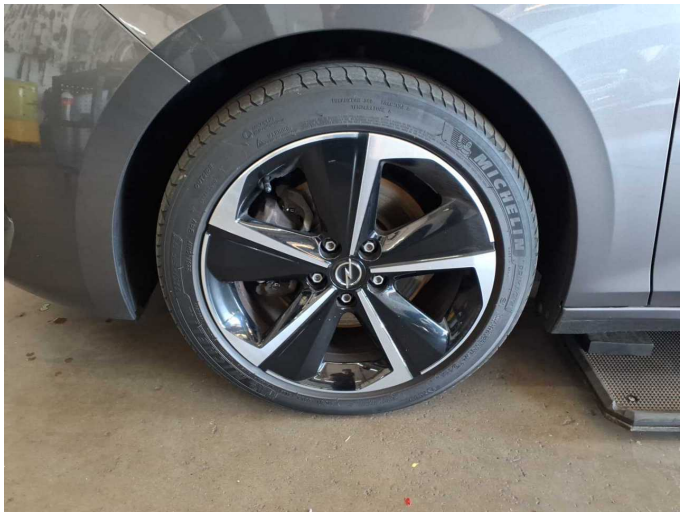
Figure 11: Mounted tyres

#	Tyre size	Type of tyre	Manufacturer	Tread depth
1)	225/45 R17 94V	Summer tyres on Light alloy	Michelin	2mm / 2mm
2)	225/45 R17 94V	Summer tyres on Light alloy	Michelin	4mm / 4mm

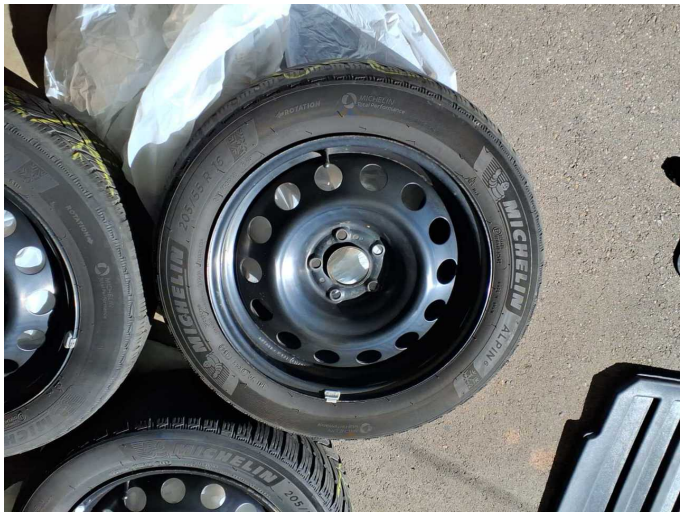
Figure 18: Additional tyres

#	Tyre size	Type of tyre	Manufacturer	Tread depth
1)	205/55 R16 91H	Winter tyres on Steel	Michelin	0mm / 0mm
2)	205/55 R16 91H	Winter tyres on Steel	Michelin	3mm / 3mm

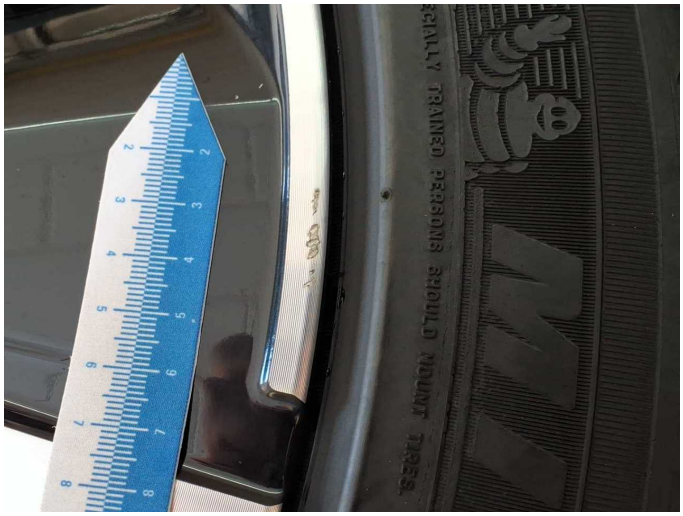
Damage 2: Wheel / tyres: Alloy rim - rear right side - Scratch(es) - Loss in value

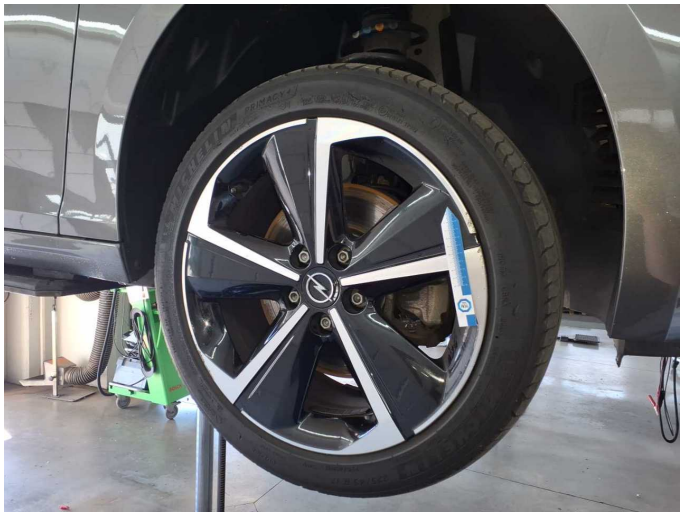
Damage 2: Wheel / tyres: Alloy rim - rear right side - Scratch(es) - Loss in value

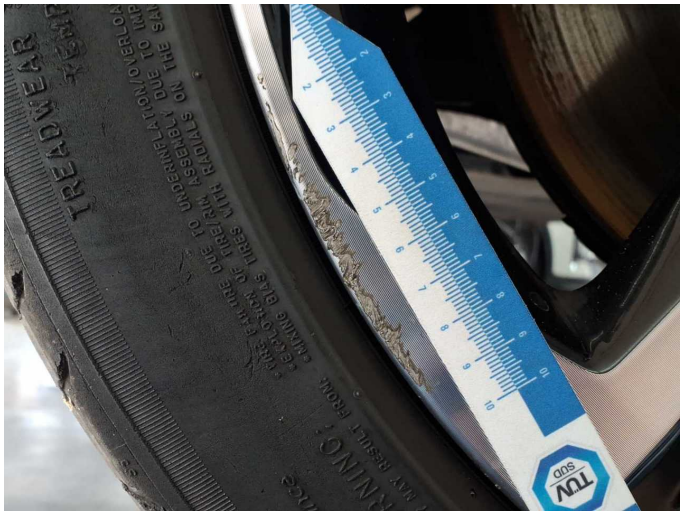
Damage 3: Wheel / tyres: Alloy rim - front right side - Scratched - Loss in value

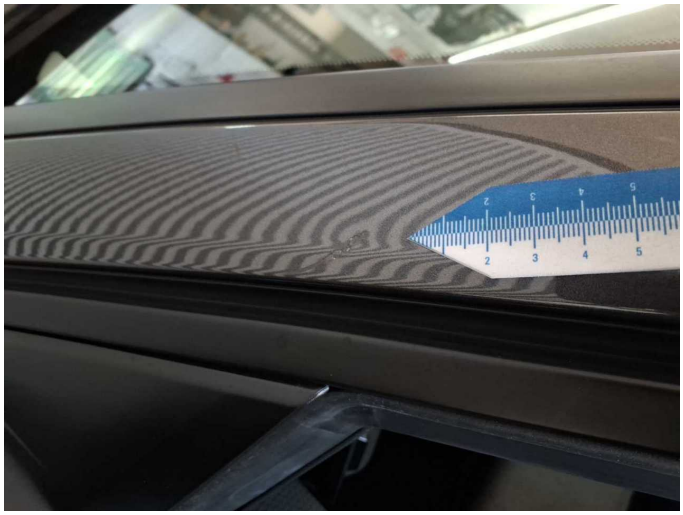
Damage 5: Body: A-pillar - left side - Dent / paintcoat damage - Smart repair
