Expertise

Protocol number: 48198583
Order No. / Reference: 27115635
Inspection date: 19 Oct 2026

Manufacturer: Skoda	Model: Octavia Combi 2.0 TDI DSG Tour
VIN: TMBJJ8NX9PY164266

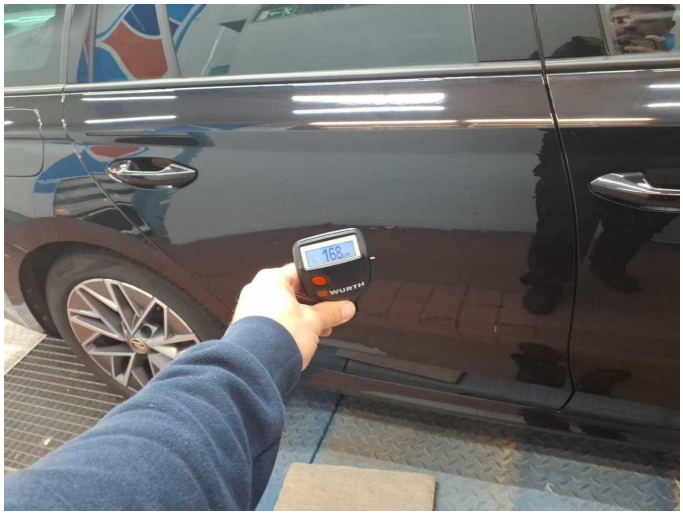
No.	Repainting
1	Bonnet, Side panel - rear left side, Door - rear right side, Professionally carried out, Invoice of repair done Non-existent

Bonnet	255 µm	Side panel - rear left side	155 µm
Door - rear right side	168 µm

Repainting 1: Bonnet, Side panel - rear left side, Door - rear right side

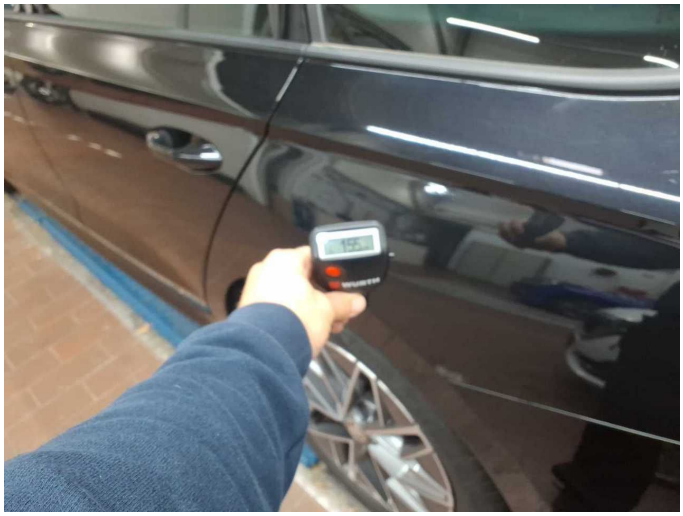
Repainting 1: Bonnet, Side panel - rear left side, Door - rear right side
