# Expertise

Protocol number: 48376794
Order No. / Reference: 27175290
Inspection date: 28 Oct 2026

| Manufacturer: Ford | Model: Transit Connect 230 L2 S&S Trend |
| VIN: WF07XXWPG7NY75975 | |

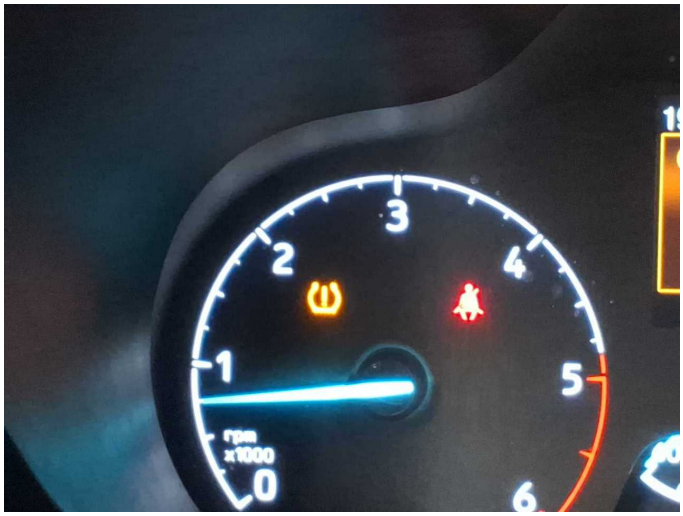
| No. | Component group | Description |
|---|---|---|
| 3 | Wheel / tyres | Tyre - front left side - Leaking - Replace |

**Damage 3:** Wheel / tyres: Tyre - front left side - Leaking - Replace

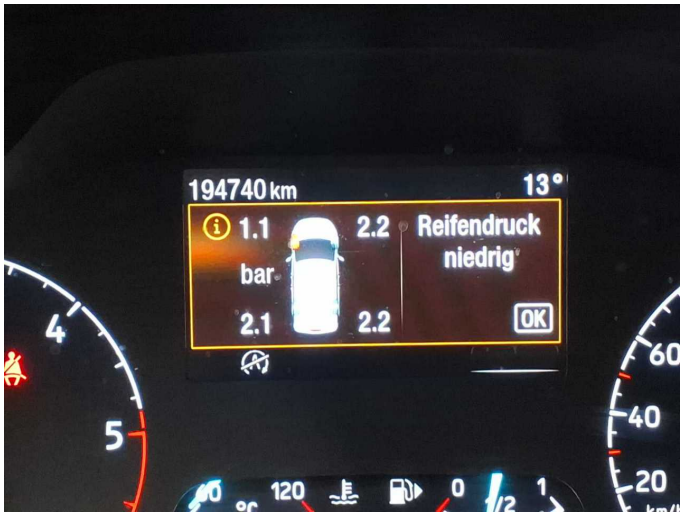
**Damage 3:** Wheel / tyres: Tyre - front left side - Leaking - Replace

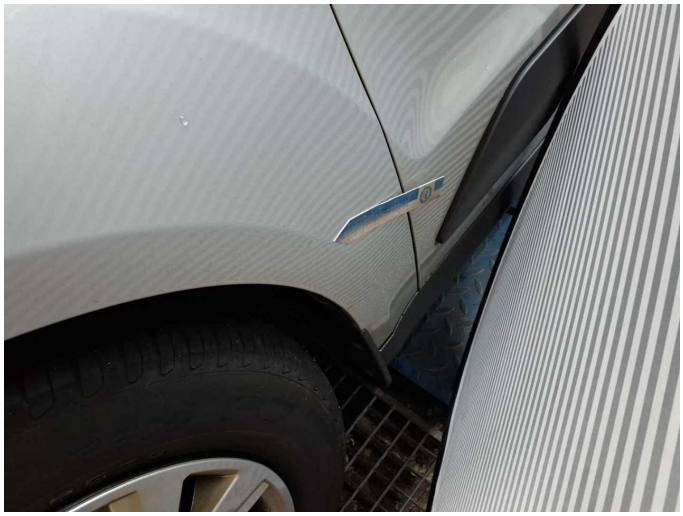
| No. | Component group | Description |
|---|---|---|
| 6 | Mudguard - left side | Mudguard - left side - dent(s) - No deduction |

**Wear and tear 6:** Mudguard - left side: Mudguard - left side - dent(s) - No deduction
