TÜV SÜD Auto Partner GmbH
Wiesenring 2
04159 Leipzig

Expertise

Protocol number: 48445718
Order No. / Reference: 27171644
Inspection date: 31 Oct 2026

Manufacturer: Audi	Model: A4 Avant 30 TDI S tronic
VIN: WAUZZZF46RA061563

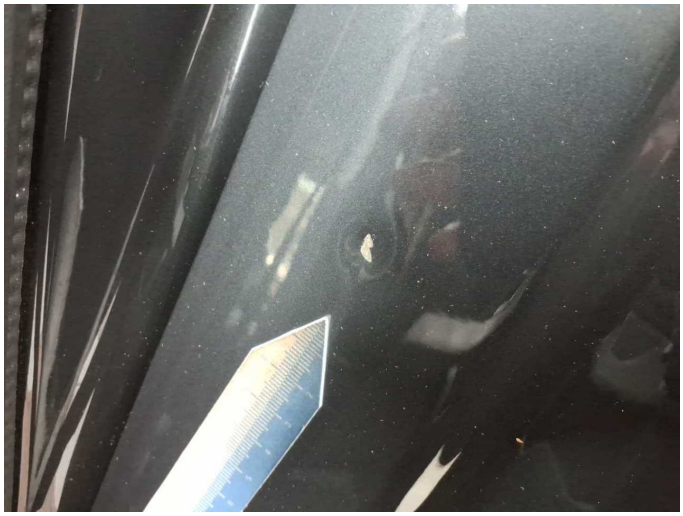
No.	Component group	Description
1	Side panel - rear right side	Side panel - dent(s) - Smart repair
2	Side panel - rear left side	Sill - Dent / paintcoat damage - Smart repair
3	Wheel / tyres	Alloy rim - rear right side - Scratch(es) - Loss in value

Damage 1: Side panel - rear right side: Side panel - dent(s) - Smart repair
