TÜV SÜD Auto Partner GmbH
Wiesenring 2
04159 Leipzig

Expertise

Protocol number: 48238552
Order No. / Reference: 27107726
Inspection date: 21 Oct 2026

Manufacturer: Mercedes-Benz	Model: C 200 d T 9G-TRONIC Avantgarde
VIN: W1KAH0DB5PF118261

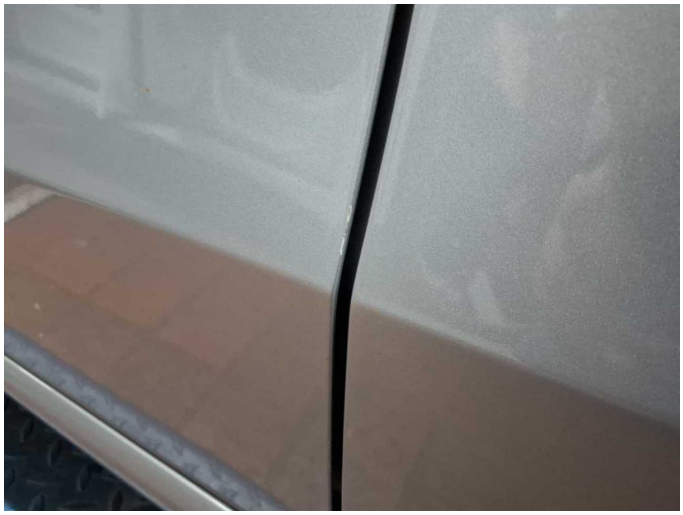
No.	Component group	Description
1	Door - front left side	Door - Scratch(es) - Smart repair
2	Door - rear left side	Brightware - centre - Scratch(es) - Replace

Damage 1: Door - front left side: Door - Scratch(es) - Smart repair
