Expertise

Protocol number: 48463068
Order No. / Reference: 27236927
Inspection date: 30 Oct 2026

Manufacturer: Ford	Model: Transit 310 L2H2 Lkw VA Trend Kasten
VIN: WF0EXXTTREKM31791

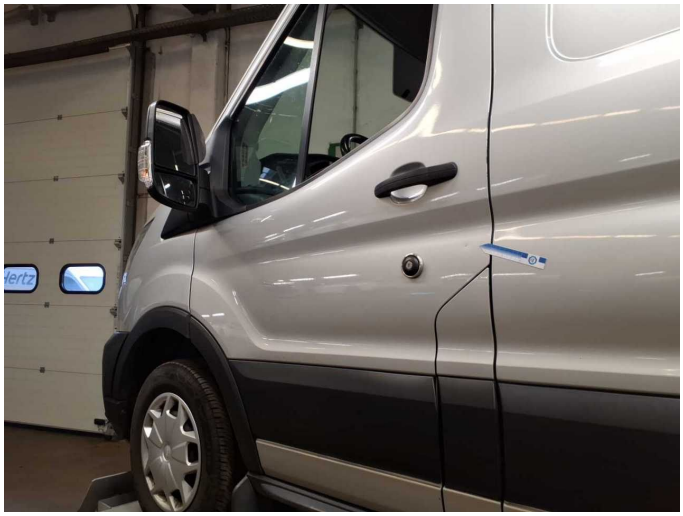
Damage 1: Rear bumper: Rear bumper - Scratch(es) - Loss in value

Damage 2: Door - front left side: Door - Dent / paintcoat damage - Smart repair

Damage 3: Boot lid / rear door: Rear door - right side - Scratch(es) - Smart repair

Damage 4: Boot lid / rear door: Rear door - left side - Dent / paintcoat damage - Smart repair

Accident 1: Side right

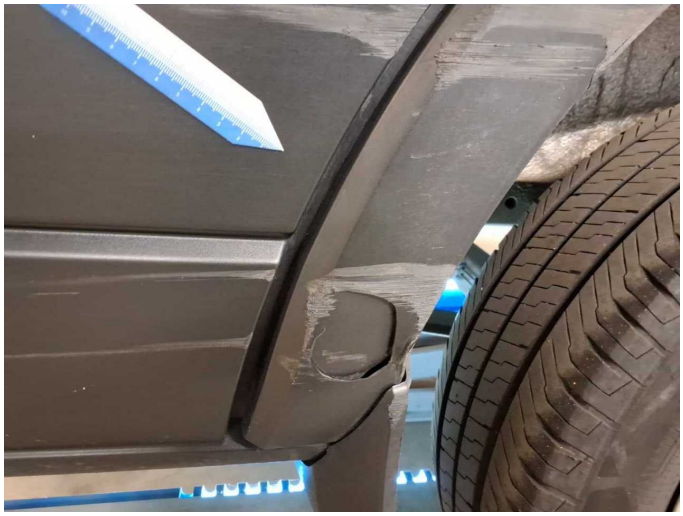
Accident 1: Side right
