Expertise

Protocol number: 48492289
Order No. / Reference: 27087403
Inspection date: 4 Nov 2026

Manufacturer: Opel	Model: Astra 1.5 D Start/Stop Sports Tourer Ultimate
VIN: W0VBE8EV8M8022063

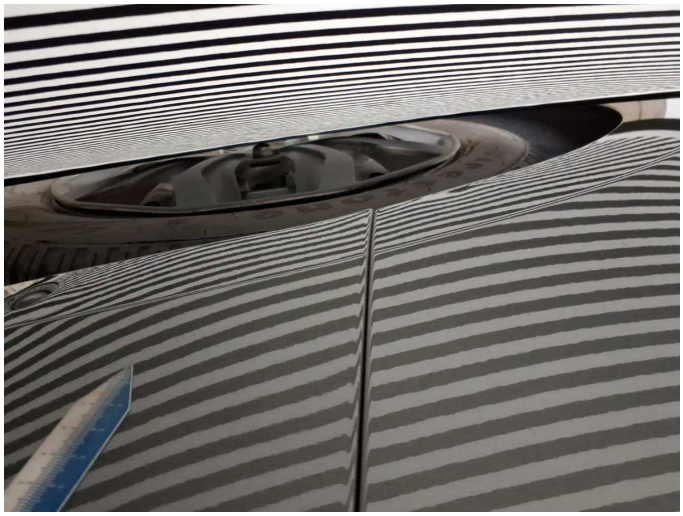
No.	Accident
1	Rear, Side - left

Accident 1: Rear, Side - left
