2CTV323

INSPECTION REPORT

End of contract

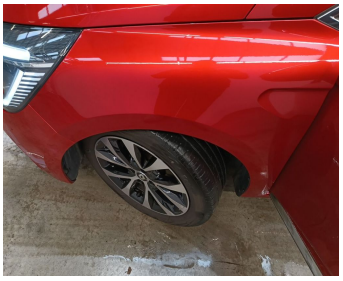
Door Front Left // Painting-bad repair

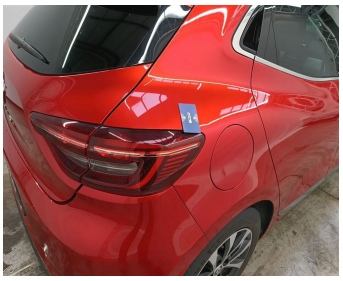
Trunk Lid Interior Coating / Complete Panel / Replace-cracked
