TÜV SÜD Auto Partner GmbH
Wiesenring 2
04159 Leipzig

Expertise

Protocol number: 48511973
Order No. / Reference: 27208692
Inspection date: 4 Nov 2026

Manufacturer: Audi	Model: A5 Sportback 40 TDI S tronic S line business
VIN: WAUZZZF58RA031876

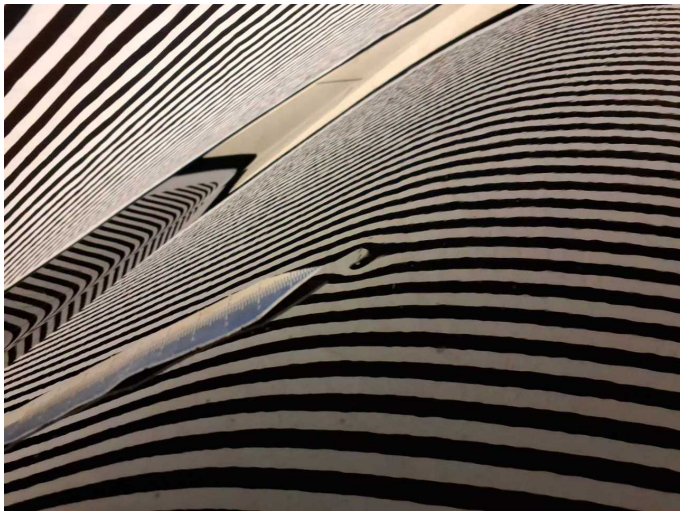
Damage 7: Door - rear left side: Door - Dent / paintcoat damage - Smart repair

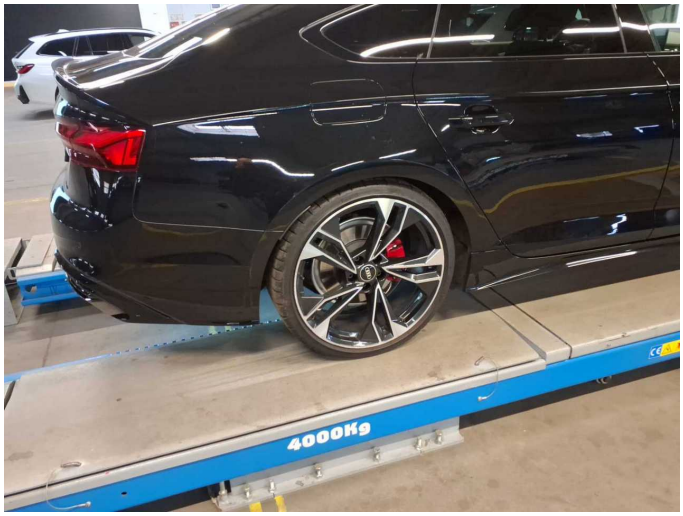
Damage 11: Wheel / tyres: Alloy rim - rear left side (Materialabtrag) - Scratched - Loss in value

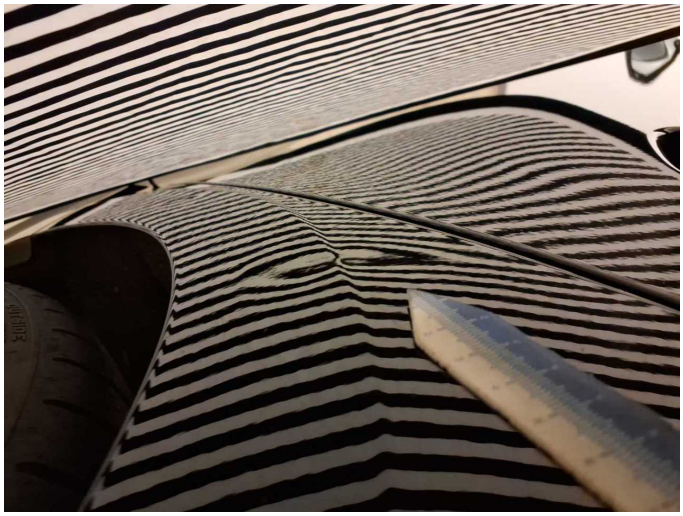
Damage 16: Side panel - rear left side: Side panel - Dent / paintcoat damage - Repair and paint

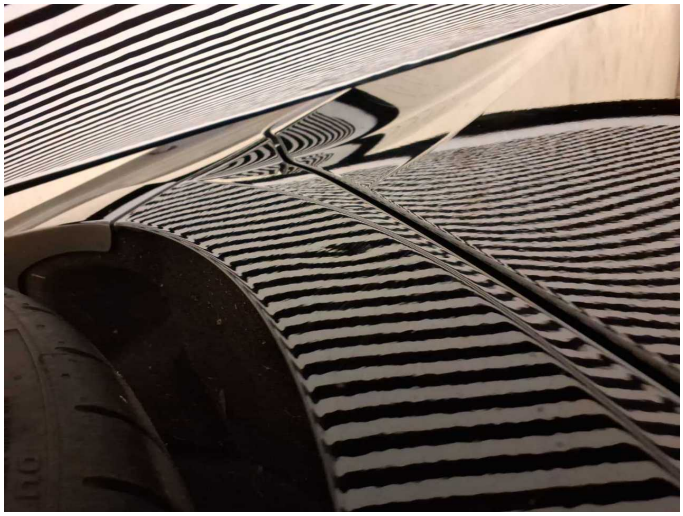
Damage 16: Side panel - rear left side: Side panel - Dent / paintcoat damage - Repair and paint

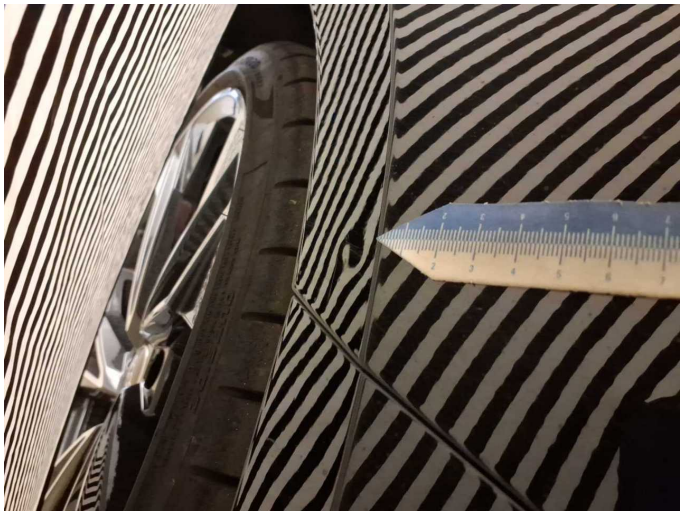
Damage 17: Mudguard - right side: Mudguard - right side - Dent / paintcoat damage - Repair and paint

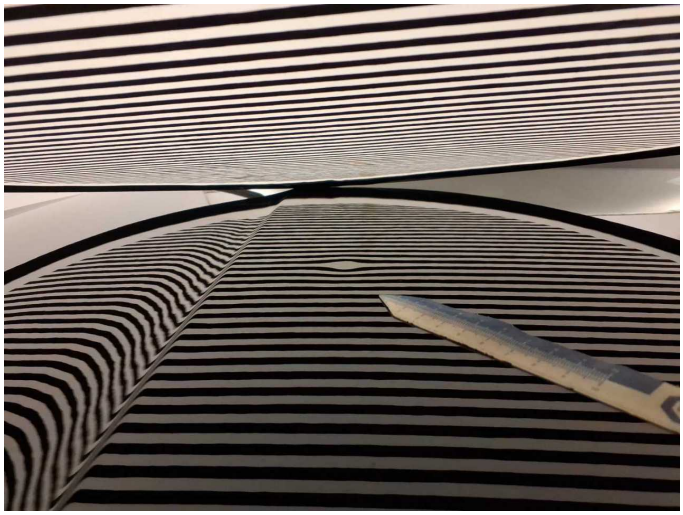
Damage 17: Mudguard - right side: Mudguard - right side - Dent / paintcoat damage - Repair and paint

Damage 18: Bonnet: Bonnet (Rostbildung) - Dent / paintcoat damage - Repair and paint

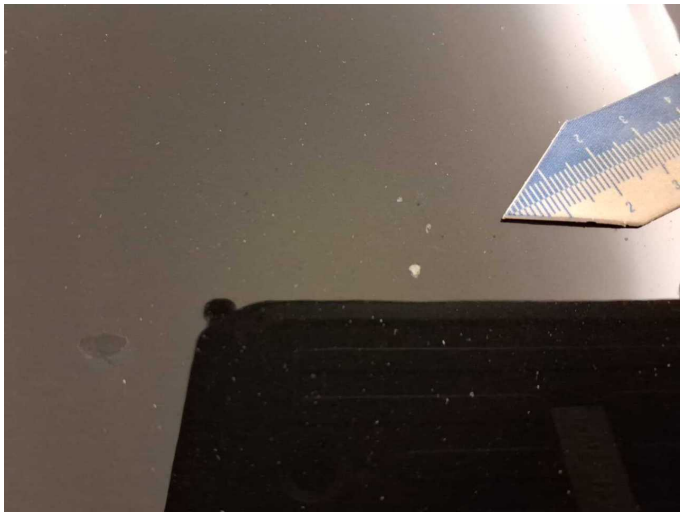
Damage 18: Bonnet: Bonnet (Rostbildung) - Dent / paintcoat damage - Repair and paint

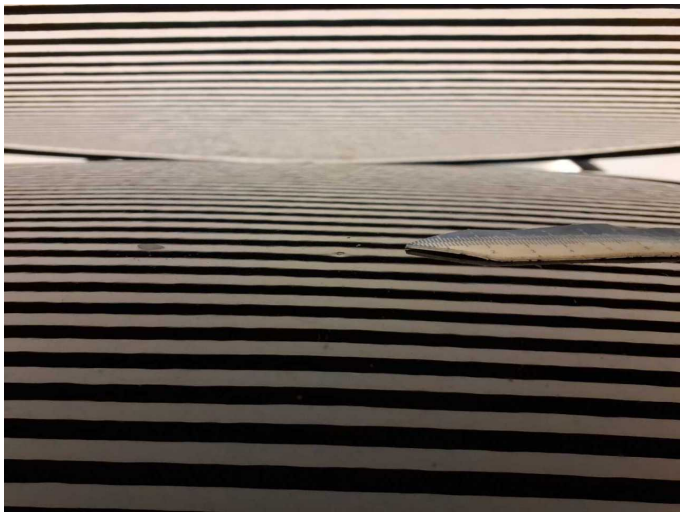
Damage 18: Bonnet: Bonnet (Rostbildung) - Dent / paintcoat damage - Repair and paint

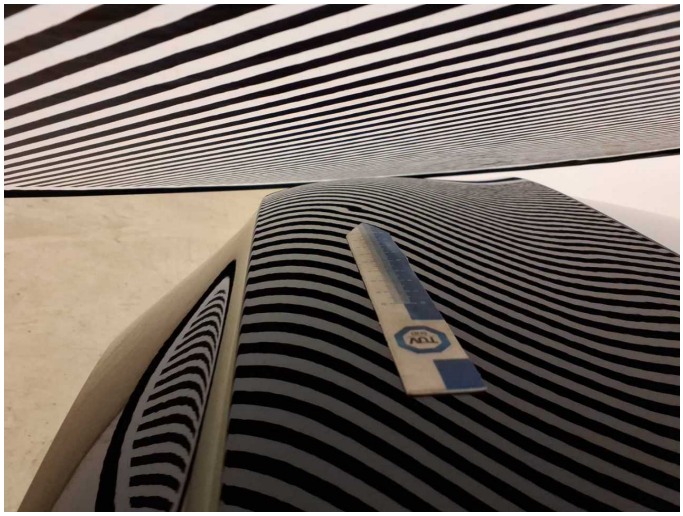
Damage 18: Bonnet: Bonnet (Rostbildung) - Dent / paintcoat damage - Repair and paint
