Expertise

Protocol number: 48264091
Order No. / Reference: 26997224
Inspection date: 21 Oct 2026

Manufacturer: Skoda	Model: Superb Combi 2.0 TSI DSG Style
VIN: TMBJM9NP0R7023141

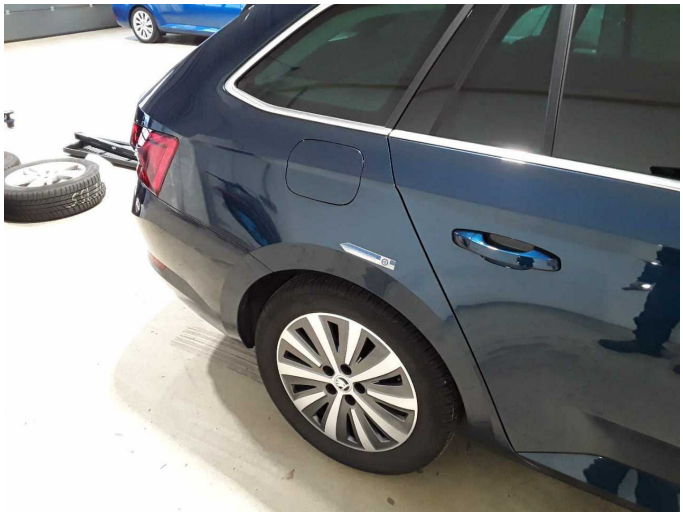
No.	Component group	Description
1	Side panel - rear left side	Sill - Dent / paintcoat damage - Smart repair
2	Side panel - rear right side	Side panel - Scratch(es) - Paint
3	Rear bumper	Rear bumper - Scratch(es) - Paint
4	Front bumper	Front bumper - Scratch(es) - Paint

Damage 1: Side panel - rear left side: Sill - Dent / paintcoat damage - Smart repair

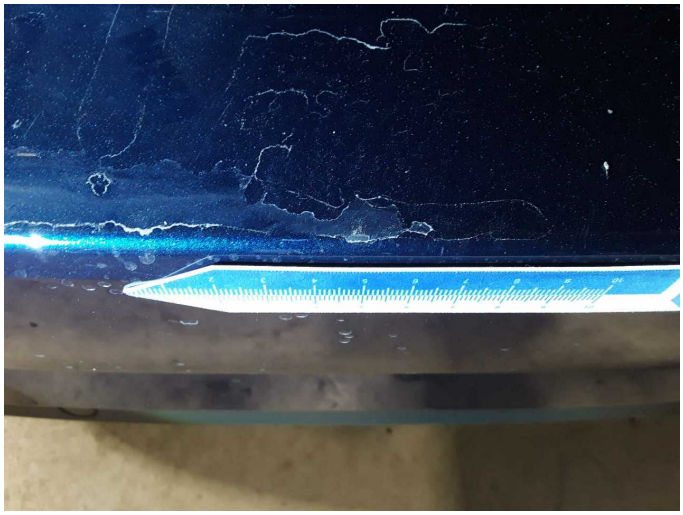
Damage 3: Rear bumper: Rear bumper - Scratch(es) - Paint

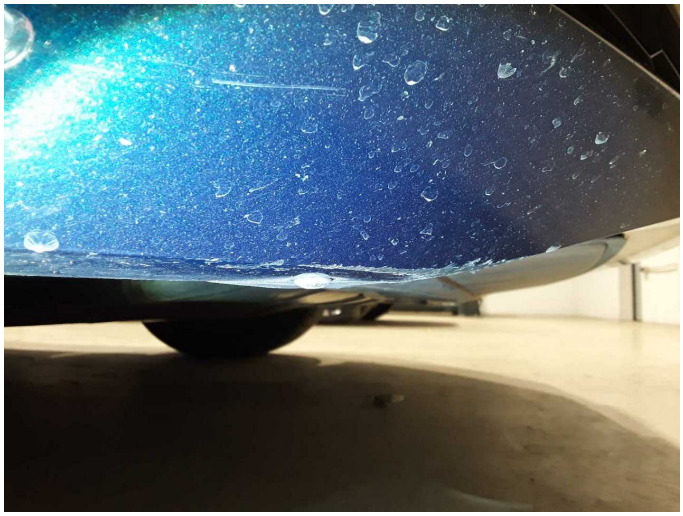
Damage 4: Front bumper: Front bumper - Scratch(es) - Paint
