Expertise

Protocol number: 48546650
Order No. / Reference: 27186722
Inspection date: 4 Nov 2026

Manufacturer: Volkswagen	Model: Passat Variant 2.0 TDI SCR DSG Elegance
VIN: WVWZZZ3CZPE067743

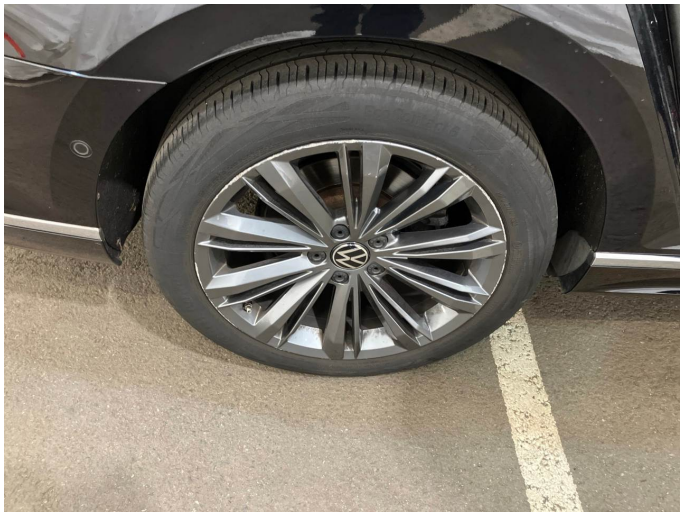
Figure 11: Mounted tyres

#	Tyre size	Type of tyre	Manufacturer	Tread depth
1)	235/45 R18 94W	Summer tyres on Light alloy	Continental	4mm / 4mm
2)	235/45 R18 94W	Summer tyres on Light alloy	Continental	3mm / 3mm

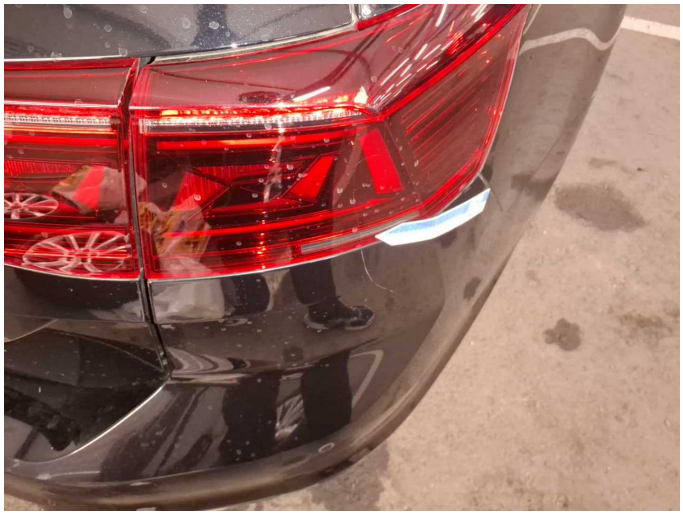
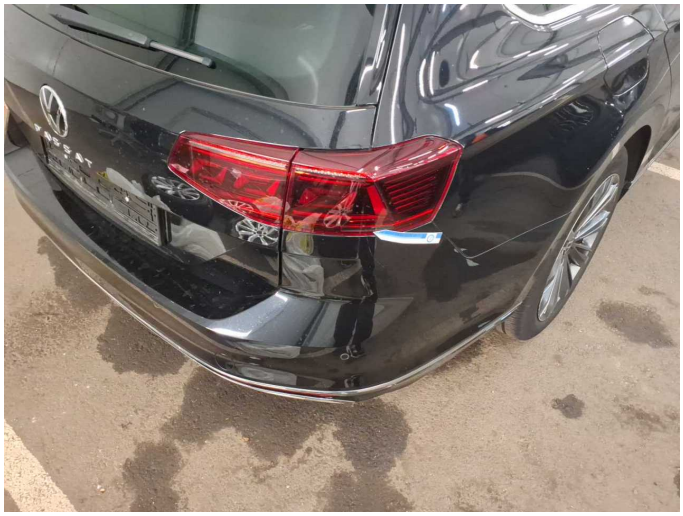
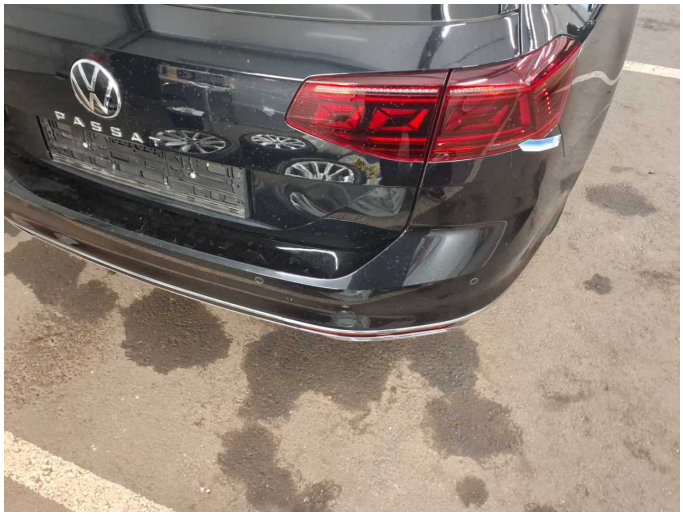
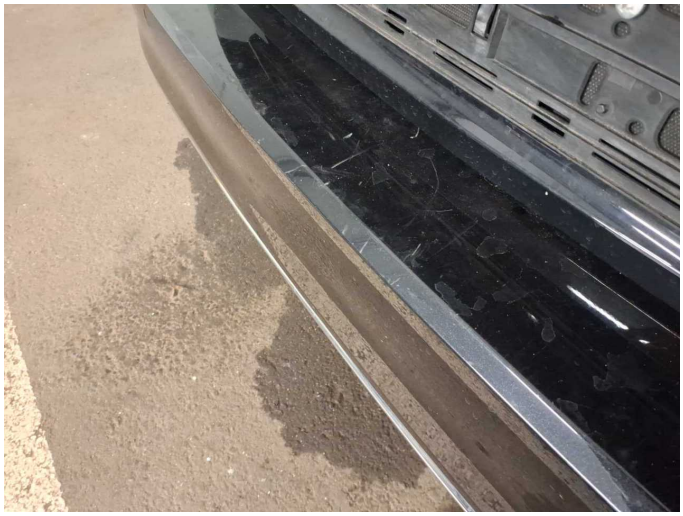
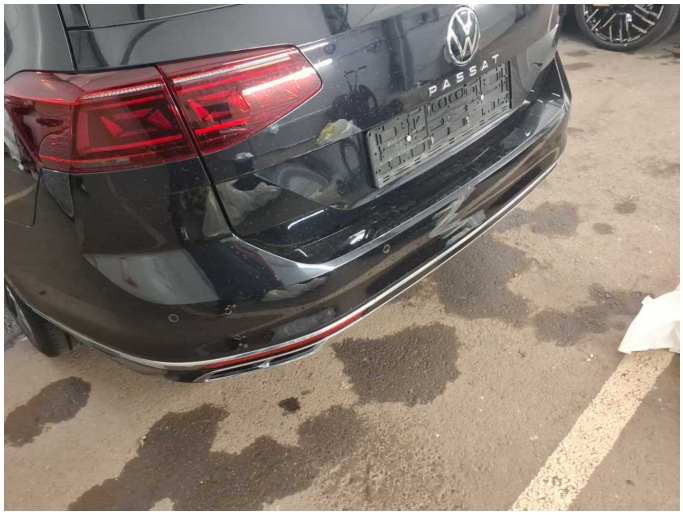
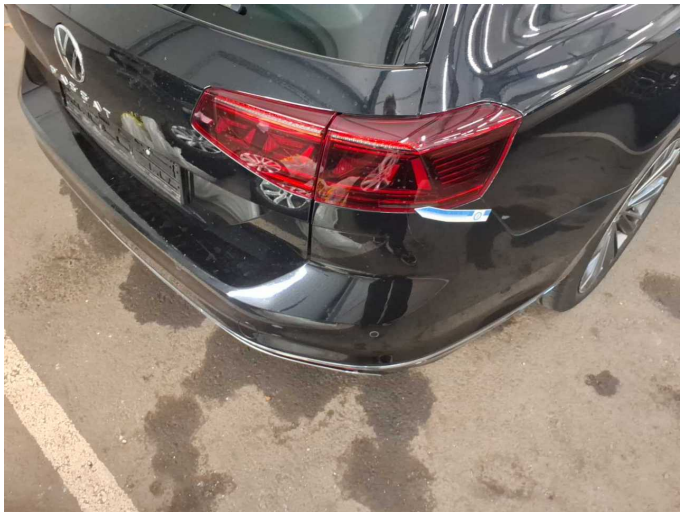
Accident 1: Rear

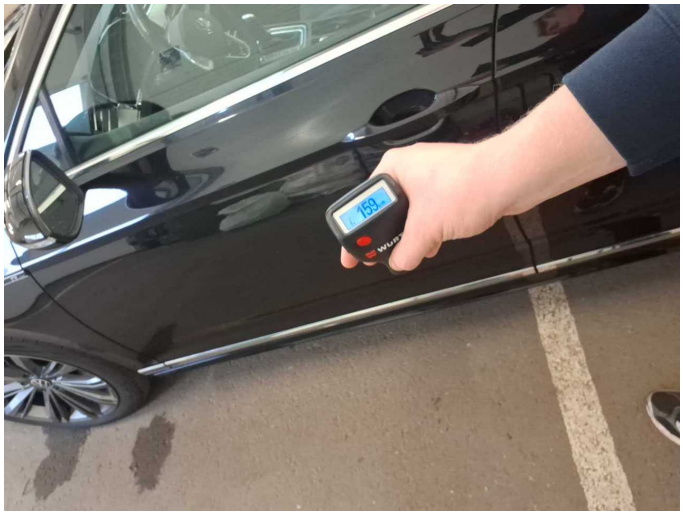
Side panel - rear left side	155 µm	Door - front left side	159 µm

Repainting 1: Side panel - rear left side

Repainting 2: Door - front left side
