# Expertise

Protocol number: 48502413
Order No. / Reference: 27135598
Inspection date: 2 Nov 2026

| Manufacturer: Opel | Model: Corsa-e Edition |
| VIN: VXKUHZKXZM4301523 | |

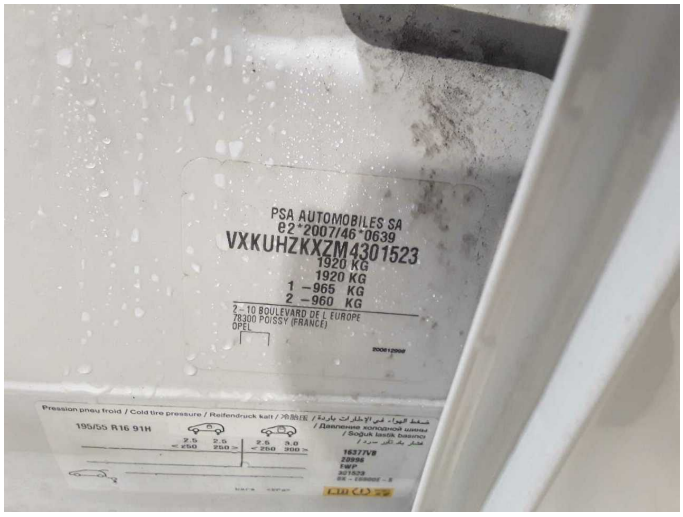
**Figure 10:** Cargo area

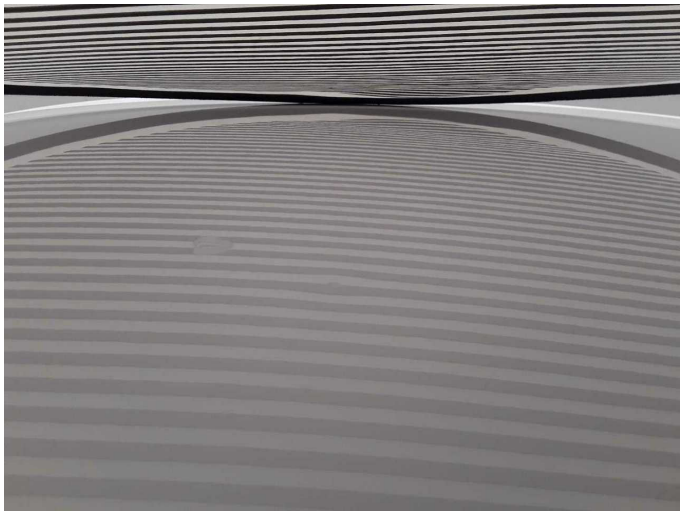
| No. | Component group | Description |
|---|---|---|
| 4 | Roof | Roof - dent(s) - No deduction |

**Wear and tear 4:** Roof: Roof - dent(s) - No deduction
