Expertise

Protocol number: 48468766
Order No. / Reference: 27092563
Inspection date: 31 Oct 2026

Manufacturer: Ford	Model: Focus Turnier 1.0 EcoBoost Hybrid Aut. ST-LINE X
VIN: WF0PXXGCHPSC41900

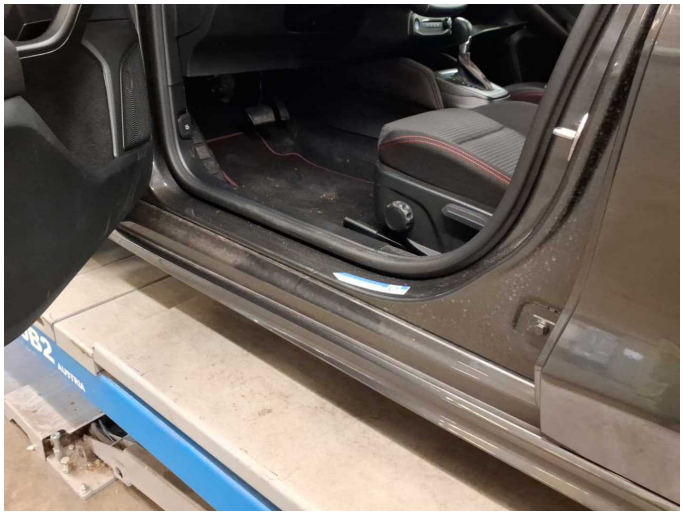
No.	Component group	Description
1	Sill - left side	Sill - Scratch(es) - Smart repair

Damage 1: Sill - left side: Sill - Scratch(es) - Smart repair
