ARVAL
BNP PARIBAS GROUP

2AMN105

INSPECTION REPORT

End of contract

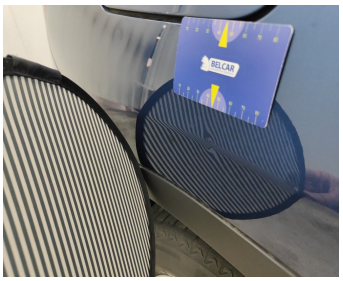
Bumper Front / Spoiler / Replace-dent

Rocker Panel Right // Smart Repair Medium-dent

Door Rear Right // Repair & Painting-scratch + dent

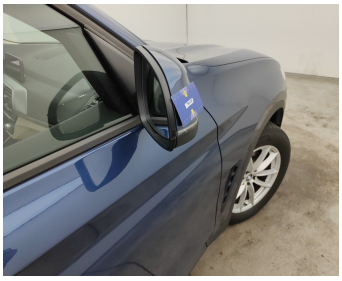
Bumper Rear // Painting-scratch

Wing Rear Left // Painting-scratch

Side View Mirror Right / Shell / Replace Not Painted-scratch

Side View Mirror Right / Direction Indicator / Replace-scratch

Side View Mirror Right // Painting-scratch

Bumper Front // Painting-scratch

Headlight / Front left / Replace-scratch
