TÜV SÜD Auto Partner GmbH
Wiesenring 2
04159 Leipzig

Expertise

Protocol number: 48136636
Order No. / Reference: 27110798
Inspection date: 14 Oct 2026

Manufacturer: Volkswagen	Model: Caddy Cargo 2.0 TDI BMT
VIN: WV1ZZZSK4RX014882

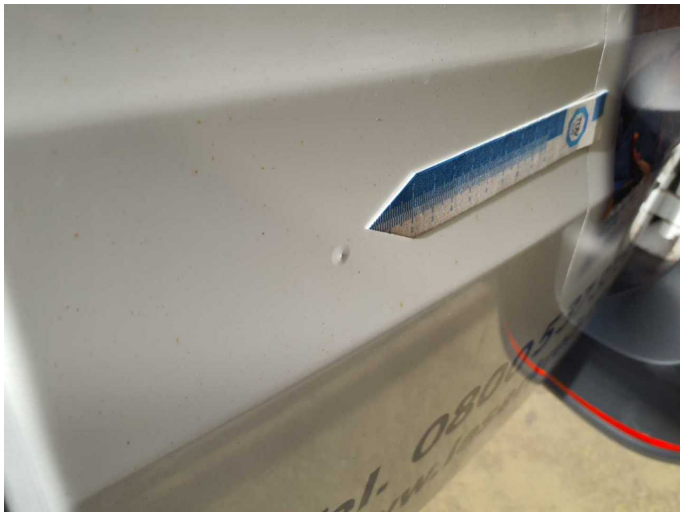
Damage 14: Boot lid / rear door: Rear door - right side (unterhalb) - Corrosion - Repair and paint

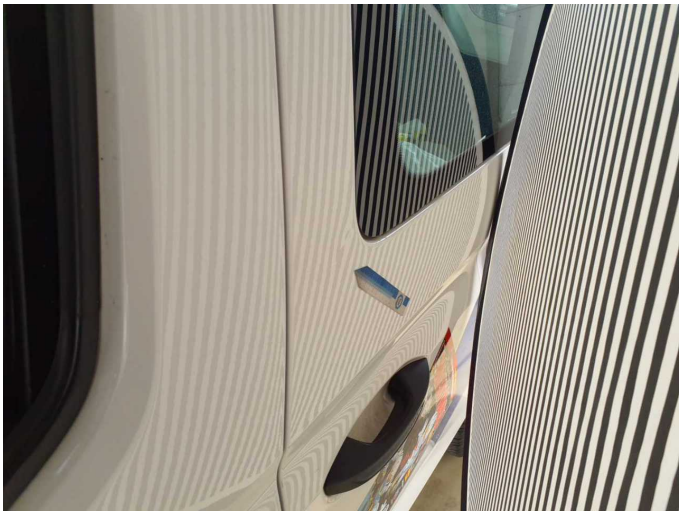
Damage 16: Sliding door - left side: Sliding door - Dent / paintcoat damage - Repair and paint

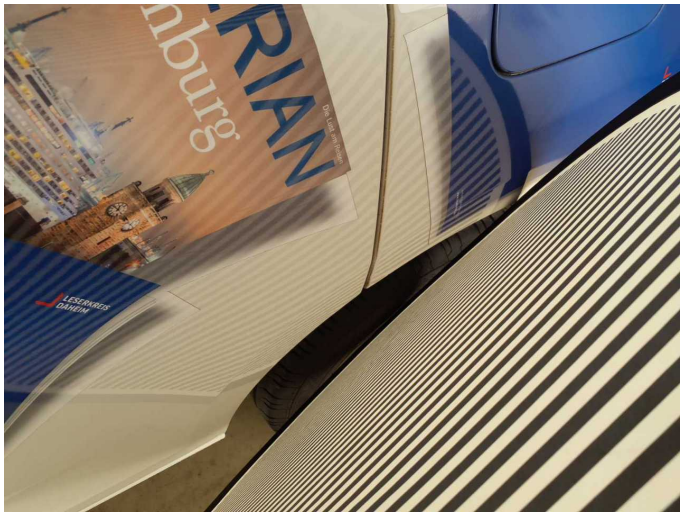
Damage 16: Sliding door - left side: Sliding door - Dent / paintcoat damage - Repair and paint
