Expertise

Protocol number: 48404349
Order No. / Reference: 27216257
Inspection date: 27 Oct 2026

Manufacturer: Volkswagen	Model: Crafter 35 TDI VA Kasten
VIN: WV1ZZZSYZM9061523

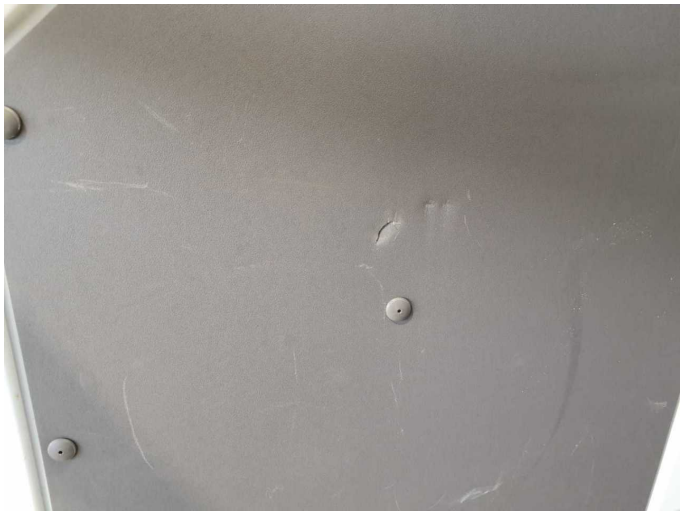
Damage 10: Trim / covers: Trim / covers (Hinten rechts und links) - Broken / torn - Replace

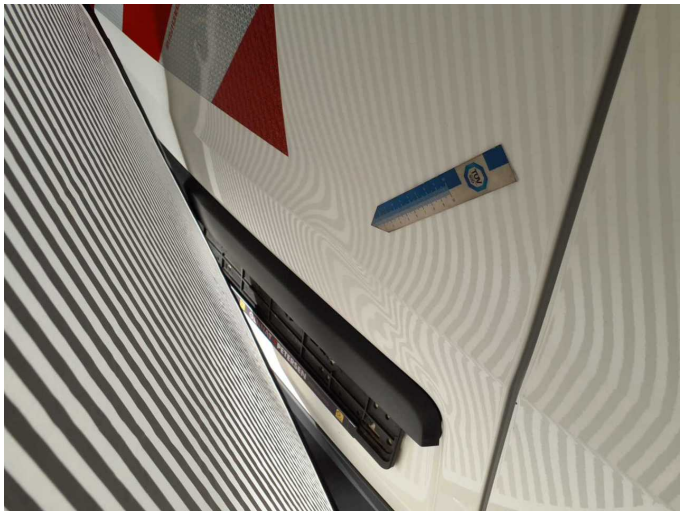
Damage 12: Door - front left side: Door seal - Broken / torn - Replace

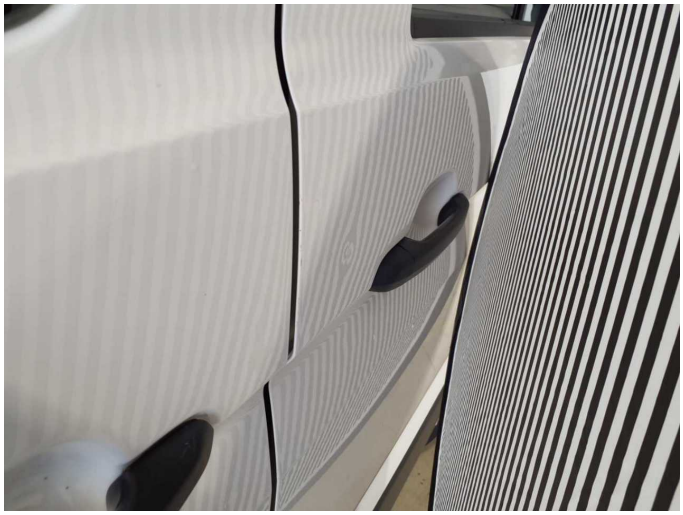
Damage 14: Door - front right side: Door - Dent / paintcoat damage - Repair and paint

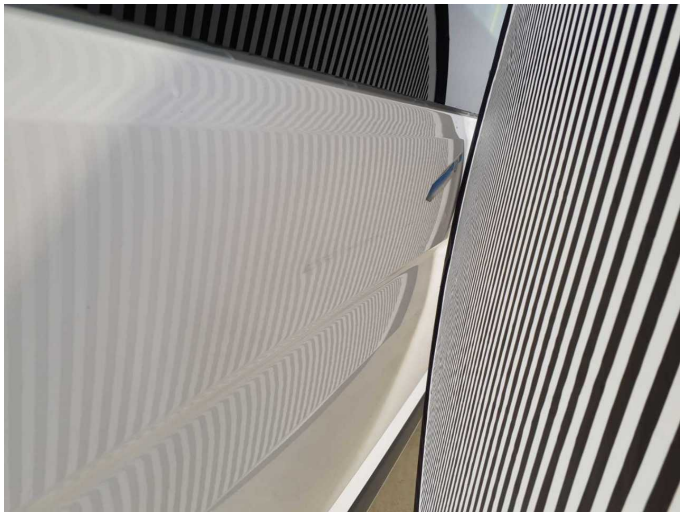
Damage 15: Sliding door, right: Sliding door - Dent / paintcoat damage - Repair and paint

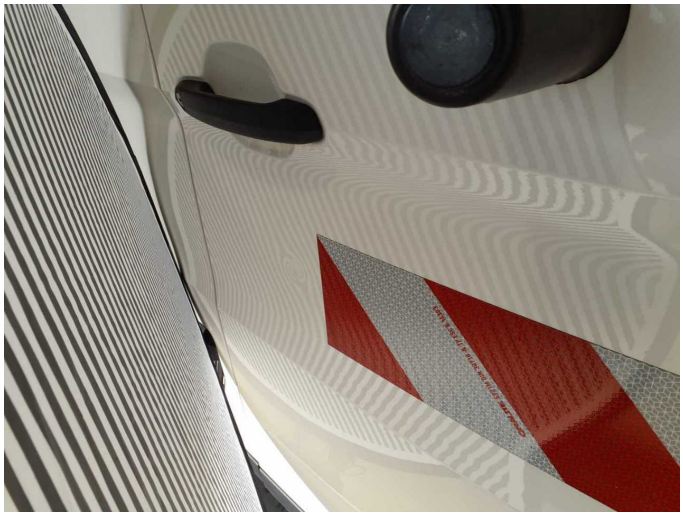
Accident 1: Rear
