Expertise

Protocol number: 48499636
Order No. / Reference: 27235550
Inspection date: 2 Nov 2026

Manufacturer: Mercedes-Benz	Model: GLA 180 d 8G-DCT
VIN: W1N4N1AB2PJ504782

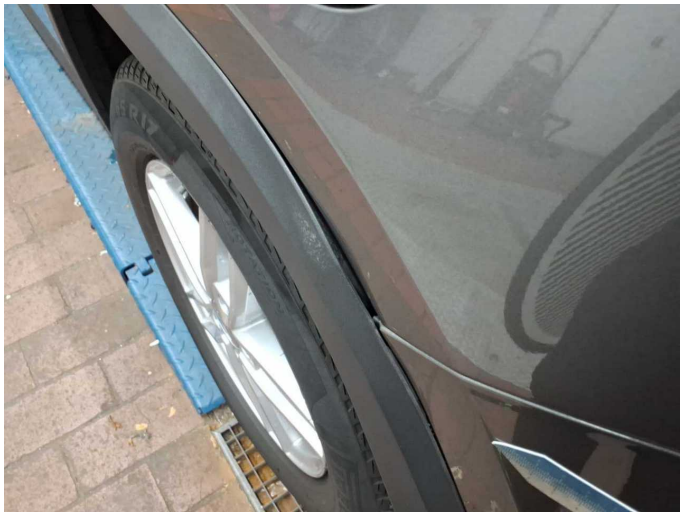
Damage 1: Side panel - rear right side: Wheel well extension (Zierleiste) - Deformed - Replace

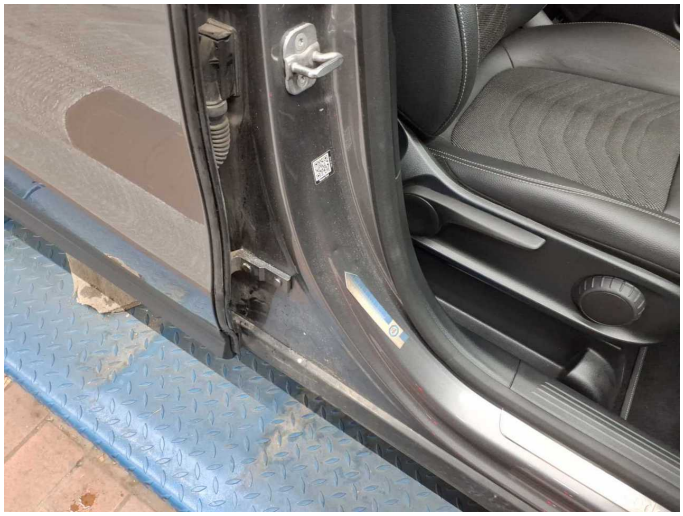
No.	Component group	Description
1	Side panel - rear right side	Wheel well extension (Zierleiste) - Deformed - Replace
2	Sill - right side	Sill - dent(s) - Smart repair
3	Sill - left side	Sill - dent(s) - Smart repair
4	Vehicle glazing	Windscreen seal - Broken / torn - Replace
5	Rear bumper	Rear bumper - Deformed - Repair and paint

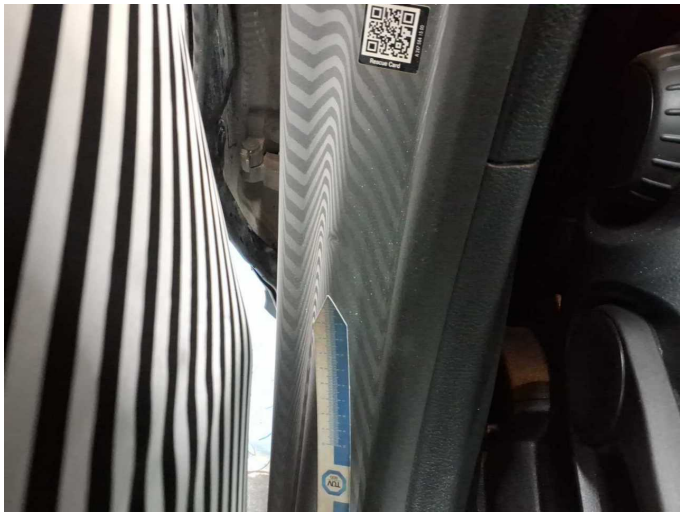
Damage 2: Sill - right side: Sill - dent(s) - Smart repair

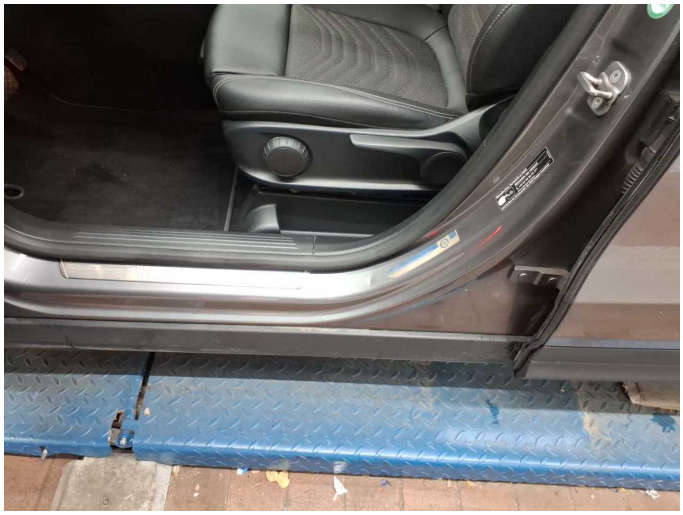
Damage 2: Sill - right side: Sill - dent(s) - Smart repair

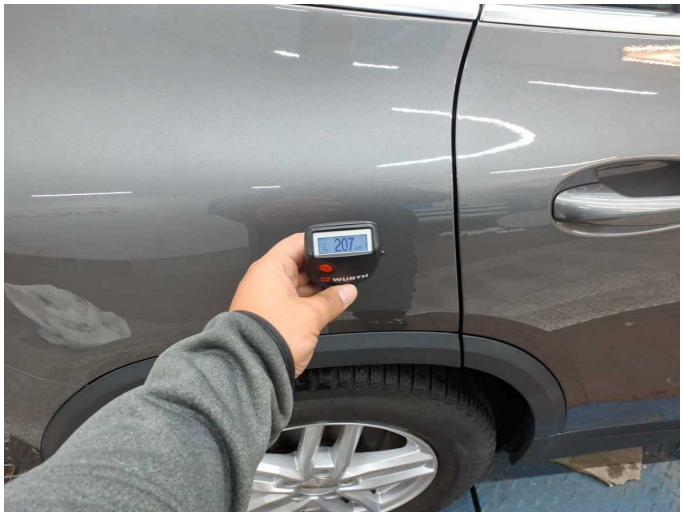
No.	Repainting
1	Boot lid / rear door, Side panel - rear right side, Door - rear right side, Door - front left side, Door - front right side, Professionally carried out, Invoice of repair done Non-existent

Boot lid / rear door	319 µm	Side panel - rear right side	207 µm
Door - rear right side	164 µm	Door - front left side	158 µm
Door - front right side	224 µm

Repainting 1: Boot lid / rear door, Side panel - rear right side, Door - rear right side, Door - front left side, Door - front right side
