Expertise

Protocol number: 48178768
Order No. / Reference: 27134555
Inspection date: 19 Oct 2026

Manufacturer: Skoda	Model: Octavia Combi 2.0 TDI DSG 4x4 Style
VIN: TMBLJ8NX1RY029858

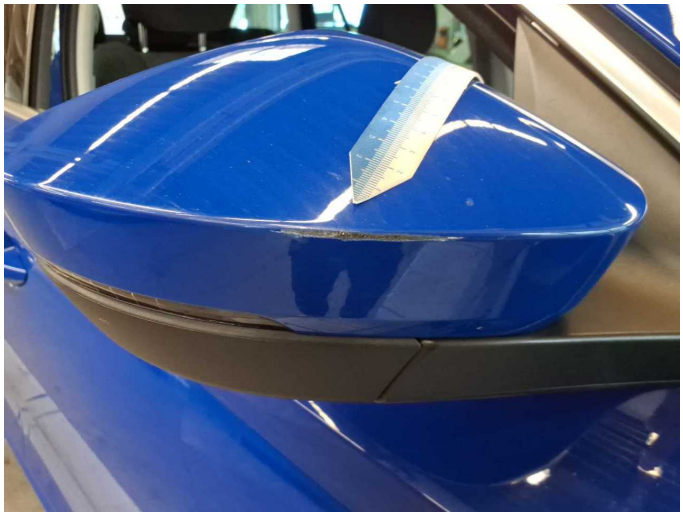
Damage 1: Wing mirror - right side: Cap - Scratch(es) - Smart repair

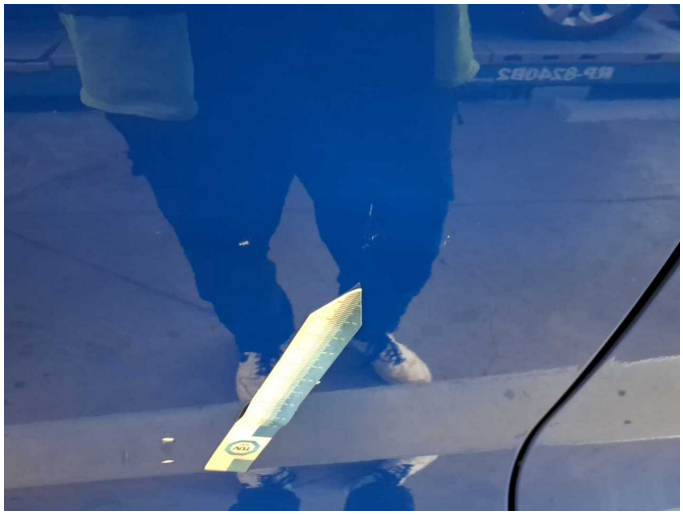
Damage 2: Door - rear right side: Door - Scratch(es) - Paint

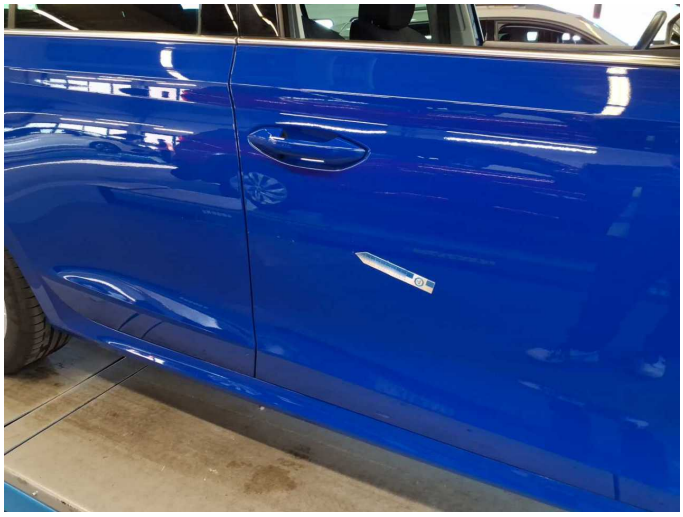
Damage 3: Door - front right side: Door - Scratch(es) - Paint

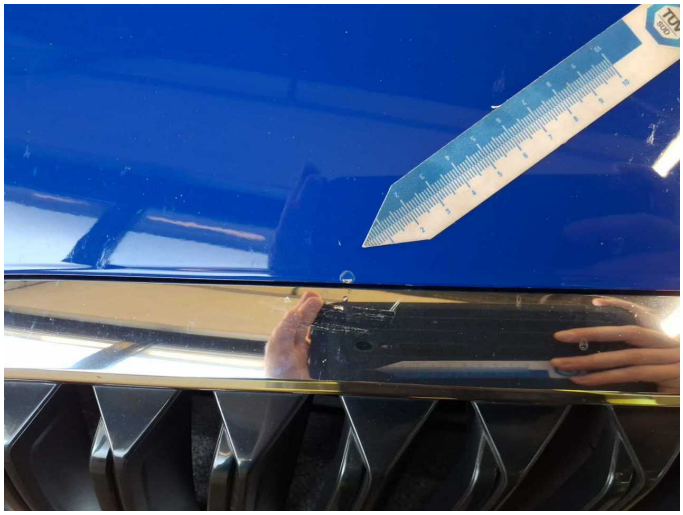
Damage 4: Bonnet: Bonnet (Lackabplatzer) - Paint defect - Paint

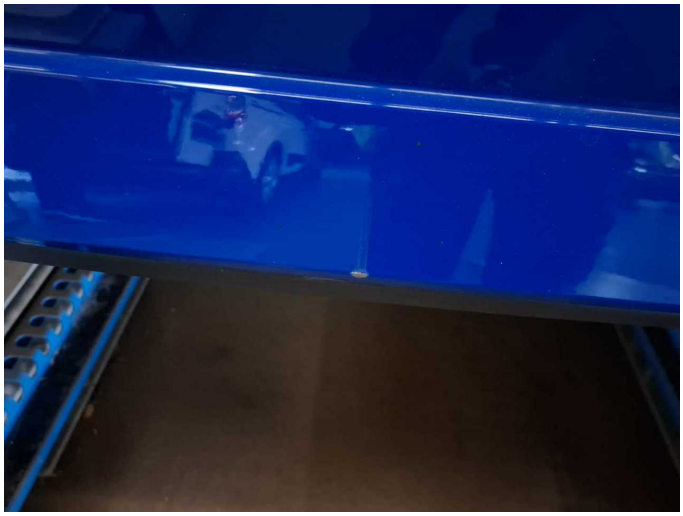
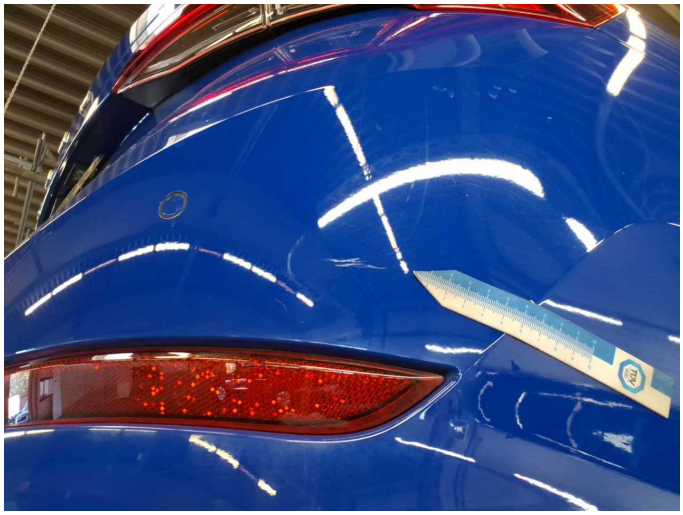
Damage 5: Rear bumper: Rear bumper - Scratch(es) - Paint

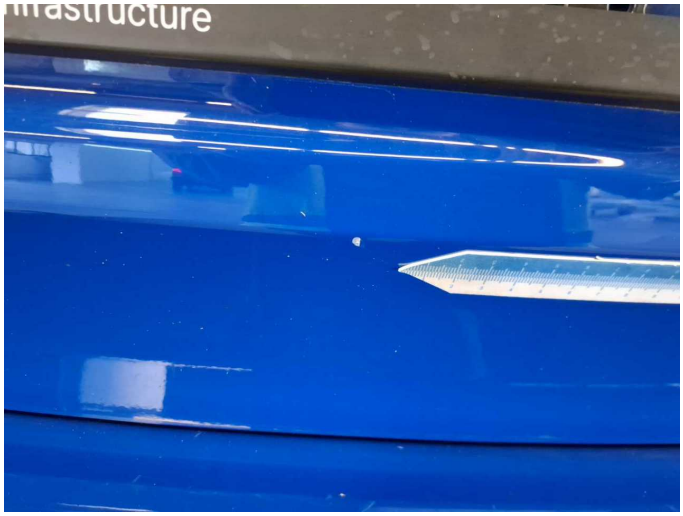
Damage 6: Boot lid / rear door: Boot lid - Scratch(es) - Paint
