Expertise

Protocol number: 47672950
Order No. / Reference: 26986650
Inspection date: 18 Sept 2026

Manufacturer: Mercedes-Benz	Model: C 200 d T 9G-TRONIC AMG Line Advanced
VIN: W1KAH0DB4RF151805

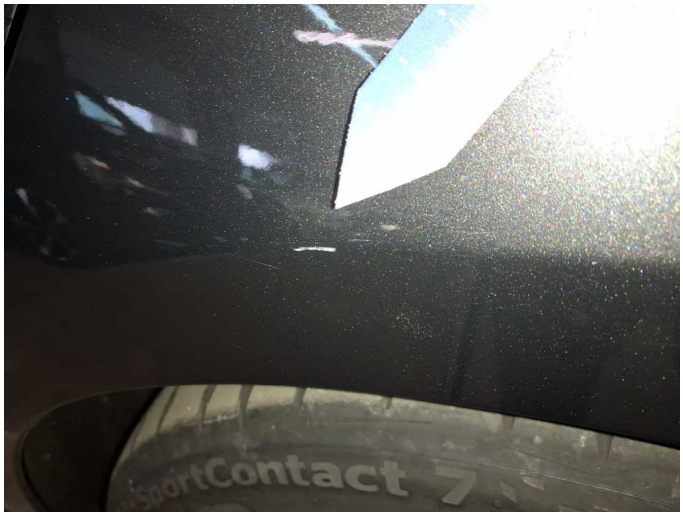
Damage 5: Side panel - rear left side: Side panel - Dent / paintcoat damage - Repair and paint

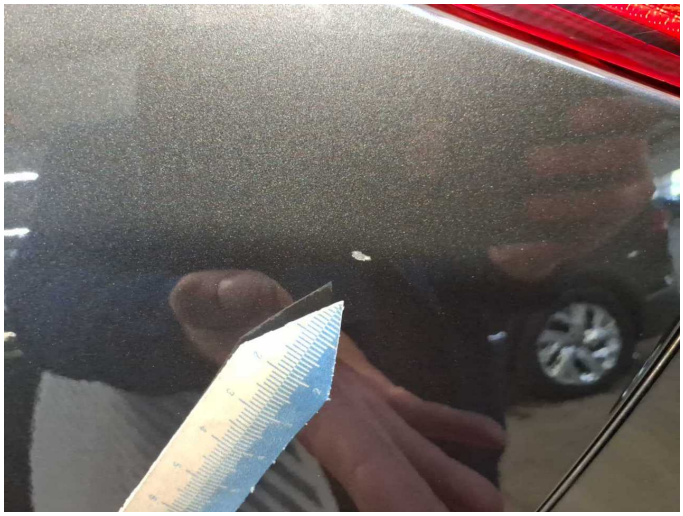
Damage 5: Side panel - rear left side: Side panel - Dent / paintcoat damage - Repair and paint

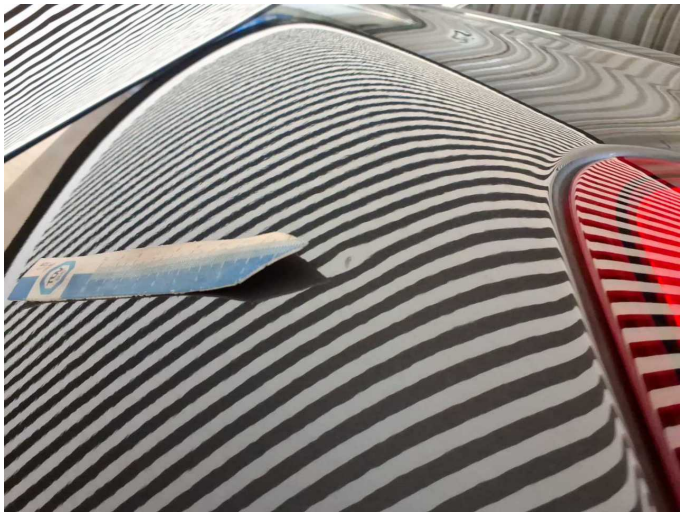
Damage 5: Side panel - rear left side: Side panel - Dent / paintcoat damage - Repair and paint

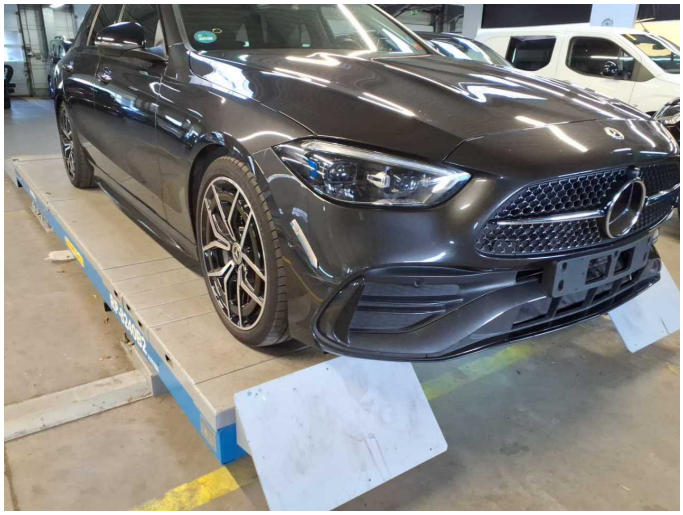
Damage 6: Front bumper: Front bumper - Scratched - Paint

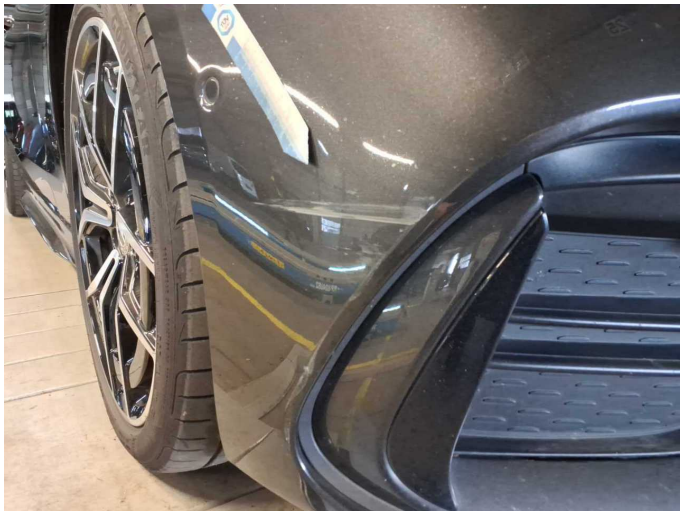
Damage 6: Front bumper: Front bumper - Scratched - Paint

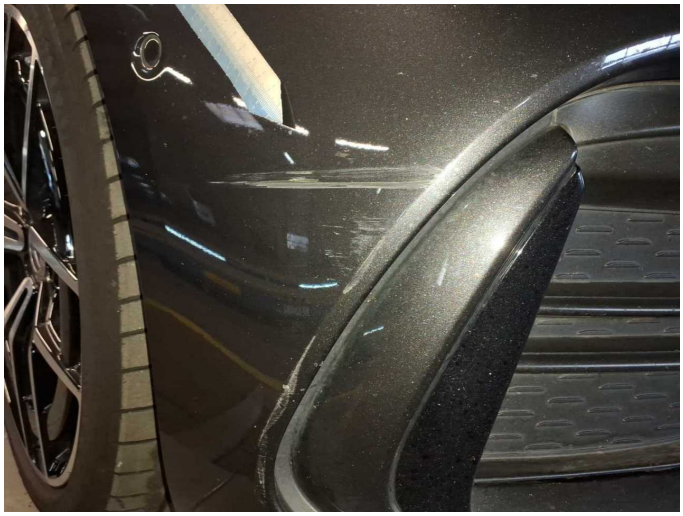
Damage 6: Front bumper: Front bumper - Scratched - Paint

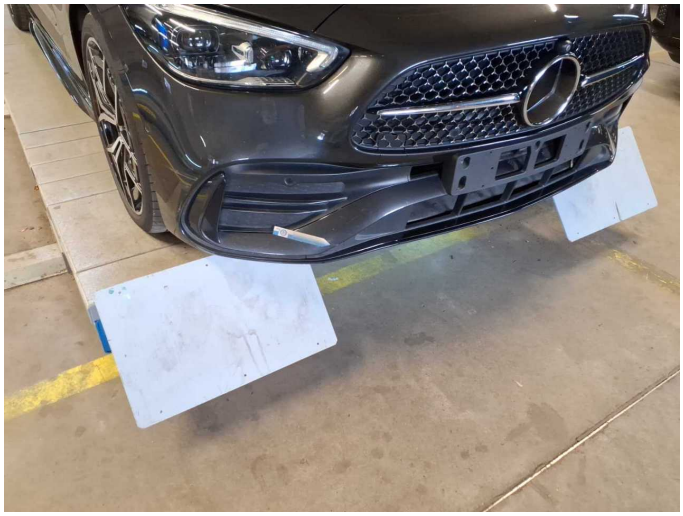
Damage 6: Front bumper: Front bumper - Scratched - Paint

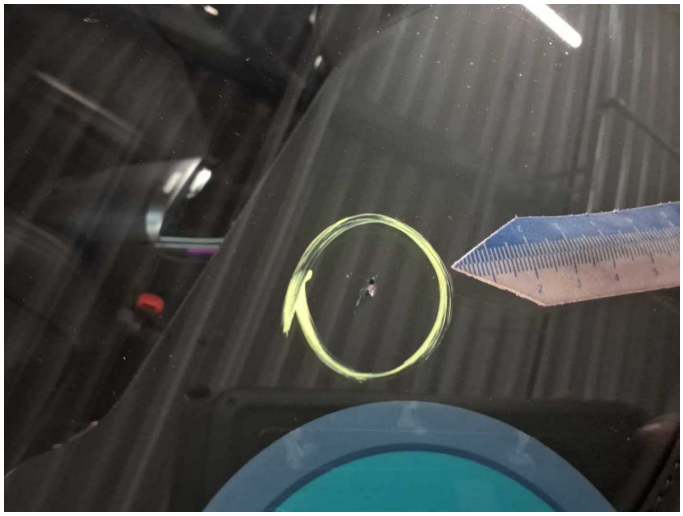
Damage 7: Vehicle glazing: Windscreen (Rissbildung) - Stone chips - Replace

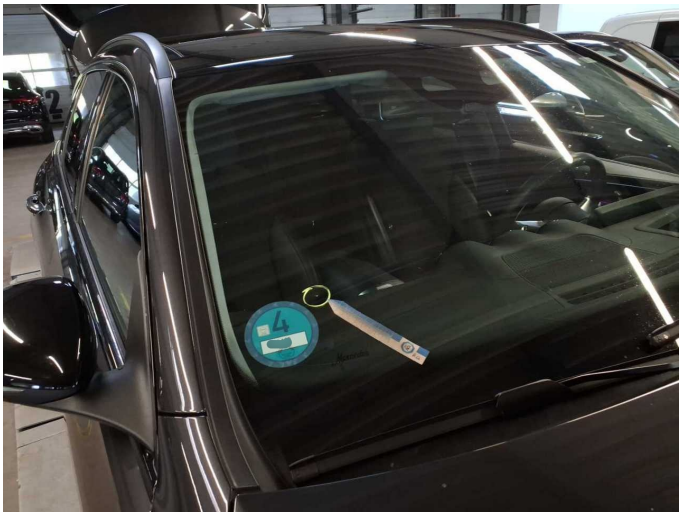
Damage 7: Vehicle glazing: Windscreen (Rissbildung) - Stone chips - Replace
