MACADAM

BMW X3

Vehicle information

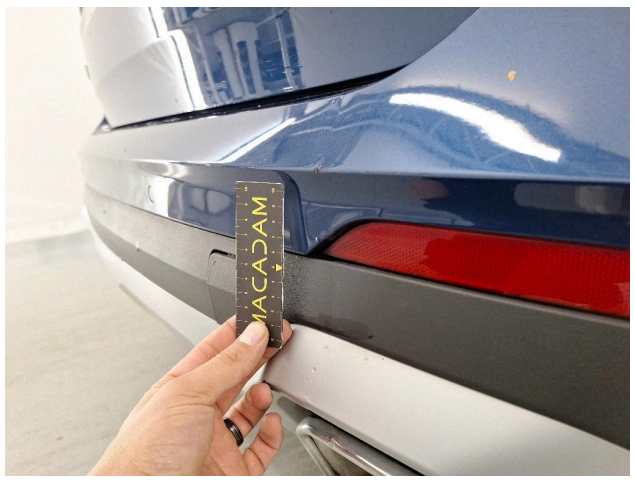
Bodywork
Damaged - Acceptable.
Roof & other
