TÜV SÜD Auto Partner GmbH
Wiesenring 2
04159 Leipzig

Expertise

Protocol number: 48073355
Order No. / Reference: 26745568
Inspection date: 12 Oct 2026

Manufacturer: Mercedes-Benz	Model: C 200 d T 9G-TRONIC
VIN: W1KAH0DB2PF117228

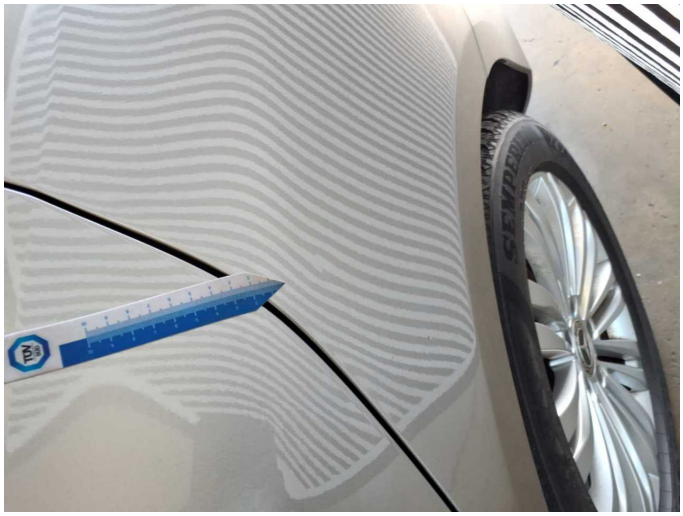
Damage 2: Door - front left side: Door edge - Scratch(es) - Smart repair

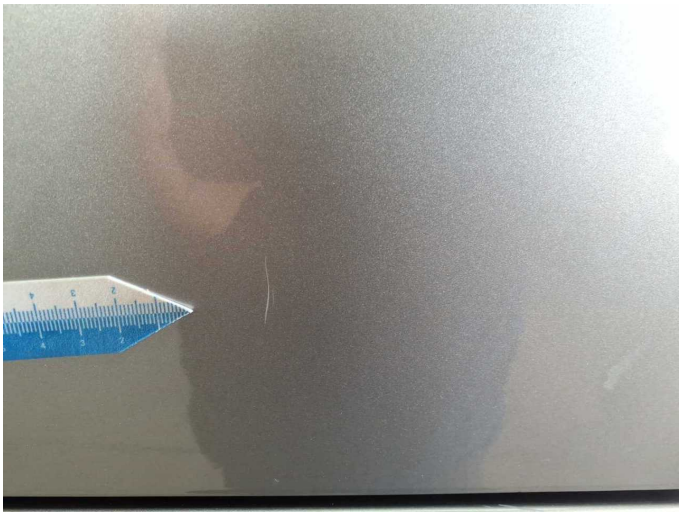
Damage 7: Door - rear left side: Door - Scratch(es) - Lacquer

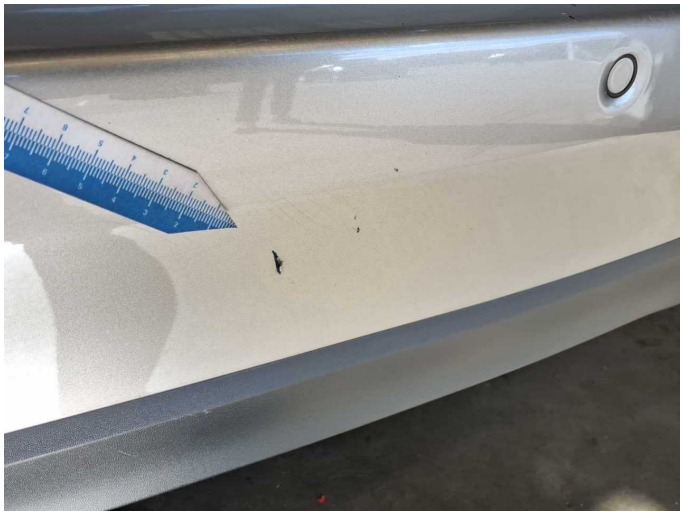
Damage 9: Rear bumper: Rear bumper - Scratch(es) - Paint

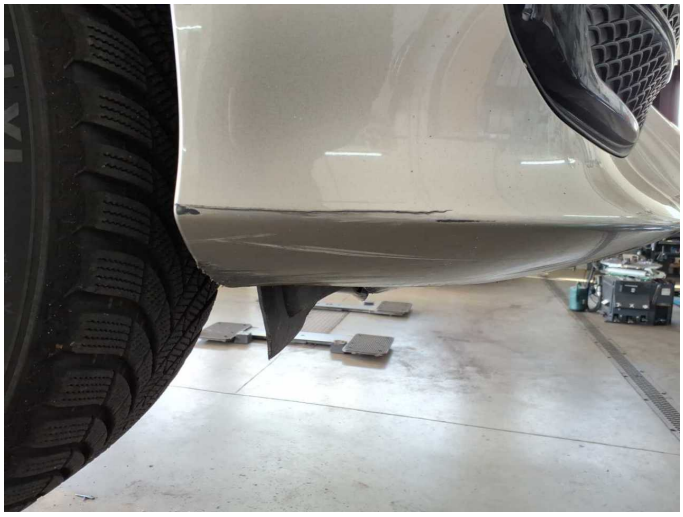
Damage 10: Front bumper: Front bumper - Scratched - Repair and paint

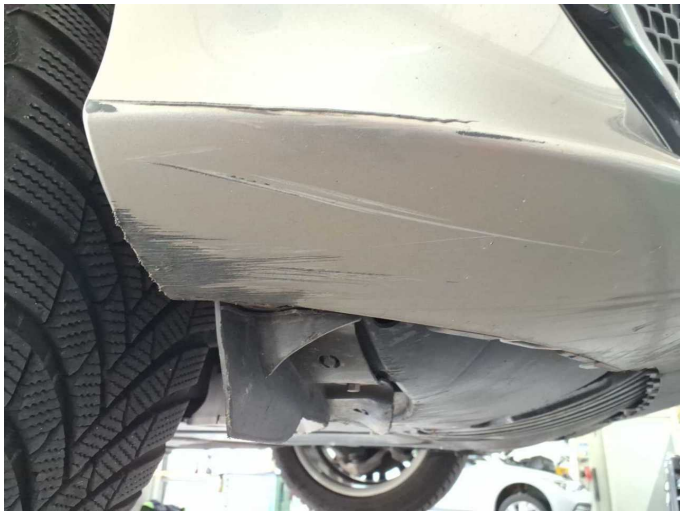
Damage 10: Front bumper: Front bumper - Scratched - Repair and paint
