Expertise

Protocol number: 48437725
Order No. / Reference: 27048971
Inspection date: 2 Nov 2026

Manufacturer: Opel	Model: Insignia Sports Tourer 2.0 Diesel Aut. Ultimate
VIN: W0VZS8GP3N1047825

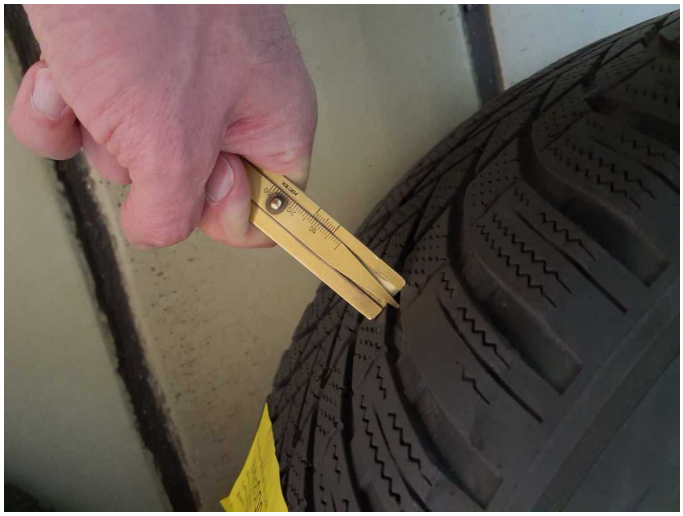
Damage 7: 2nd wheel set: 2 tyres - Does not meet the leasing specifications - Replace
