ARVAL
BNP PARIBAS GROUP

2BLF286

INSPECTION REPORT

End of contract

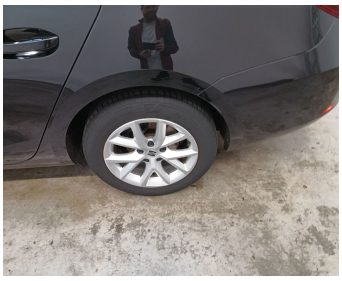
Door Front Left / Trim / Replace-scratch

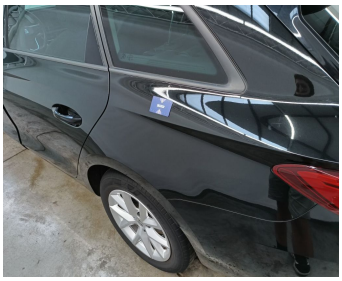
Door Rear Left / Trim / Replace-scratch

Door Rear Left // Polish-scratch

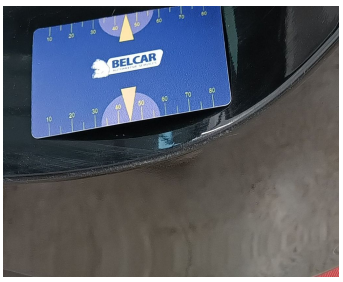
Wheel Alloy Rear Left // Repair-scratch

Wing Rear Left // Polish-scratch

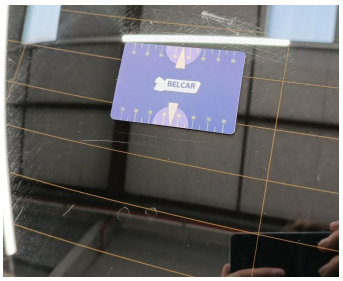
Bumper Rear // Polish-scratch

Rear Bonnet / Spoiler / Replace & Painting-scratch

Rear Bonnet / Rear Window / Replace-scratch

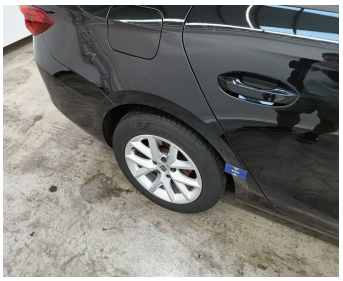
Trunk Compartment / Side Cover Left / Replace-scratch

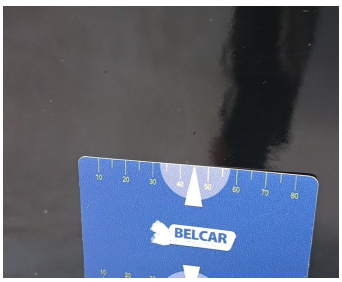
Rear Bonnet // Repair & Painting-scratch + dent

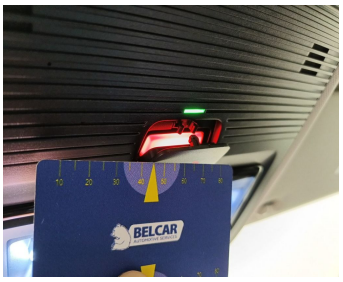
Rocker Panel Right / Cover Not Painted / Replace-tear

Bumper Front // Painting-stone chipping

Interior // Repair 1-N comf / out of order
