AUDI A3 SPORTBACK

Vehicle information

Damages

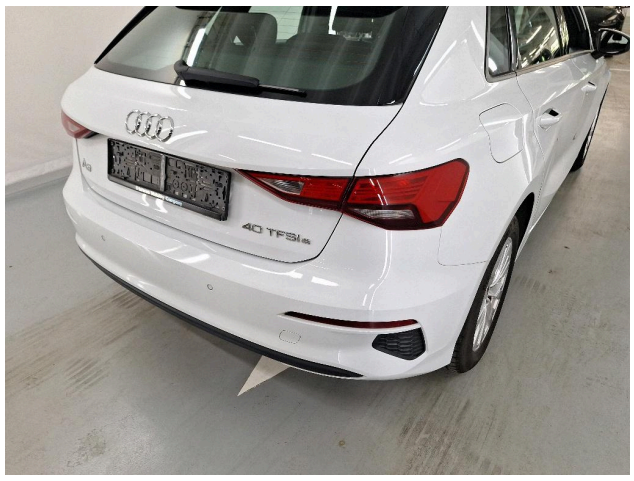
Bumper R
Bad repair
Paint
Rear

Charging cable (fast)
Missing
Replace
Rear

Charging cable (normal)
Missing
Check
Rear

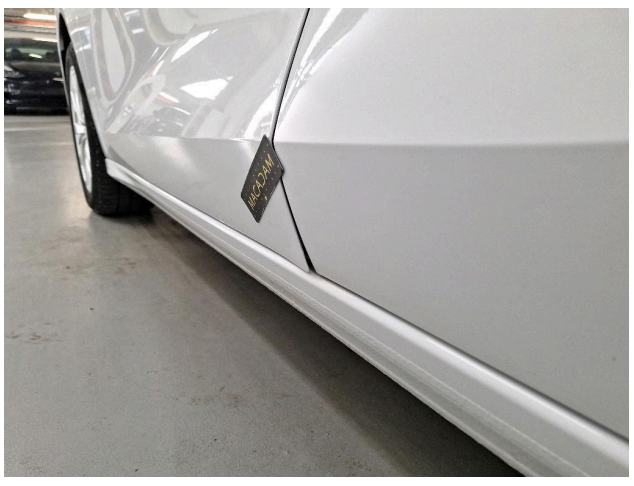
Door FL
Deformed / Strained
Repair and paint (complete)
Left

Door RR
Repaired
No repair
Right
