Expertise

Protocol number: 48231151
Order No. / Reference: 27124873
Inspection date: 21 Oct 2026

Manufacturer: Opel	Model: Insignia Grand Sport 2.0 Diesel Automatik Business Elegance
VIN: W0VZT6GP6M1025981

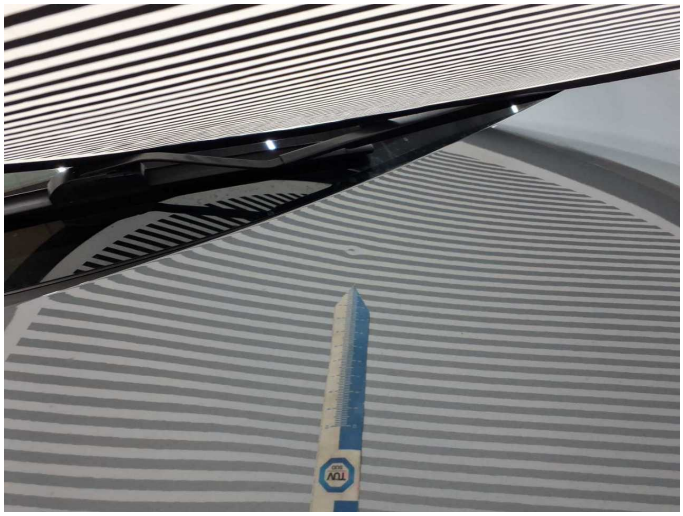
No.	Component group	Description
1	Boot lid / rear door	Boot lid - dent(s) - Smooth repair work
2	Bonnet	Bonnet - dent(s) - Smooth repair work
3	Roof	Roof - dent(s) - Smooth repair work
4	Front bumper	Front bumper - Scratch(es) - Paint

Damage 2: Bonnet: Bonnet - dent(s) - Smooth repair work

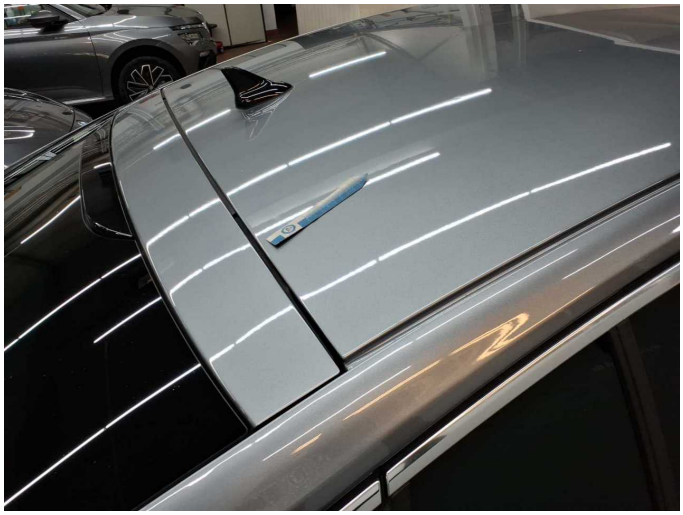
Damage 3: Roof: Roof - dent(s) - Smooth repair work

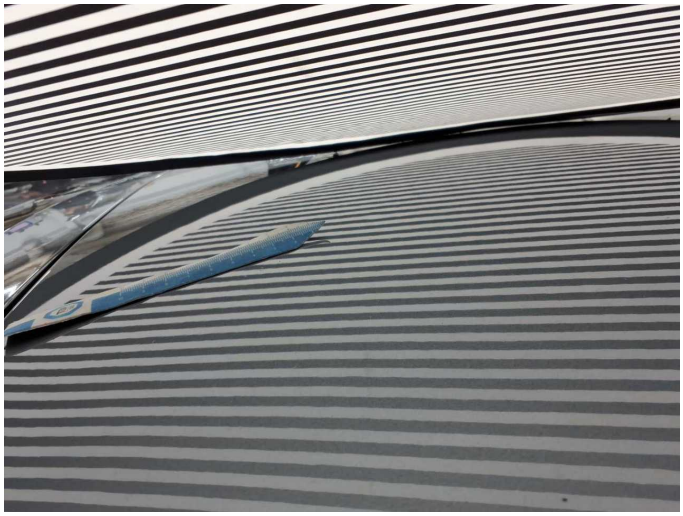
Damage 3: Roof: Roof - dent(s) - Smooth repair work

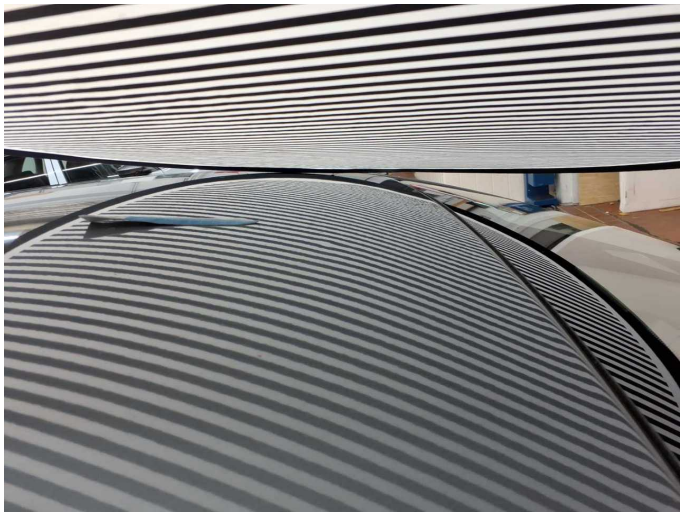
Damage 3: Roof: Roof - dent(s) - Smooth repair work

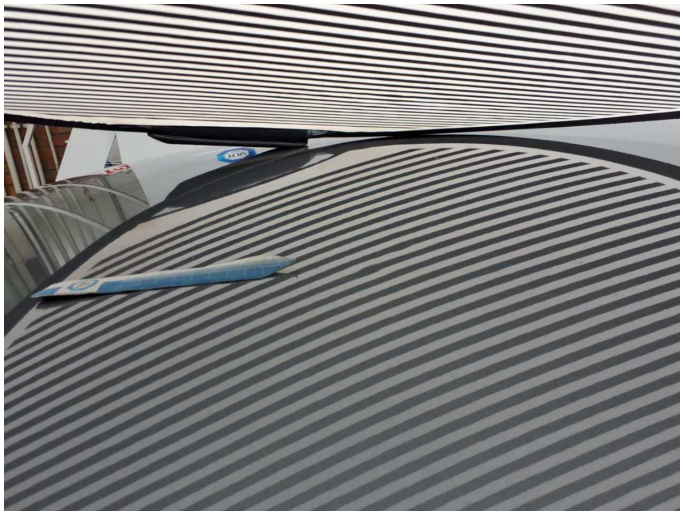
Damage 3: Roof: Roof - dent(s) - Smooth repair work
