Expertise

Protocol number: 48190085
Order No. / Reference: 26976207
Inspection date: 15 Oct 2026

Manufacturer: Volkswagen	Model: Multivan T7 Kurz
VIN: WV2ZZZST9PH009737

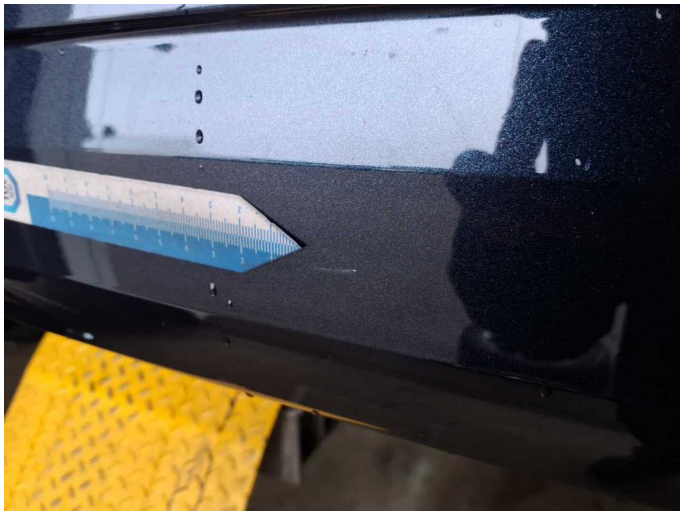
No.	Component group	Description
1	Side panel - rear left side	Side panel - Scratch(es) - Smart repair
2	Rear bumper	Rear bumper - Scratch(es) - Paint
3	Sliding door - left side	Sliding door with glass panel - Scratch(es) - Paint

Damage 1: Side panel - rear left side: Side panel - Scratch(es) - Smart repair

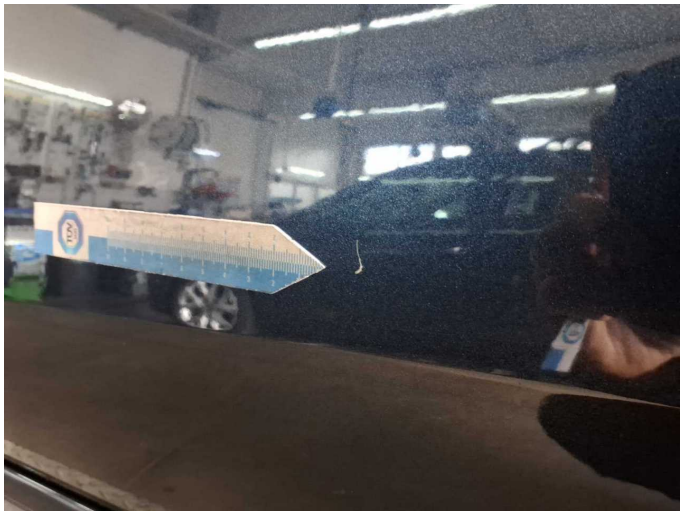
Damage 2: Rear bumper: Rear bumper - Scratch(es) - Paint

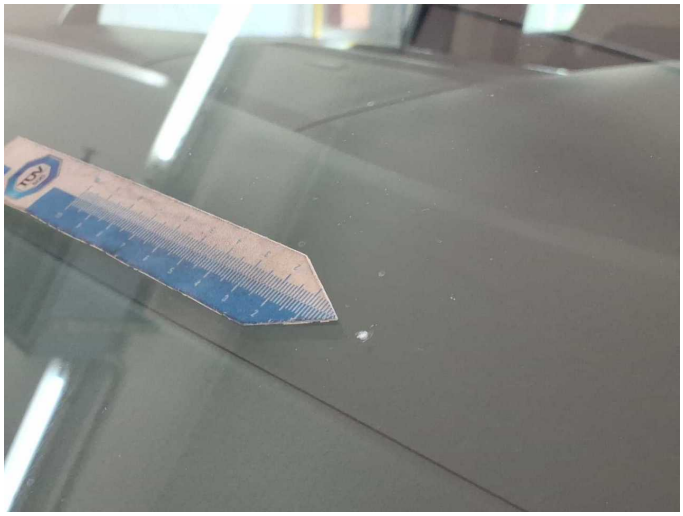
Damage 3: Sliding door - left side: Sliding door with glass panel - Scratch(es) - Paint
