BMW

VIN: WBA7M710X07G21621

Estimated repair cost

Statement details

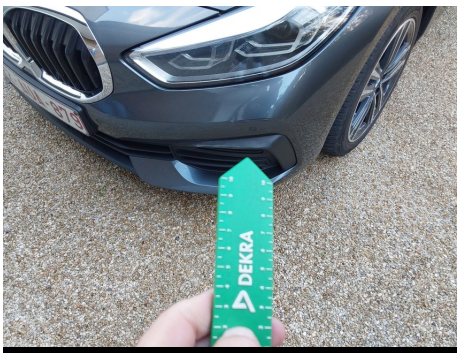
003	Bumper / Front Painted : Yes	Dent	Repair	231.50 EUR

Bumper / Front / Dent

Bodywork time	Paint time	Part Price	Lumpsum
1.50 h	1.40 h	-	-
Bodywork cost	**Paint cost**	**MaterialCost**	
112.50 EUR	119.00 EUR	-
