Expertise

Protocol number: 48435133
Order No. / Reference: 27224368
Inspection date: 29 Oct 2026

Manufacturer: Seat	Model: CUPRA Formentor 1.4 e-Hybrid DSG
VIN: VSSZZZKM3RR022308

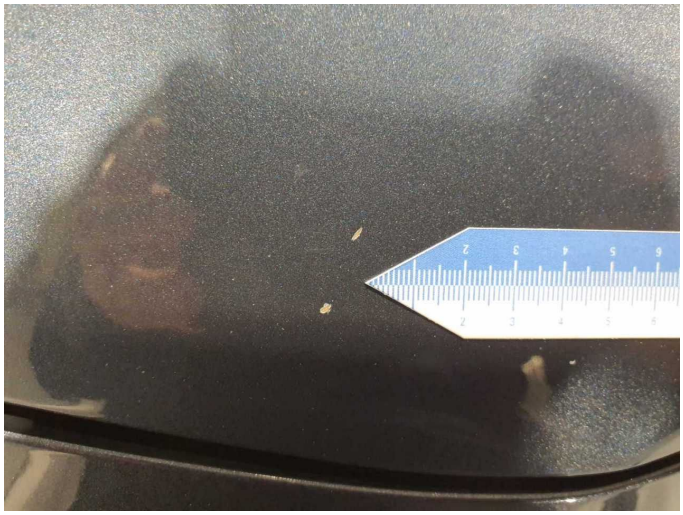
Damage 9: Bonnet: Bonnet - Corrosion - Repair and paint
