# Expertise

Protocol number: 48035306
Order No. / Reference: 27081276
Inspection date: 8 Oct 2026

| Manufacturer: Volkswagen | Model: Passat Variant 2.0 TDI SCR DSG Business |

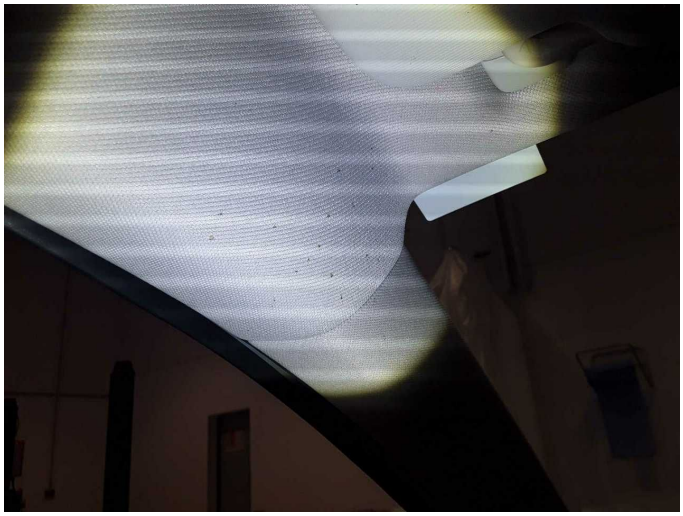
| No. | Component group | Description |
|---|---|---|
| 1 | Trim / covers | Roof lining - Soiled - Clean |

**Damage 1:** Trim / covers: Roof lining - Soiled - Clean

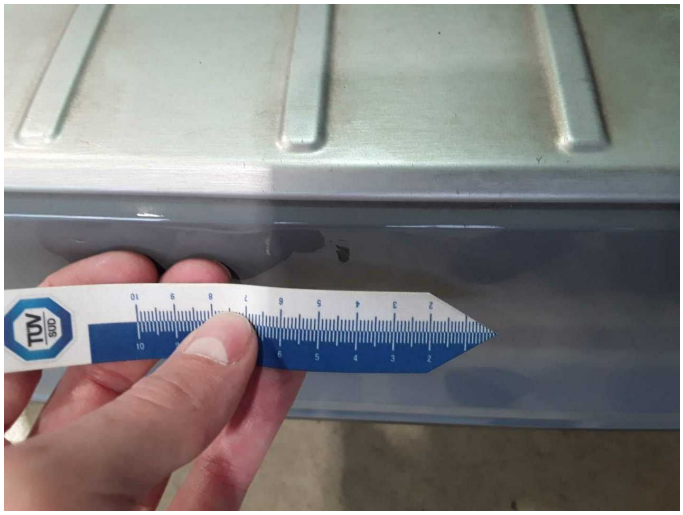
| No. | Component group | Description |
|---|---|---|
| 3 | Rear bumper | Rear bumper - Scratch(es) - Smart repair |

**Damage 3:** Rear bumper: Rear bumper - Scratch(es) - Smart repair

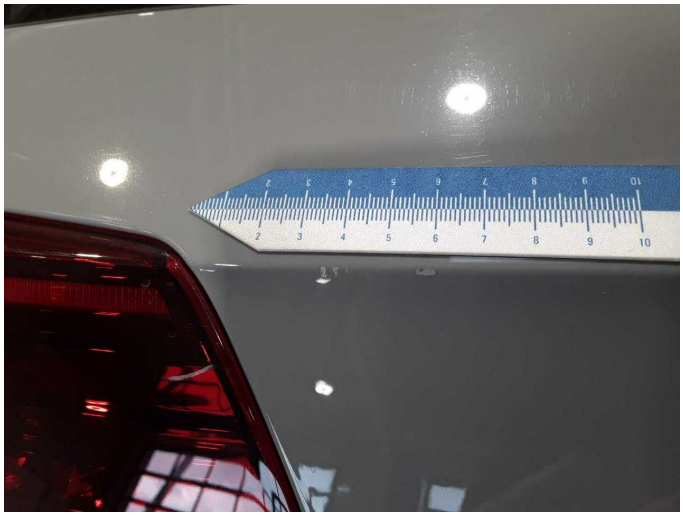
| No. | Component group | Description |
|---|---|---|
| 5 | Boot lid / rear door | Boot lid - Scratch(es) - Paint |

**Damage 5:** Boot lid / rear door: Boot lid - Scratch(es) - Paint

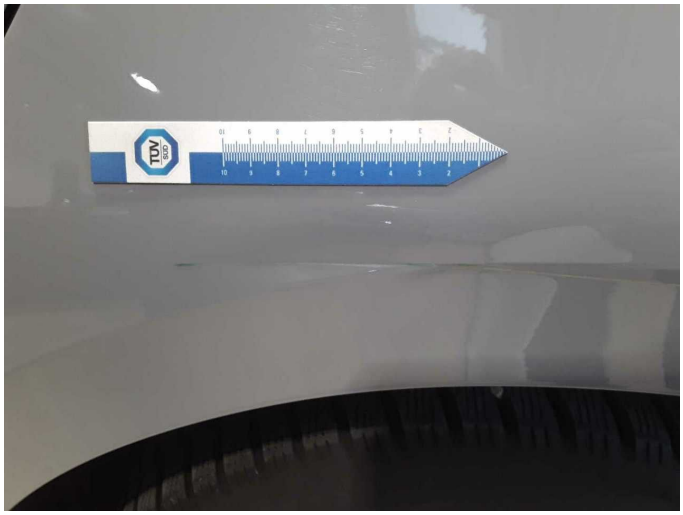
| No. | Component group | Description |
|---|---|---|
| 6 | Side panel - rear left side | Side panel - Dent / paintcoat damage - Repair and paint |

**Damage 6:** Side panel - rear left side: Side panel - Dent / paintcoat damage - Repair and paint
