Expertise

Protocol number: 48259371
Order No. / Reference: 27104998
Inspection date: 20 Oct 2026

Manufacturer: Mercedes-Benz	Model: A 250 e 8G-DCT AMG Line
VIN: W1K3G8GB1PJ386033

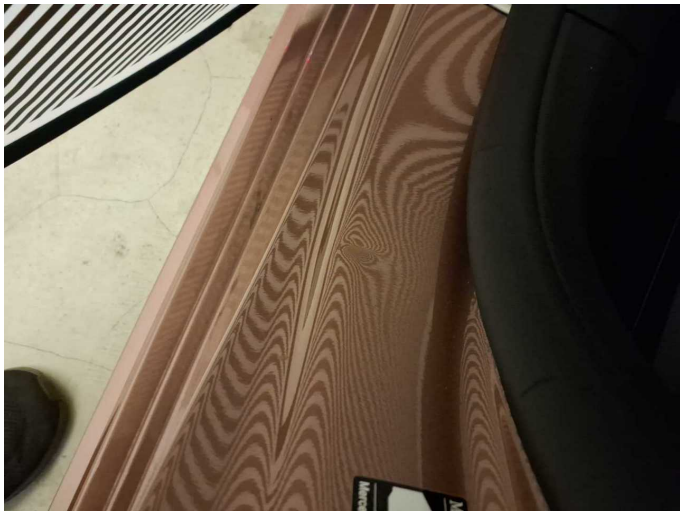
Damage 1: Sill - left side: Sill - dent(s) - Smooth repair work

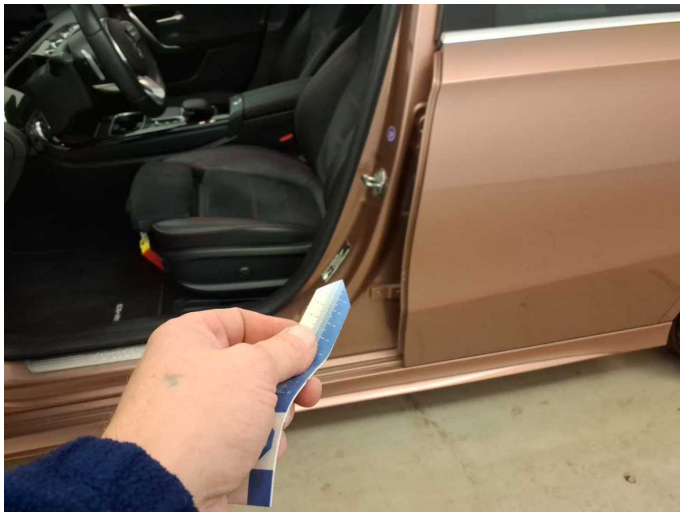
Damage 1: Sill - left side: Sill - dent(s) - Smooth repair work

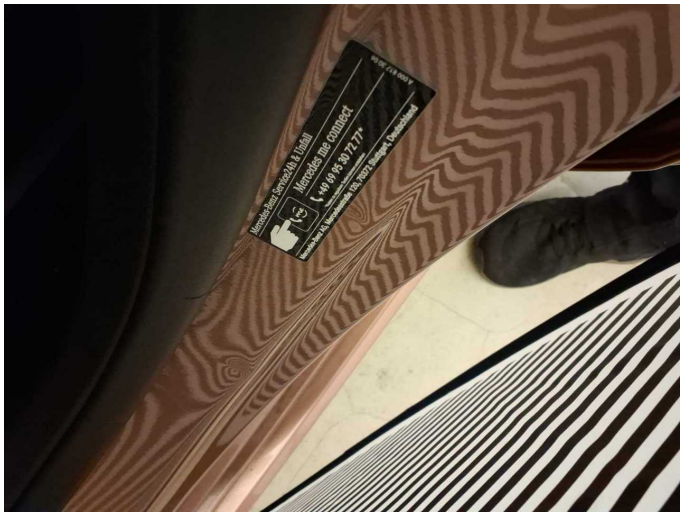
Damage 1: Sill - left side: Sill - dent(s) - Smooth repair work

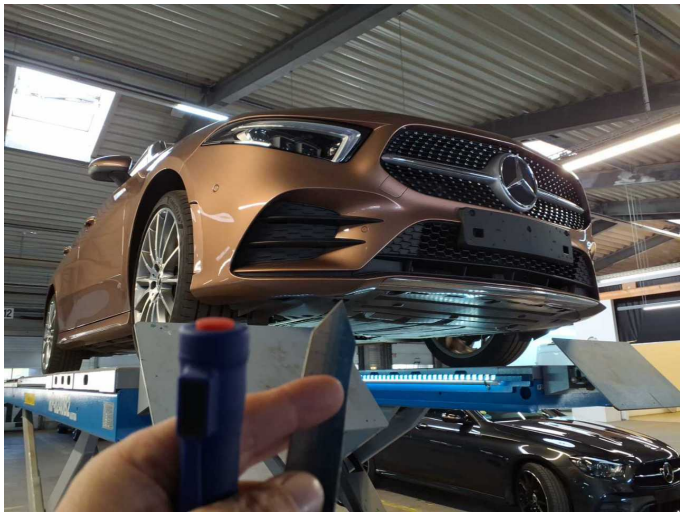
Damage 2: Front bumper: Spoiler - Scratched - Smart repair

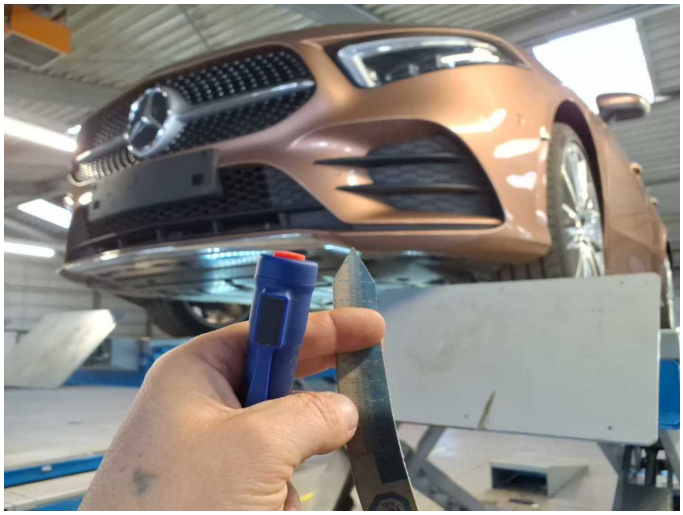
Damage 2: Front bumper: Spoiler - Scratched - Smart repair

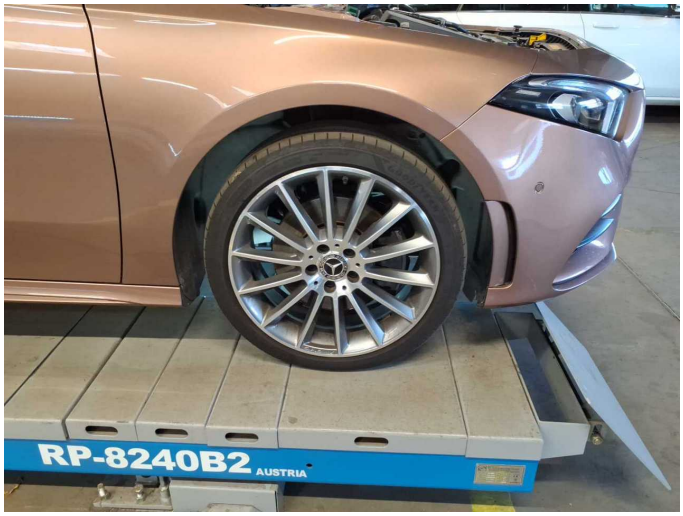
Damage 4: Wheel / tyres: Tyre - front right side (Flanke) - Damaged - Replace

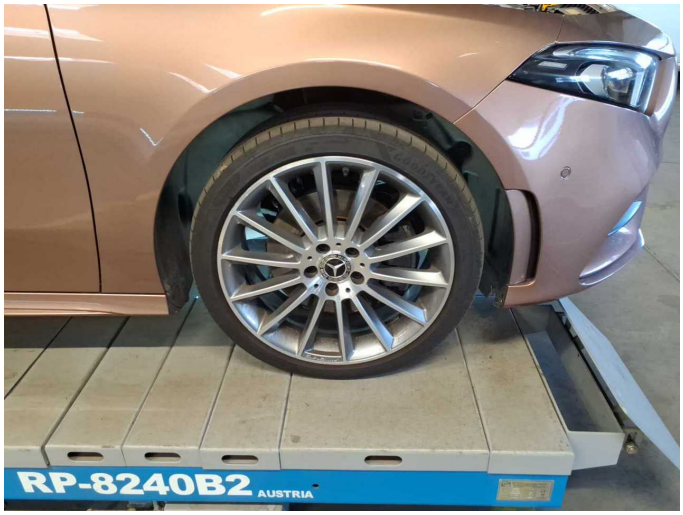
Damage 5: Wheel / tyres: Alloy rim - front left side - Scratch(es) - Loss in value

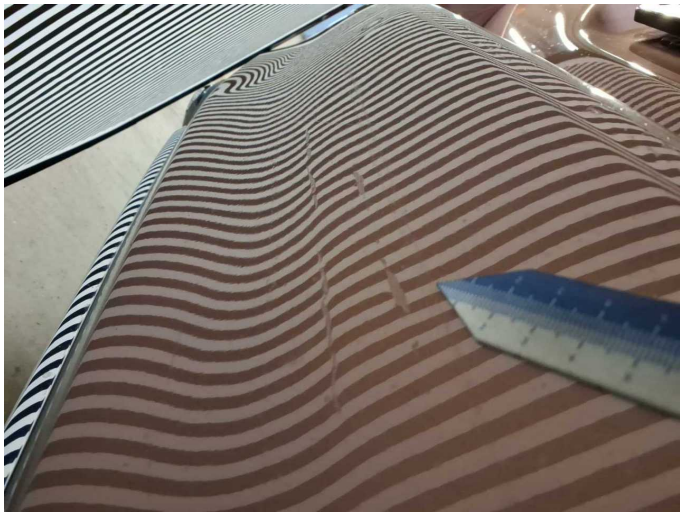
Damage 7: Rear bumper: Rear bumper (Spachtel/ Schleifspuren) - Paint defect - Repair and paint

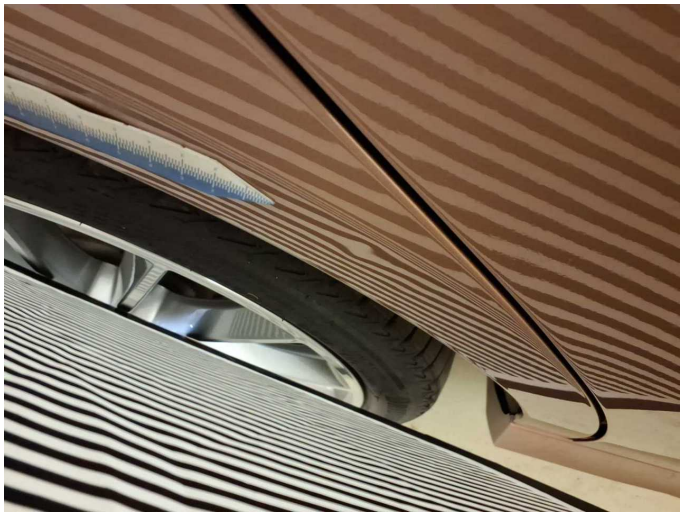
Damage 7: Rear bumper: Rear bumper (Spachtel/ Schleifspuren) - Paint defect - Repair and paint

Wear and tear 2: Side panel - rear right side: Side panel - dent(s) - No deduction
