TÜV SÜD Auto Partner GmbH
Wiesenring 2
04159 Leipzig

Expertise

Protocol number: 48609880
Order No. / Reference: 27197979
Inspection date: 10 Nov 2026

Manufacturer: Ford	Model: Transit Custom 280 L1H1 LKW VA Autm. Trend
VIN: WF0YXXTTGYNP04410

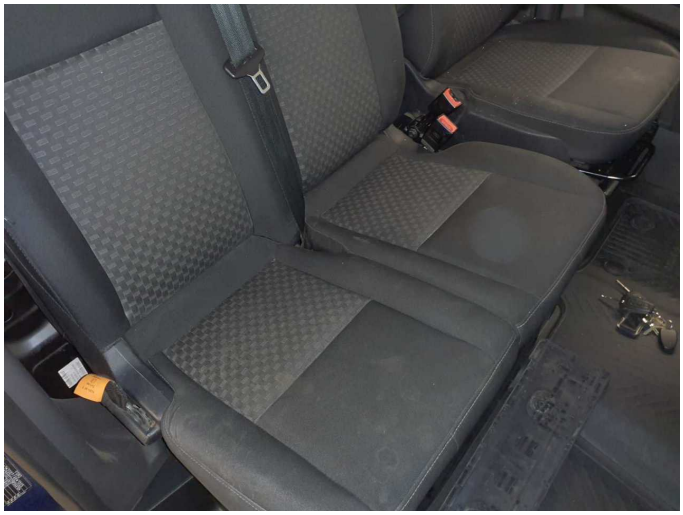
Damage 3: Seat - front: Seat cover - left side (Sitze) - Soiled - Clean

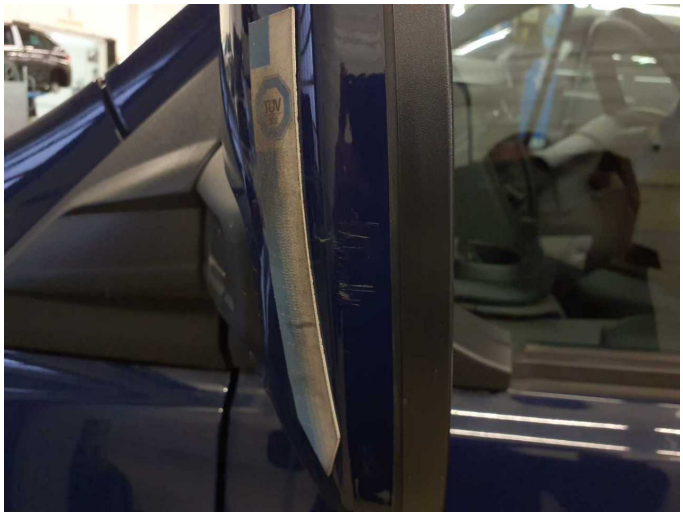
Damage 4: Wing mirror - left side: Cap - Scratch(es) - Smart repair

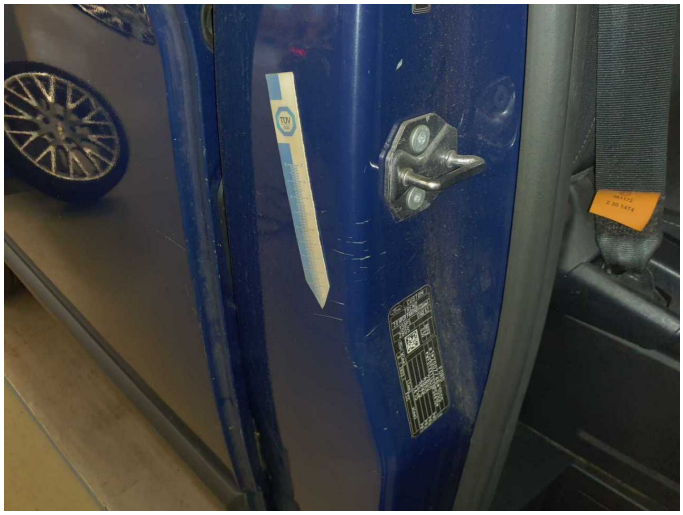
Damage 9: Sill - right side: Sill - Scratch(es) - Smart repair

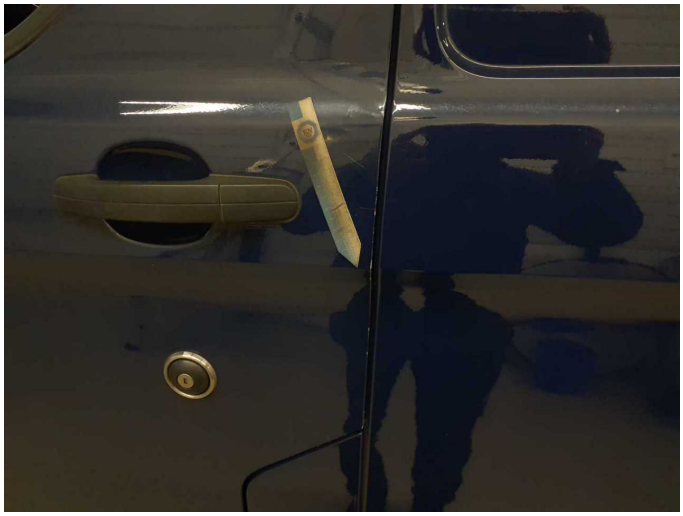
Damage 10: Door - front left side: Door - Scratch(es) - Smart repair

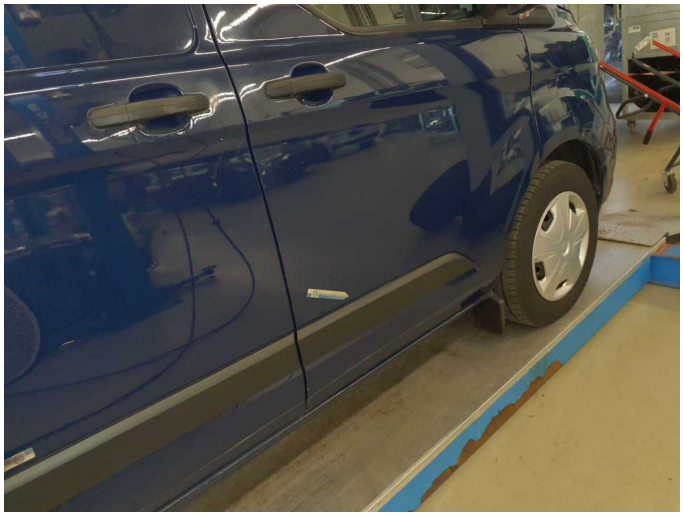
Damage 12: Door - front right side: Door (Kratzer und) - dent(s) - Repair and paint

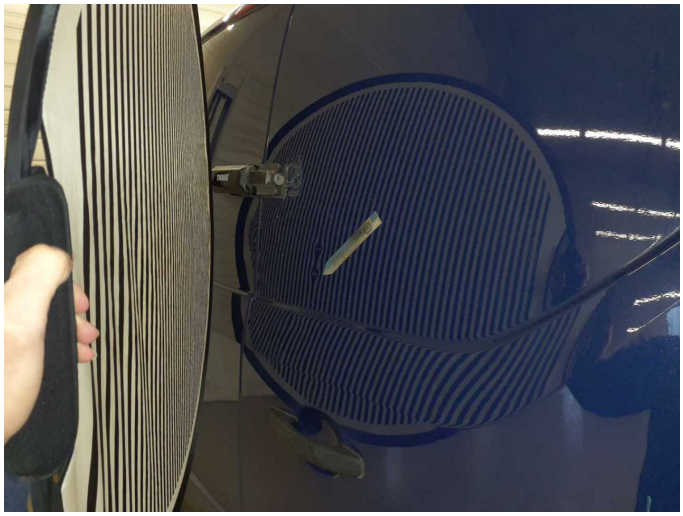
Damage 13: Boot lid / rear door: Rear door - right side - Dent / paintcoat damage - Repair and paint

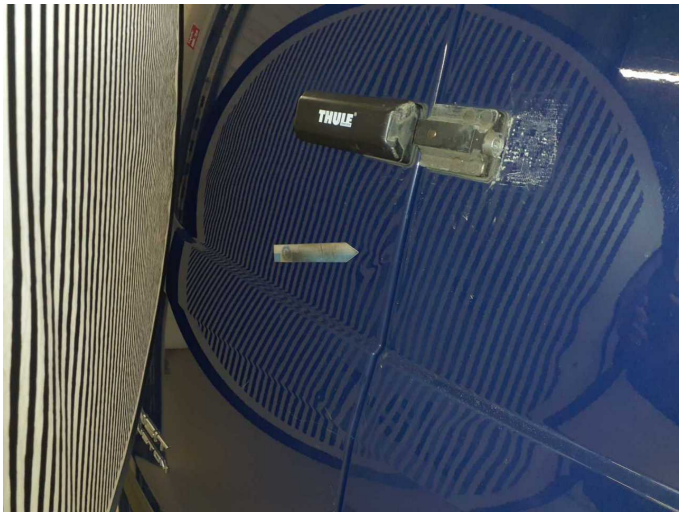
Damage 14: Boot lid / rear door: Rear door - left side - Dent / paintcoat damage - Repair and paint

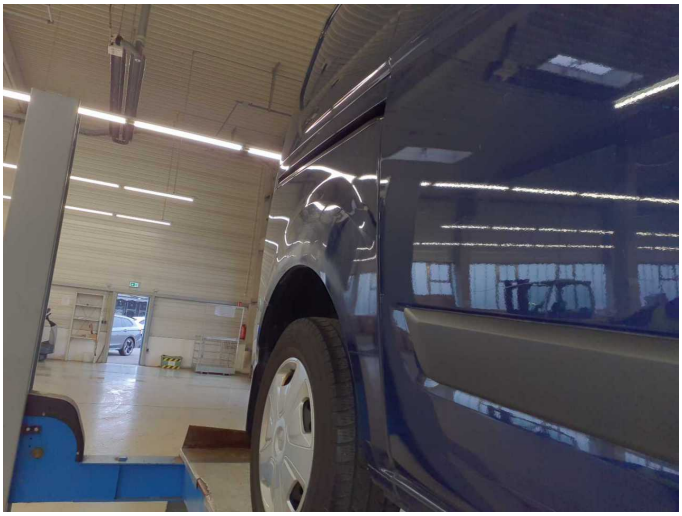
Damage 15: Side panel - rear right side: Side panel (Dellen und) - Scratched - Repair and paint

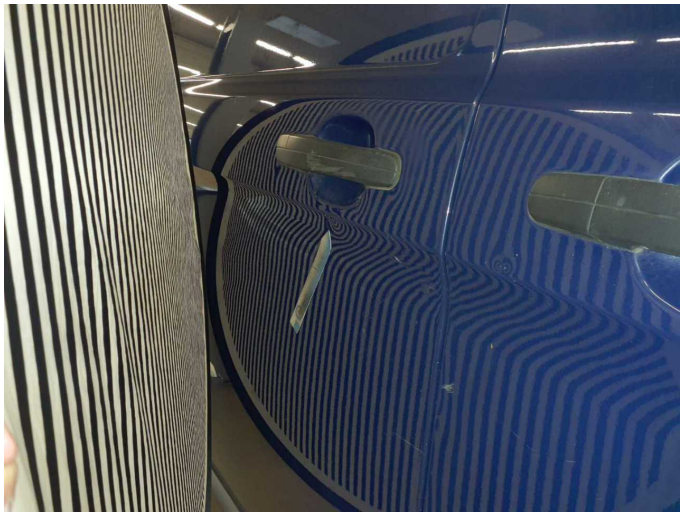
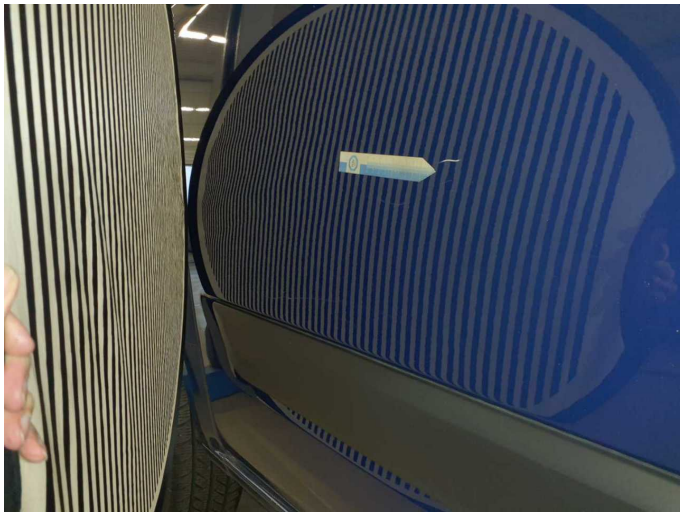
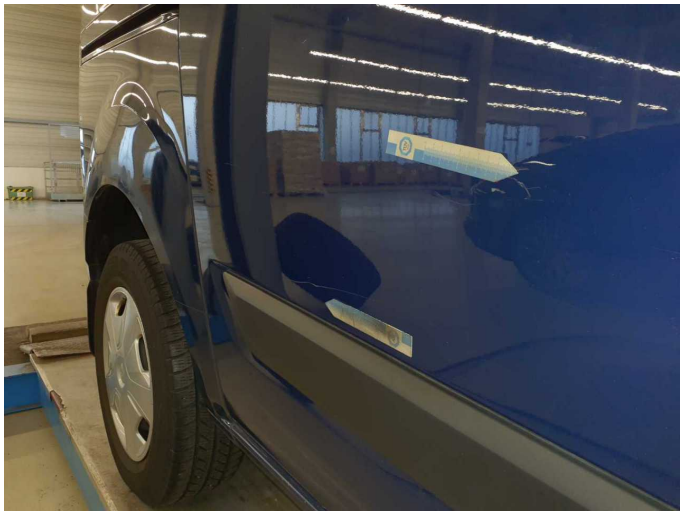
Damage 17: Sliding door, right: Sliding door - Dent / paintcoat damage - Repair and paint

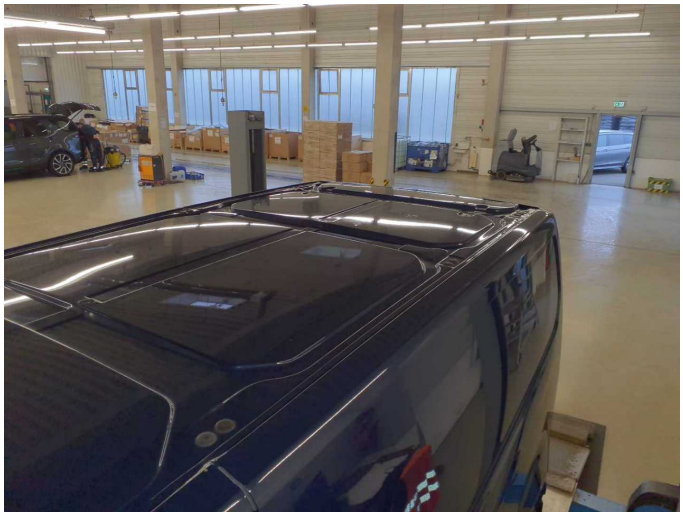
Damage 18: Vehicle glazing: Windscreen - Stone chips - Replace
