# HYUNDAI TUCSON

## Vehicle information

| Model: | **TUCSON** | VIN: | **TMAJD812DNJ113166** |
| Version: | **1.6 T-GDI PHEV 4WD FEEL AUTO** | First registration | **13/07/2022** |

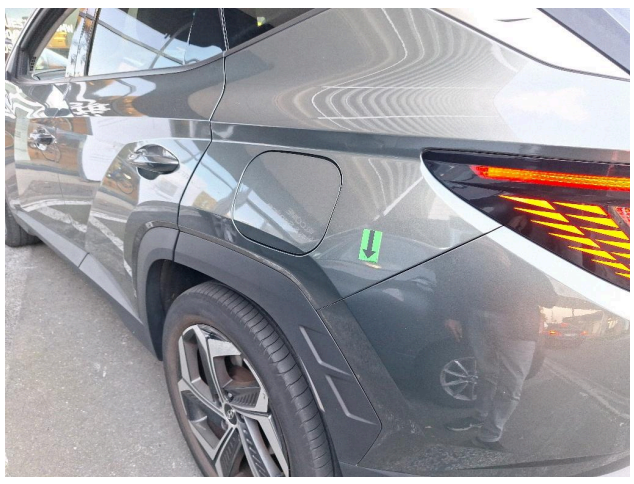
**Bodywork**

Damaged

Acceptable

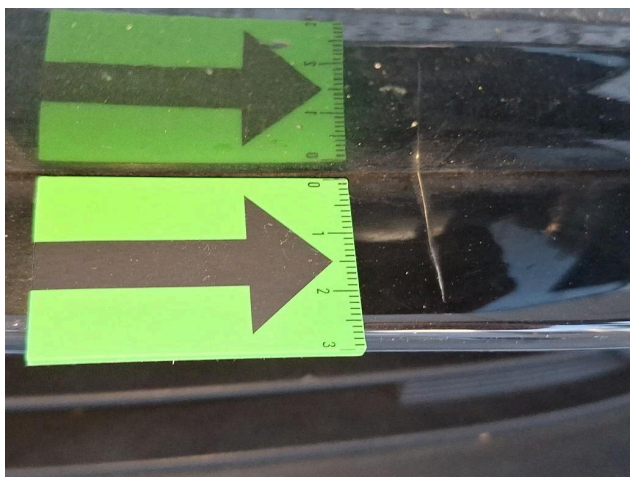
**Bumper moulding F**

Crack

Front

Replace

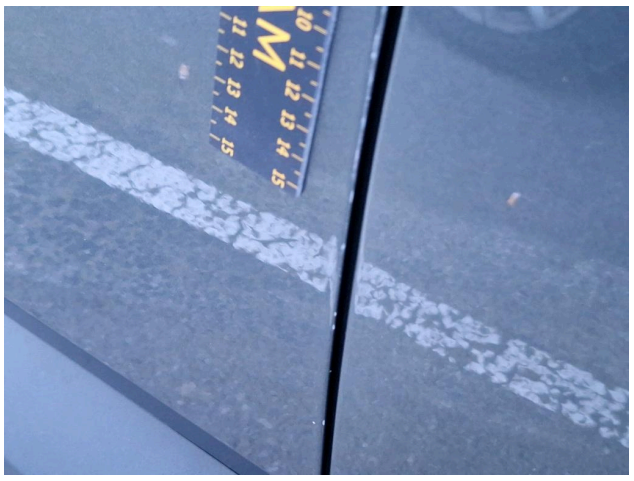
**Door FL**

Scratch(es)

Left

Paint

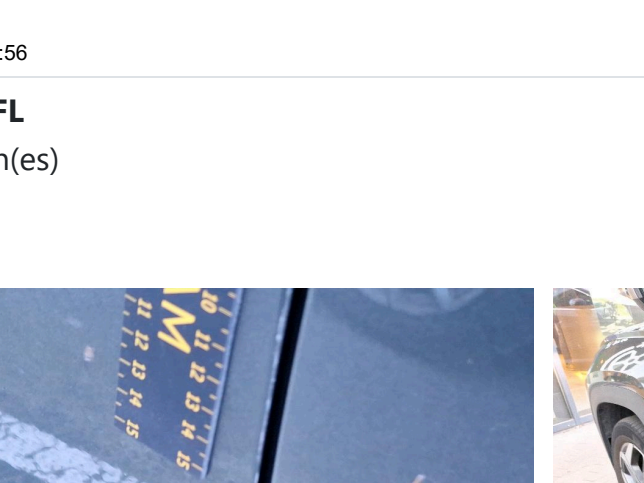
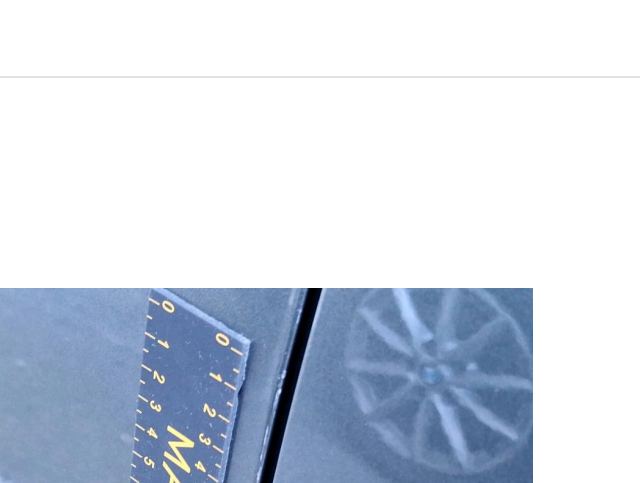
**Door RR**

Scratch(es)

Right

Polish
