Expertise

Protocol number: 48546688
Order No. / Reference: 27170140
Inspection date: 6 Nov 2026

Manufacturer: Ford	Model: Focus Turnier 1.0 EcoBoost Hybrid Aut. ST-LINE X
VIN: WF0PXXGCHPSC43690

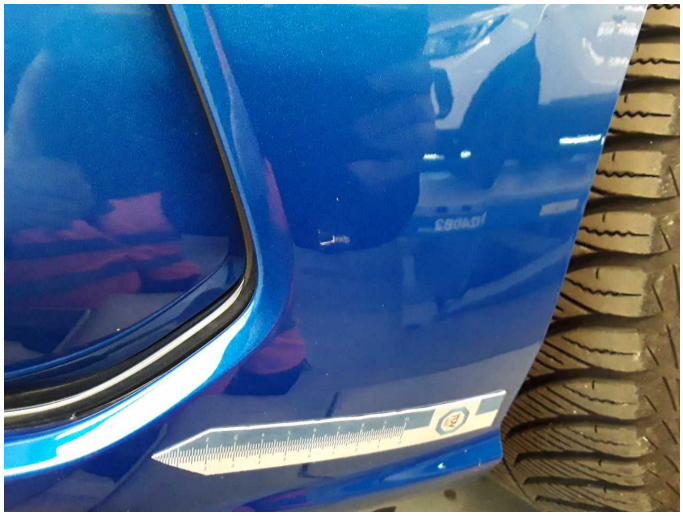
No.	Component group	Description
1	Front bumper	Front bumper - Scratch(es) - Smart repair

Damage 1: Front bumper: Front bumper - Scratch(es) - Smart repair
