TÜV SÜD Auto Partner GmbH
Wiesenring 2
04159 Leipzig

Expertise

Protocol number: 48572140
Order No. / Reference: 27212760
Inspection date: 10 Nov 2026

Manufacturer: Opel	Model: Insignia Sports Tourer 2.0 Diesel Aut. Business Edition
VIN: W0VZM8EP9M1028952

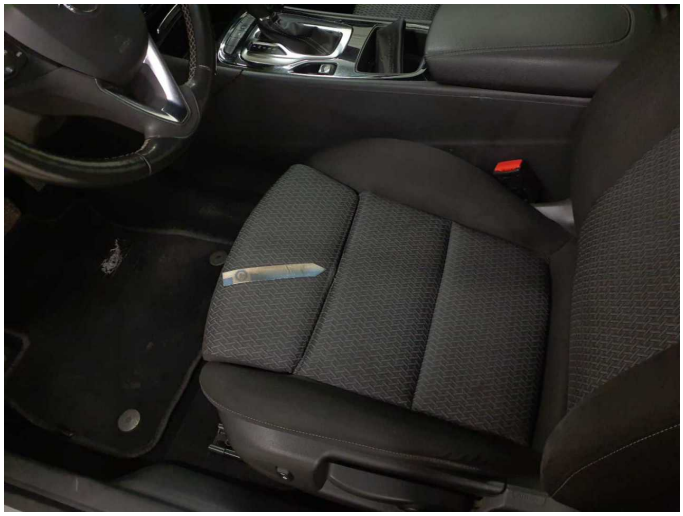
Damage 5: Seat - front: Seat cover - left side - Scratched - Replace

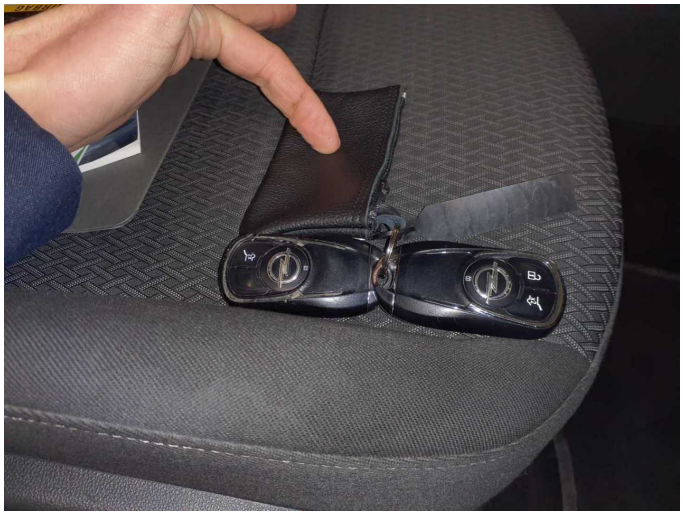
Damage 6: Equipment: Vehicle key with remote control - Broken / torn - Replace

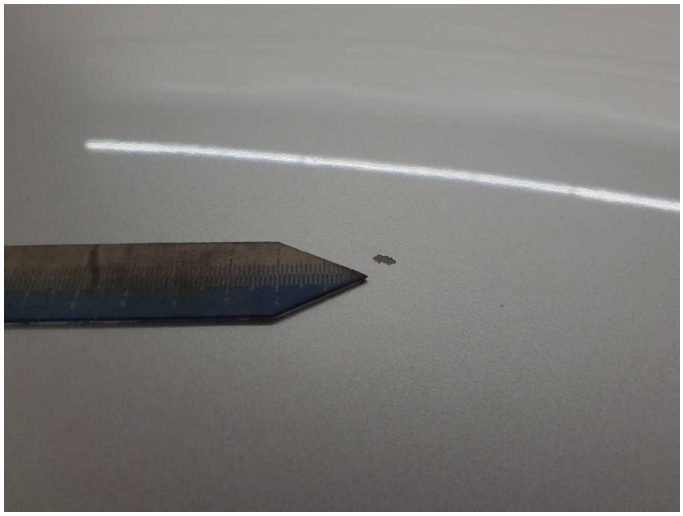
Damage 7: Front bumper: Front bumper - Scratched - Repair and paint

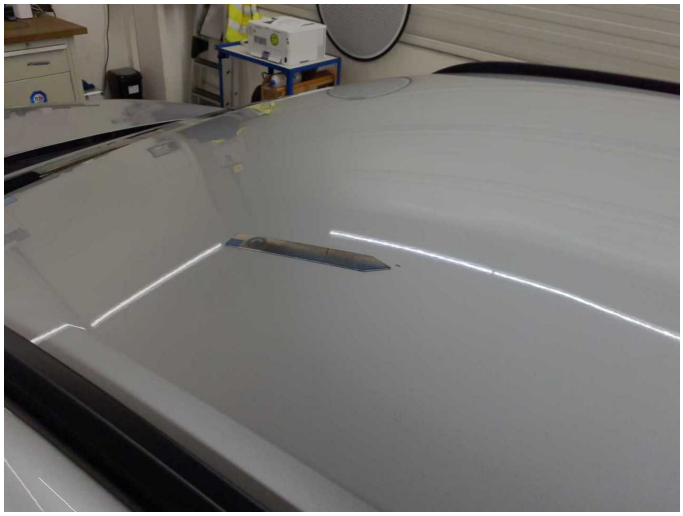
Damage 8: Roof: Roof - Stone chips - Paint
