Expertise

Protocol number: 48110005
Order No. / Reference: 27080530
Inspection date: 14 Oct 2026

Manufacturer: Mercedes-Benz	Model: E 200 d T 9G-TRONIC AMG Line
VIN: W1K2132121B089065

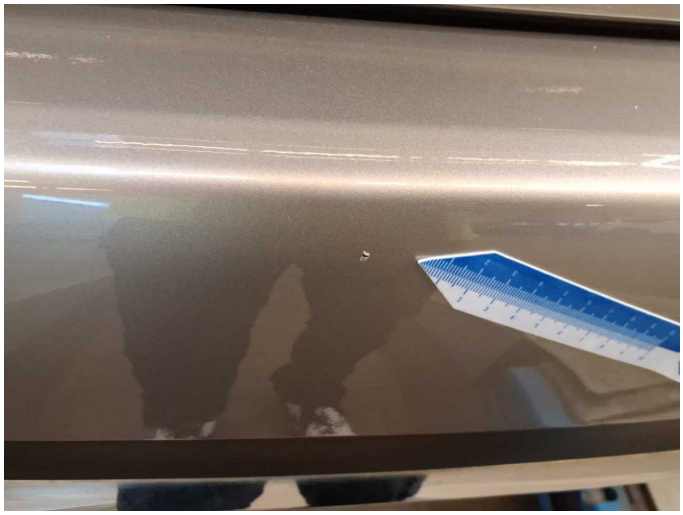
Damage 1: Rear bumper: Rear bumper - Scratch(es) - Smart repair

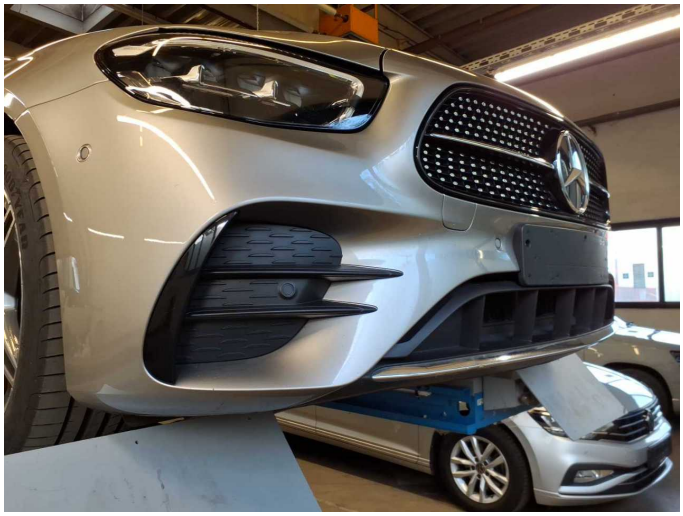
No.	Component group	Description
1	Rear bumper	Rear bumper - Scratch(es) - Smart repair
2	Front bumper	Front bumper (Chromleiste) - Broken / torn - Replace
3	Front bumper	Front bumper - Scratch(es) - Paint

Damage 2: Front bumper: Front bumper (Chromleiste) - Broken / torn - Replace
