# VOLVO XC40

## Vehicle information

## Damages

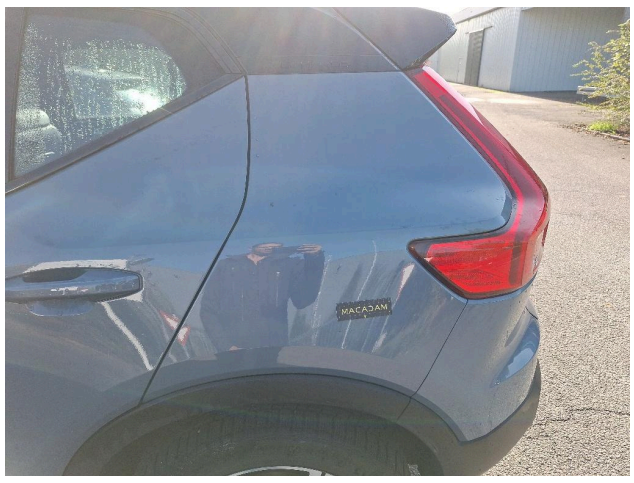
**Left Wing** Claw (
s)
Polishing

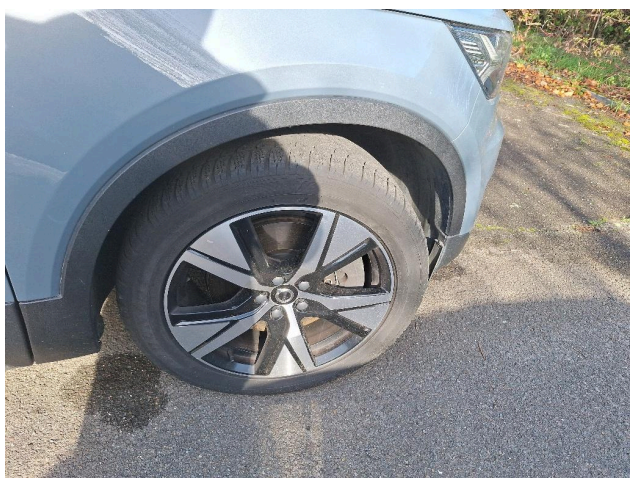
**Bodywork**
Damaged -
Acceptable.
Roof & other

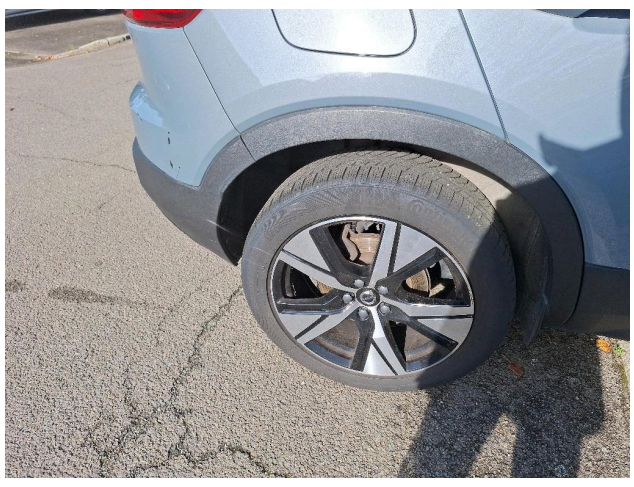
**Rear bumper trim with E-**
shaped claw(s)
-
Replace
