Expertise

Protocol number: 48473761
Order No. / Reference: 27227082
Inspection date: 2 Nov 2026

Manufacturer: Skoda	Model: Superb Combi 1.4 TSI iV DSG Sportline
VIN: TMBJW9NP9R7015582

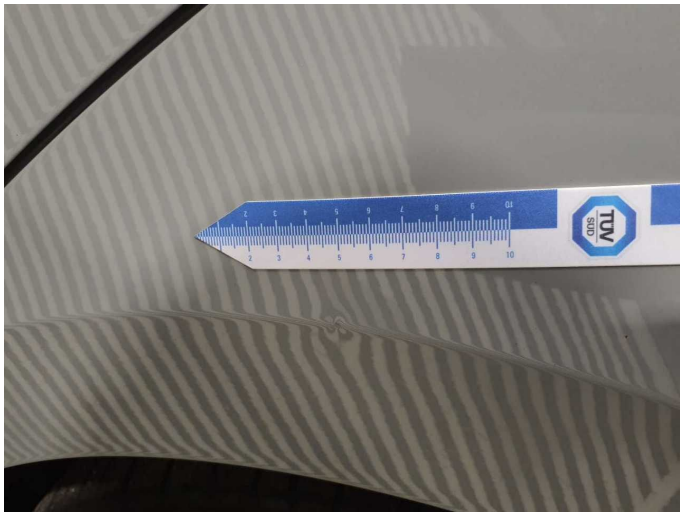
Damage 2: Side panel - rear left side: Side panel - dent(s) - Smart repair

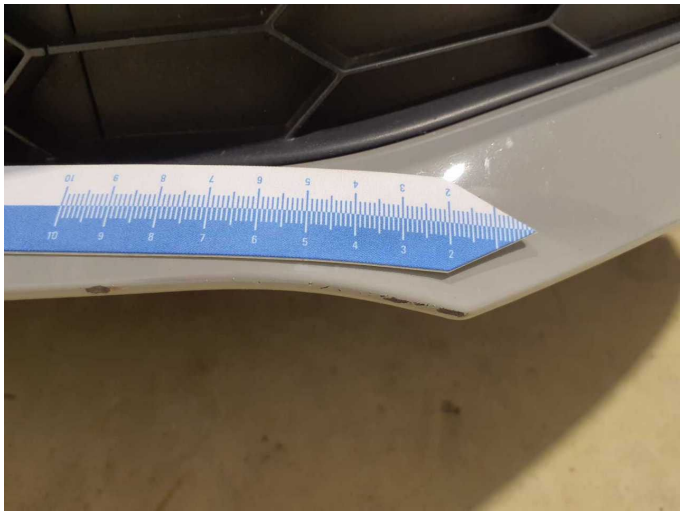
Damage 3: Front bumper: Front bumper - Scratch(es) - Smart repair

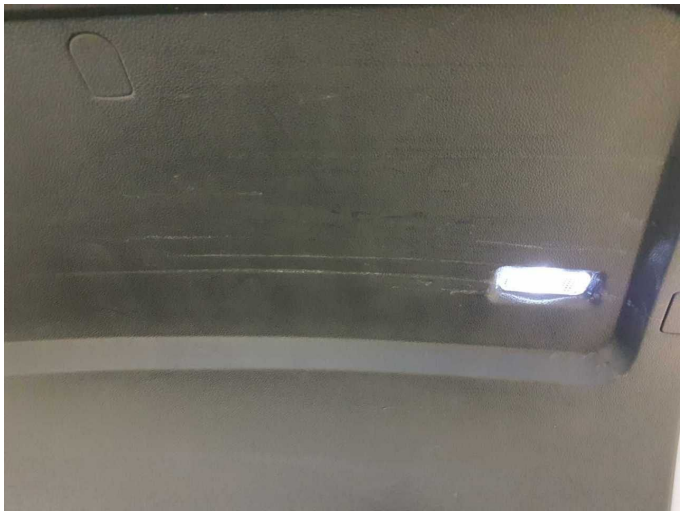
Damage 5: Interior: Cargo area floor (Bezug löst sich) - Loose - Replace
