Expertise

Protocol number: 48567806
Order No. / Reference: 27233314
Inspection date: 9 Nov 2026

Manufacturer: Ford	Model: S-Max 2.5 Duratec FHEV TITANIUM
VIN: WF0JXXWPCHNU74810

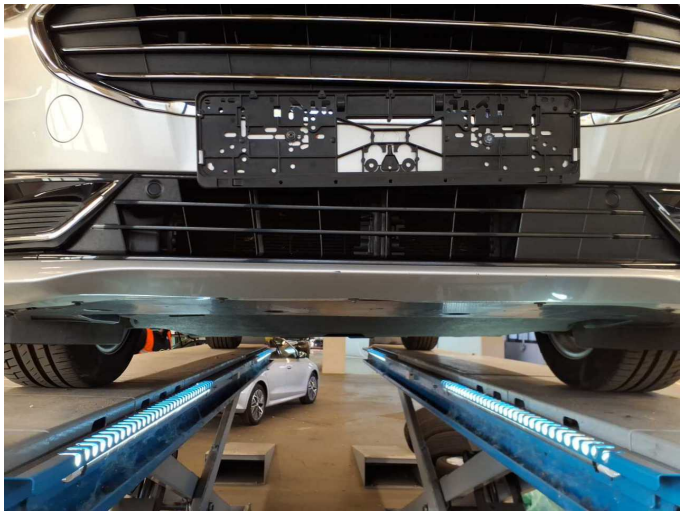
No.	Component group	Description
1	Equipment	Tirefit filler - Expired - Replace
2	Front bumper	Front bumper - Scratch(es) - Smart repair

Damage 1: Equipment: Tirefit filler - Expired - Replace
