CITROÃ‹N GRAND C4 SPACETOURER

Vehicle information

Summary of damages

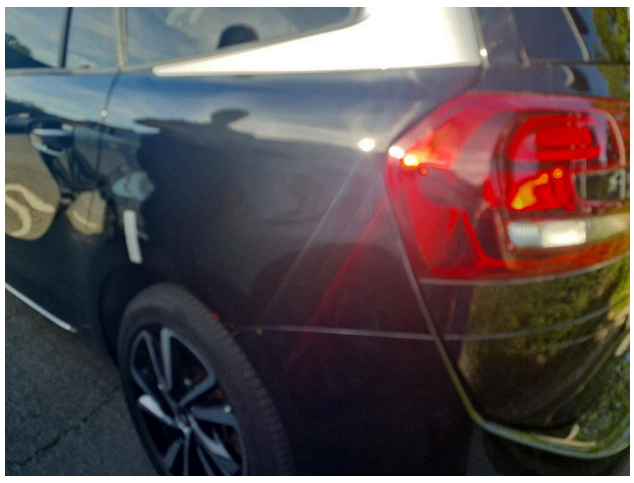
Bodywork
Damaged -
Acceptable.
Roof & other

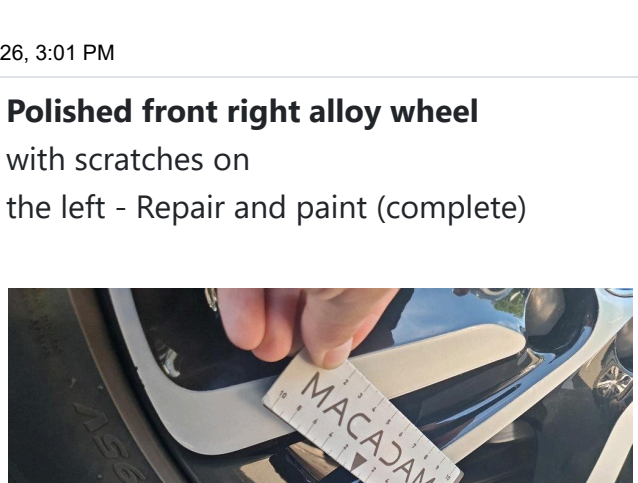
Polished front right alloy wheel
with scratches on
the left - Repair and paint (complete)
