APPRAISAL REPORT

Driver name:	HM Tongeren
Make:	VOLKSWAGEN
Model / version:	PASSAT VARIANT
Wine:	WVWZZZ3CZNE002912
Plate:	2AWU408
Mileage:	90359
First registration:	19/08/2021
Color:	manga grey

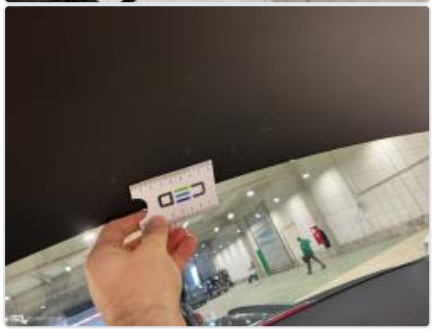
1 - Boot cover - Grooved

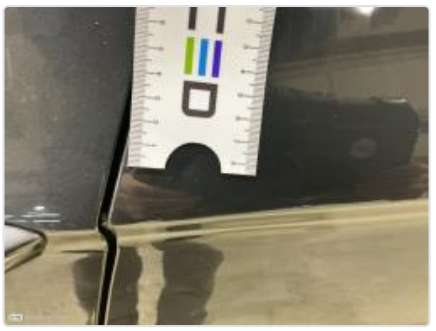
3 - Bumper F - Grooved

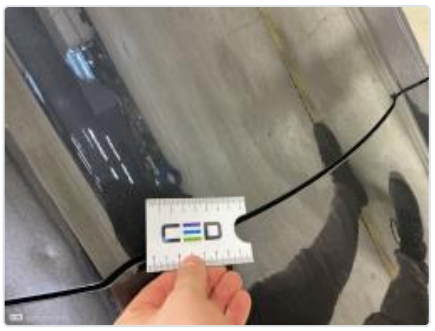
4 - Bumper spoiler F - Grooved
