ARVAL
BNP PARIBAS GROUP

2BVM781

INSPECTION REPORT

End of contract

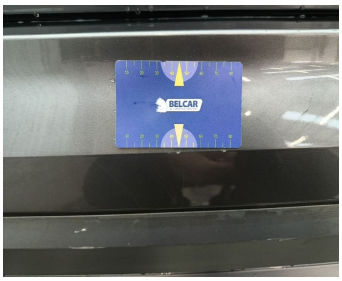
Bumper Front // Repair & Painting-scratch + dent
