TÜV SÜD Auto Partner GmbH
Wiesenring 2
04159 Leipzig

Expertise

Protocol number: 48023421
Order No. / Reference: 26837733
Inspection date: 9 Oct 2026

Manufacturer: Mercedes-Benz	Model: GLE 300 d 4Matic 9G-TRONIC AMG Line
VIN: W1NFB0KB5PA964769

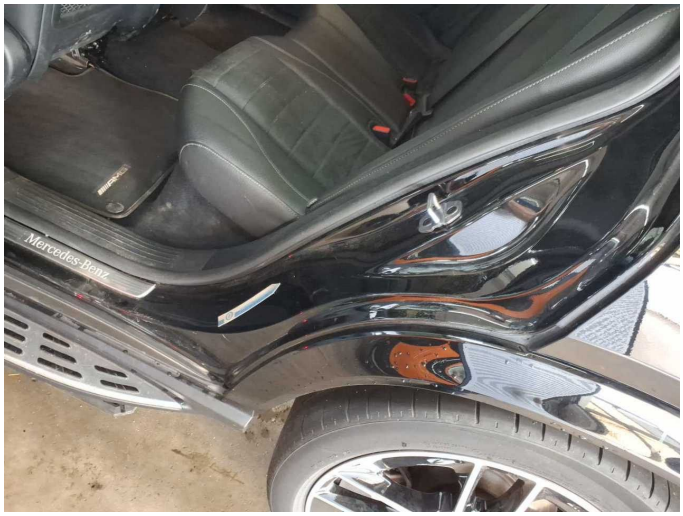
Damage 1: Side panel - rear left side: Sill - dent(s) - Smooth repair work

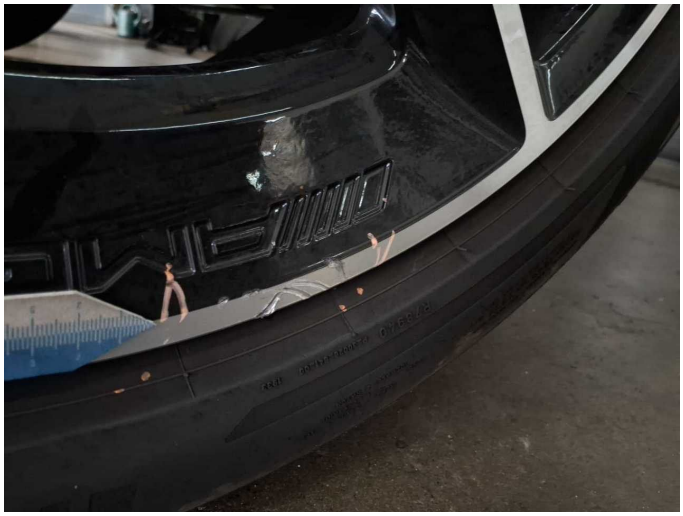
Damage 7: Wheel / tyres: Alloy rim - front right side - Scratch(es) - Loss in value

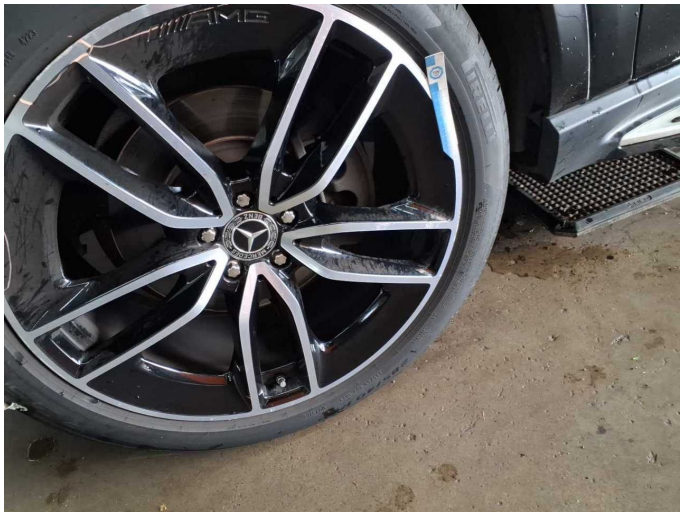
Damage 8: Wheel / tyres: Alloy rim - front left side - Scratched - Loss in value

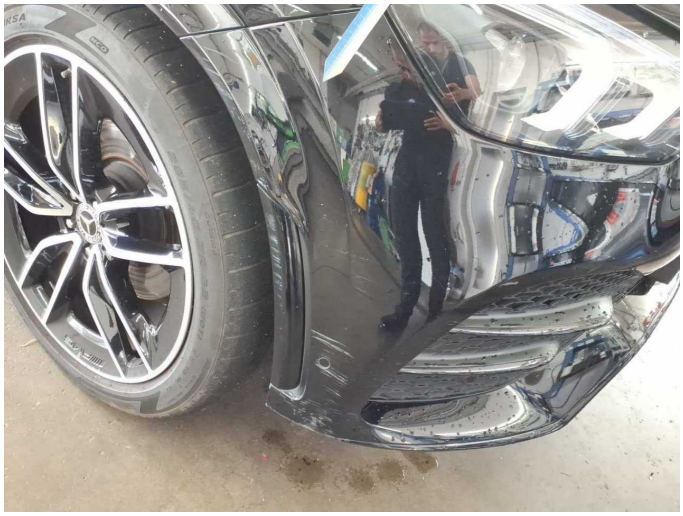
Damage 9: Rear bumper: Rear bumper (+ Spoiler lackieren) - Scratch(es) - Paint

Damage 10: Front bumper: Front bumper (+Zierleiste links unten lose+ rechtes verkratzt erneuern) - Dent / paintcoat damage - repair according to calculation

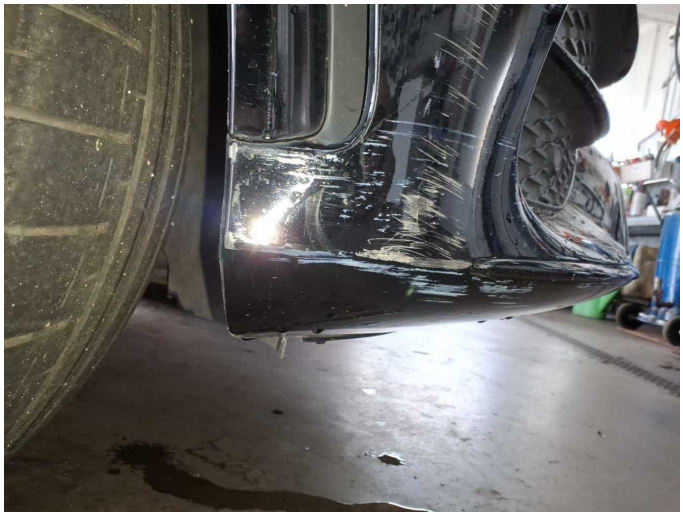
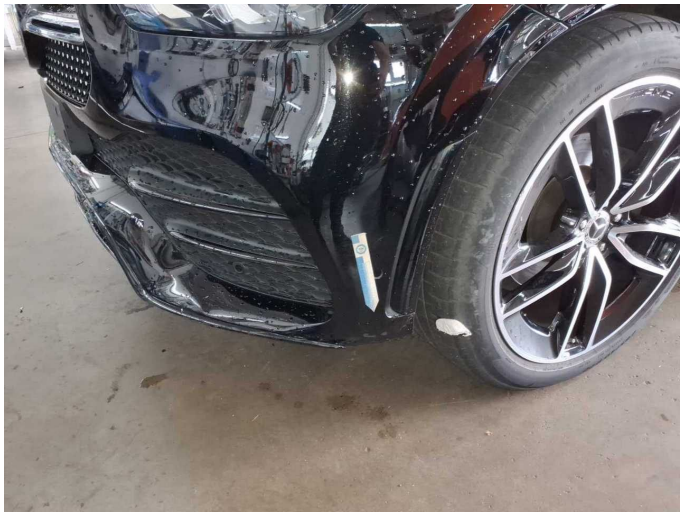
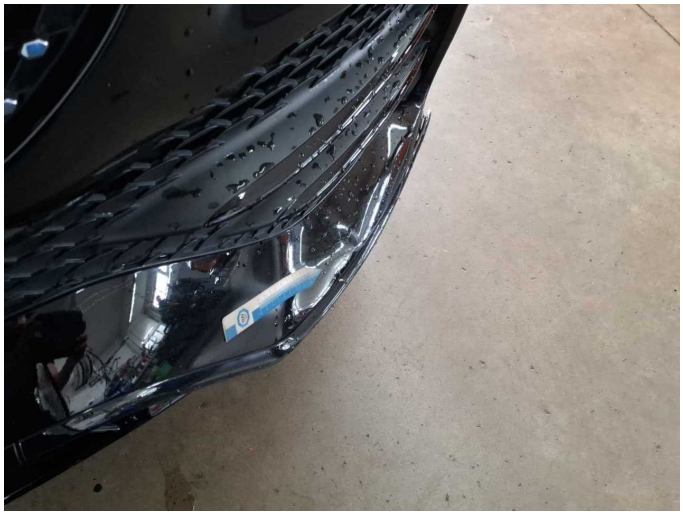
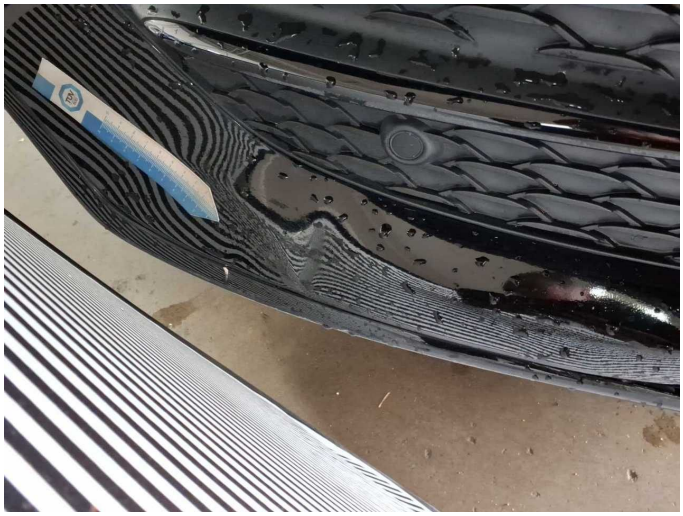
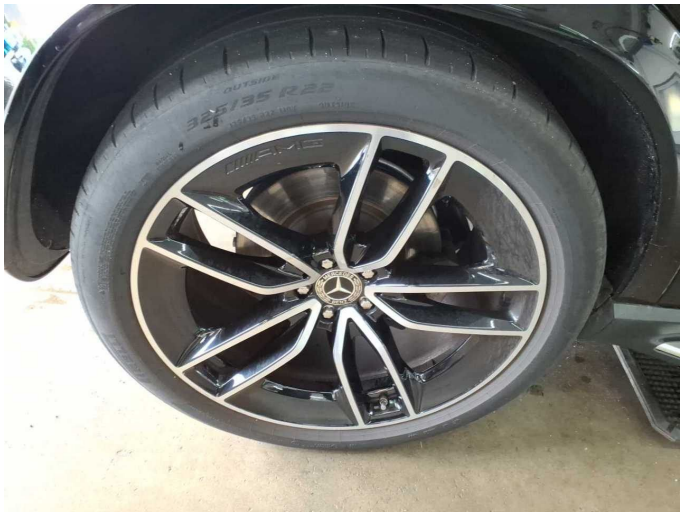
Damage 10: Front bumper: Front bumper (+Zierleiste links unten lose+ rechtes verkratzt erneuern) - Dent / paintcoat damage - repair according to calculation

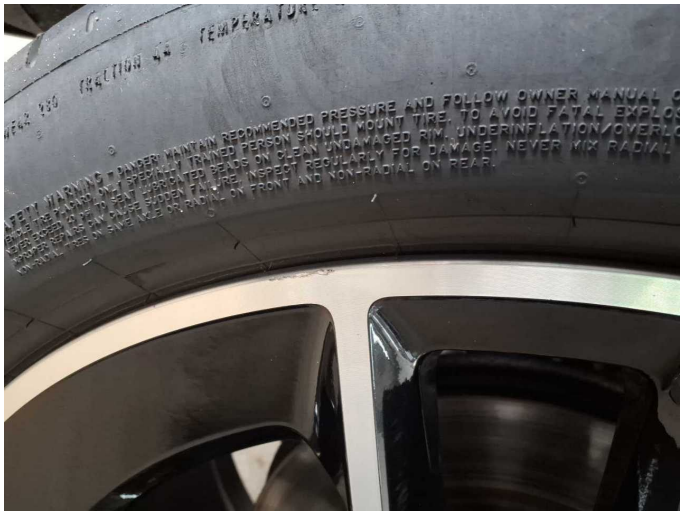
Wear and tear 1: Wheel / tyres: Alloy rim - rear right side - Scratch(es) - No deduction

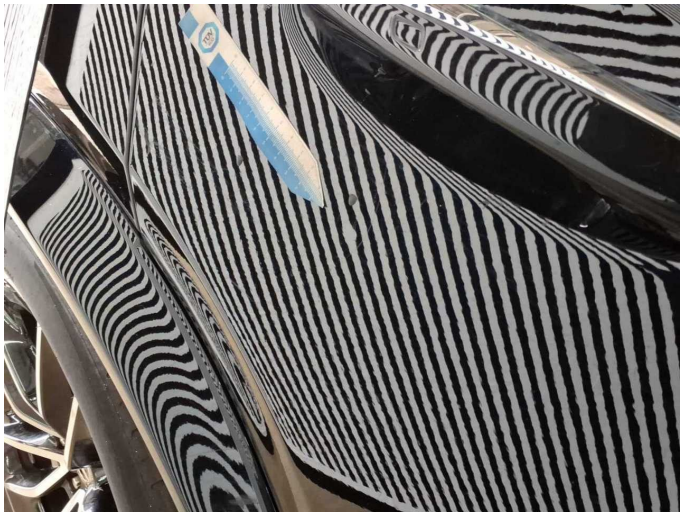
Wear and tear 3: Door - rear right side: Door - dent(s) - Smooth repair work
